Evaluation of Imminent Fire Hazards of Inheritance Ancestral Temple and Mansion in Georgetown, Penang

M.A. Othuman Mydin¹, N.A Agus Salim², N. Md. Sani³, Y.Y. Khaw⁴

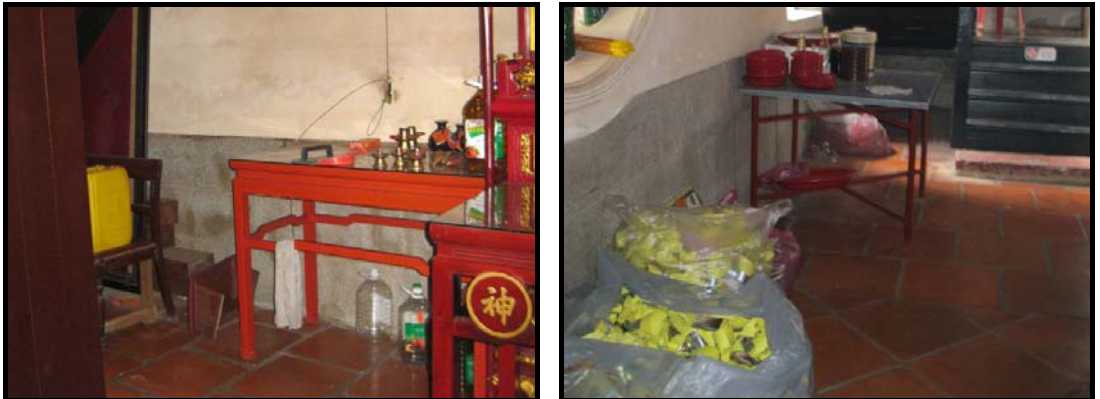
After the fire risks assessments were carried out, it is found that the fire risk of the temples is mainly from the joss stick used to worship the ancestral. Besides, the fire hazards are more likely to come from the oil lamps where the posterities light up the oil lamps as to pray for good fortune. The storage management for combustible materials vary in each temples. Khoo Kongsi makes a good example in keeping them whereas Hock Teik Cheng Sin Temple are less aware of this issue. The combustible materials are not well kept as shown in Fig. 2. There should be a store to keep all the flammable materials in the temples.

Figure 2: Oil for lamps and joss stick not well kept (left) and materials to worship not properly kept (right)

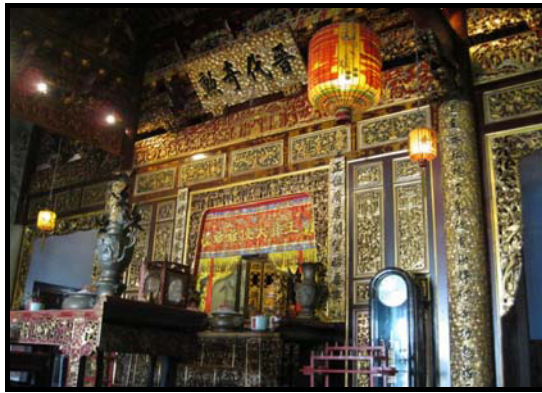
Fig. 3 shows a typical worship hall of these ancestral temples in Khoo Kongsi. It is clear that the area is made up almost 70% by timber. Timber is a highly flammable building material. Thus, the fire risks increased proportionally with the types of building materials. Nobody actually staying in four of the temples nowadays, thus there is no open flame and fire hazard from the kitchen as compared to old times. The main electrical installation and equipment are inspected occasionally, depending on situation of each temple. In preventing electrical fire, there is however, no testing procedure been carried out.

Figure 3: A typical worship hall of the ancestral temple at Khoo Kongsi

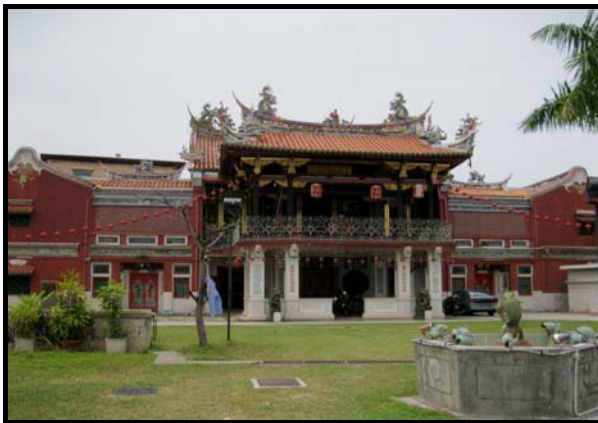
Under UBBL clause 166, it states that every floor space shall be provided with at least two exits on the basis that if one exit is inoperable, the other exit can serve the function [13]. Every ancestral temple fulfilled this aspect because all of the temples have more than one excess to upper floor. It meets the requirement of to provide with at least two exits on the basis that if one exit is inoperable, the other exit can serve the function. However, the exits routes in these temples are not provided with conspicuous exit sign such as the “Green Running Man” on a white background. However, it is quite easy to escape from these temples as the points of exits from the building clear of obstructions. All floor surface and stairs on escape routes are free from tripping and slipping hazards [14]. However, the door used in all the ancestral temples are not fire rated door. This puts people in dilemma because when efforts are made to protect the heritage art and culture of the elements of these temples, we need to compromise a little with these art values. Lighting wise, it can be considered as satisfactory as all lighting (normal and where provided emergency) on escape routes are fully operational. However, to the needs of the disable, all the four temples have not provides mean of escape adequately for them. The escape routes of these ancestral buildings are by far satisfactory and they all leads in different direction to places of safety, as shown in Fig. 4, the open space in Cheah Kongsi.

Figure 4: Large open space outside of Cheah Kongsi for mean of escape during fire outbreak.
