Refurbishment and Installation of a Monitoring and Early Warning System on the Sierroz Embankments in Aix-les-Bains. France

Jean-Robert Courivaud^{1,a}, Rémi Béguin² and Thierry Monier³

Abstract. Sierroz embankments are located in an urban area, in the city of Aix-les-Bains (Savoie, France). Their linear is 400m on both rims. These embankments protect about 900 people against Sierroz river floods. Hydraulic studies performed in the frame of the Aix-les-Bains Inundation Risk Prevention Plan (PPRI in French) have shown that these embankments have a high risk of failure by overtopping during a 100 year return period flood of the Sierroz River. These studies have defined inundation maps with High Danger areas. From these results, the city of Aix-les-Bains asked EDF to perform a safety assessment study, in order to assess the safety margins of these embankments for each of their potential failure modes: overtopping erosion, internal erosion, slope sliding and liquefaction. This study confirmed that the main risk is breaching by overtopping erosion during flood. This diagnosis led the city of Aix-les-Bains to launch two parades: (i) the embankment refurbishment in order to provide them

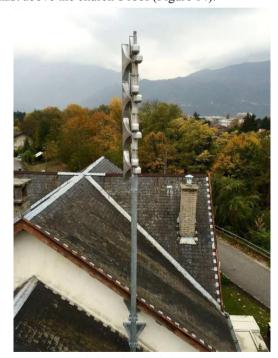
Figure 14. Sound alarm installed above the church's roof In addition to the sound alarm, an automatic phone call alert is launched at the same time. Every inhabitant living in the High Risk Area is automatically called by this system and informed of an imminent risk of embankment breach.
