# Stability evaluation of modernized bank protections in a culvert construction

**Abstract.** The paper presents stability evaluation of the banks of the Wilga River on a chosen stretch in Koźmice Wielkie, Małopolska Province. The examined stretch included the river bed upstream from the culvert on a district road. The culvert construction, built over four decades ago, was disassembled in 2014. The former construction, two pipes that were 1.4 m in diameter, was entirely removed. The investor decided to build a new construction in the form of insitu poured reinforced concrete with a 4 x 2 m cross section. Change of geometry and different location in relation to the river current caused increase in the flow velocity and, as a consequence, erosion of both protected and natural banks. Groundwater conditions were determined based on the geotechnical tests that were carried out on soil samples taken from the banks and the river bed. Stability calculations of natural slopes of the Wilga River and the ones protected with riprap indicate mistakes in the design project concerning construction of the river banks. The purpose of the study was to determine the stability of the Wilga River bank

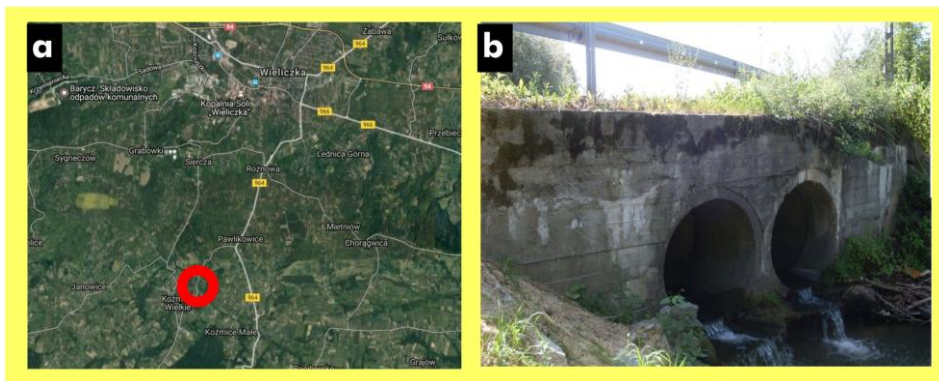
The culvert was built in 1970s for lightweight horse and vehicle traffic. At that time the road was rather quiet and unpaved. In the following years the road was paved using metallurgical slag, later an asphalt surface was placed (Fig. 2a). Two reinforced concrete pipes with an internal diameter of 1.4 m were used as elements carrying water. The length of each pipeline was 10.3 m (Fig. 2b). The culvert was built without any design project since it was not necessary at the abovementioned economic conditions.

**Fig. 2.** a) Localization of the culvert b) condition of the construction before rebuilding

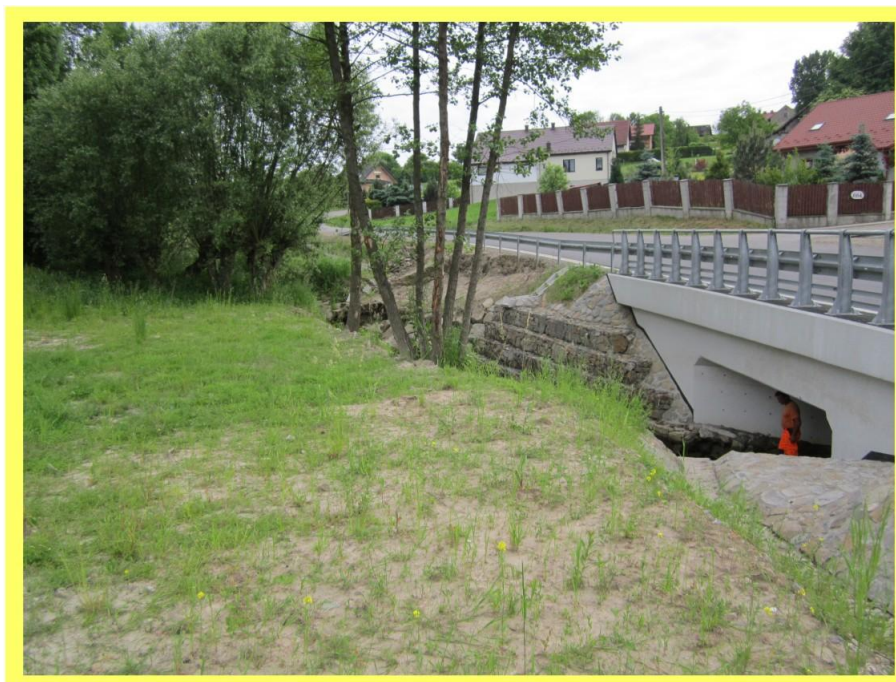
Former culvert pipe was entirely disassembled. On the ground level where geotechnical parameters were appropriate the base of a new culvert was built. It is a reinforced concrete culvert poured on site; it is a closed frame based directly on solid clayey soils. The front walls are situated parallel to the road axis. The total length of the construction is 11.74 m. The horizontal diameter is 4.00 m, the vertical 2.00 m (Fig. 3) and the total carriageway is 10.34 m wide.

**Fig. 3.** Culvert on the upstream side and the view of damages

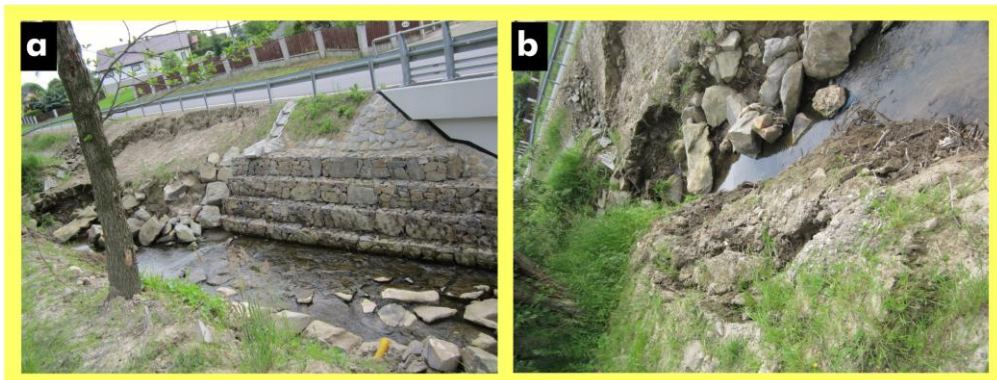
In the first year (2015) after the construction was finished the bank protection on the right side formed from riprap slid along with the soil from the slope fig. below.

**Fig. 4.** The view of damages that occurred after the first year of exploitation a) from the downstream side and b) upstream side

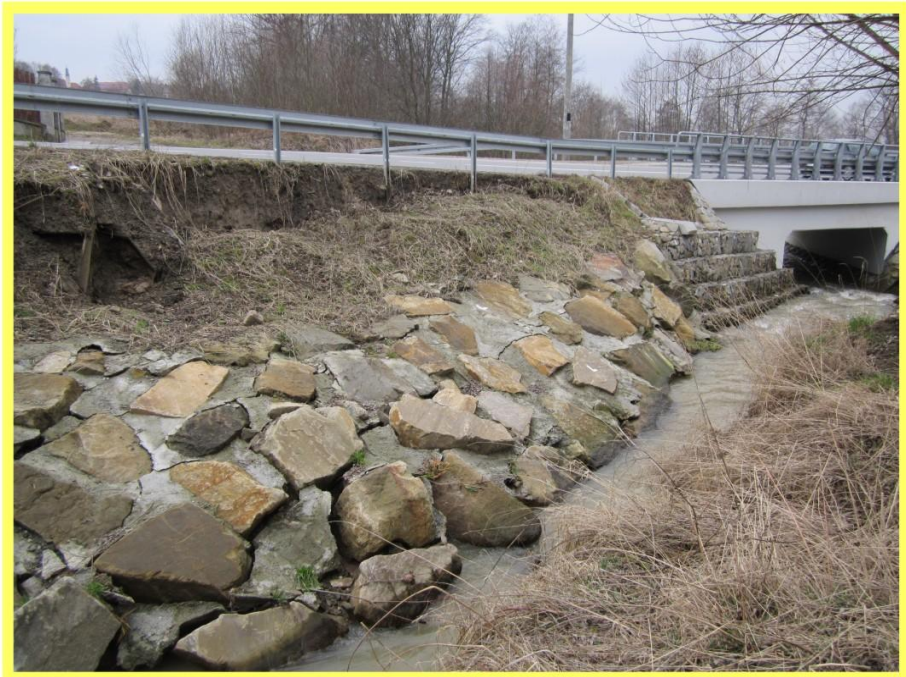
In the following year (2016) the improved protection was also gradually destroyed. Progressive failure of the bank is presented in fig. below.

**Fig. 5** The view of damages that occurred after the second year of exploitation from the upstream side

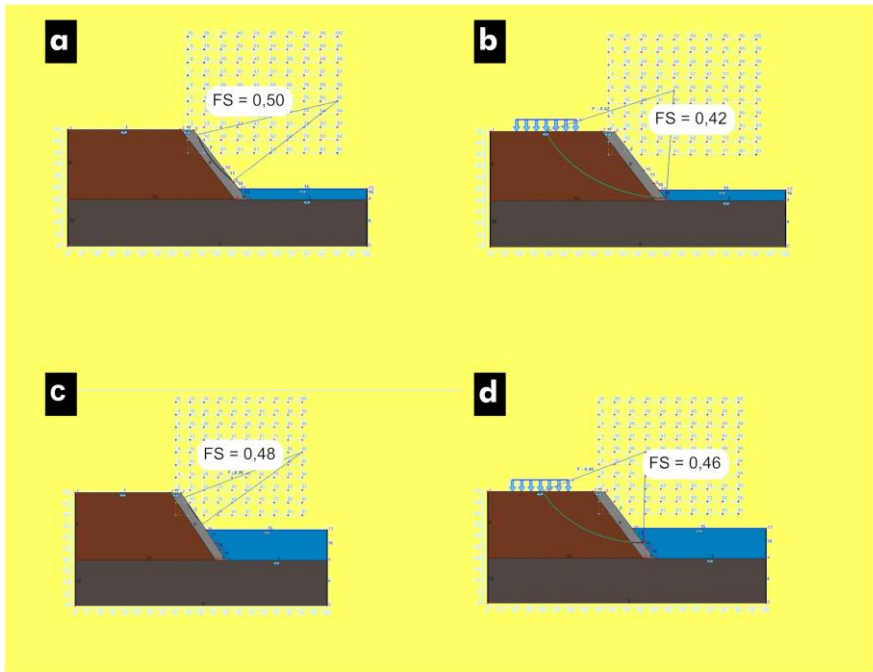
**Fig. 6** Calculation scheme for the first model – at low water level a) without any load, b) vertical load of 1000 kN. Calculation scheme for the second model – at high water level c) without any load, d) vertical load of 1000 kN

Scheme presented in Fig. 6a shows the results of calculations at low water level – parameters of the soil (Tab. 1) and geometry of the slope resulted in the value of the global stability factor of safety at 0.50.

Apart from total saturation of the slope, the scheme in Fig. 6b assumes that there is a heavy transport vehicle on the top of the road, which was presented on the scheme as vertical load of 1000 kN. The factor of safety is 0.42. Failure surface goes deeply into the road.

When the water level is high (Fig. 6 c,d) the values of the factor of safety do not differ significantly from the first model. Adequately it was 0.48 for the road without any load and 0.46 when there is a surface load of 1000 kN.

All obtained results of the factor of safety are below the limit value of 1.0 (Tab. 2). When the water level is low it undermines the base of the slope and at the same time the water filtrates through the ground from the opposite side of the road embankment. During the low and medium flow, in the hole scour, the average values of velocity at measurement points were in range from  $V = 0,210$  m/s to  $V = 0,333$  m/s. The maximum values at vertical measurements points were equal from  $V = 0,223$  m/s to  $V = 0,370$  m/s. Then, the values measured above the river bed were in range from  $V = 0,060$  m/s to  $V = 0,32$  m/s. The river bed is a natural drainage element for the adjacent area, so water supply to the river banks has to be taken into consideration [8, 9, 10]. When the water level is high the hydraulic pressure is compensated by the water pressure. Although another unfavourable phenomenon connected with water uplift pressure occurs (decrease in the value of density in the calculation scheme) [11, 12, 13]. It should also be noticed that high current velocity washes out and lifts the soil material.
