Vertical Displacement of the Surface Area over the Leakage to the Transverse salt Mine in 1992–2012

Tomasz Lipecki^{1,*}

¹ AGH University Science and Technology, Faculty of Mining Surveying and Environmental Engineering, A. Mickiewicza Av. 30, 30-059 Krakow, Poland

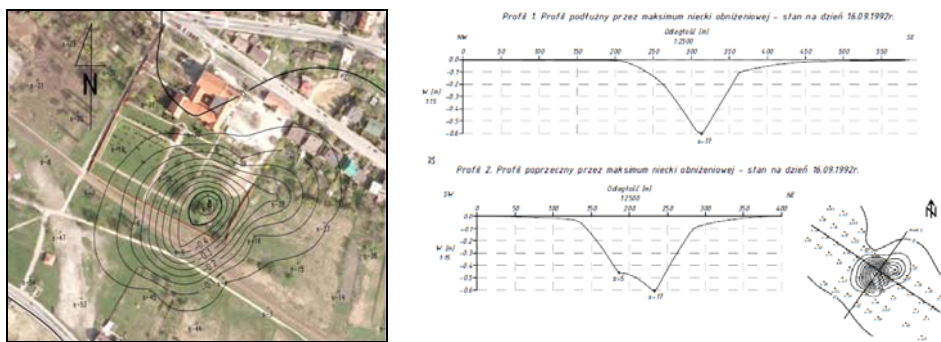
Initial measurements from June to September 1992 showed no significant changes in the surface area. Maximum reductions reached 22 mm in the two points of the observation network during that time. A sudden vertical displacement occurred at the beginning of September as a consequence of another rapid flooding of the water to the transverse, along with a large amount of rock material. The largest subsidence within 4 days reached almost 40 cm, and in the following week increased by another 21 cm. The situation of the depression formed at that time is shown in Figure 5. The reduction covered almost 3 ha and its volume amounted to over $3,800\text{ m}^3$, which gives an idea of the amount of material displaced in the transverse region.

Fig. 5. Subsidence basin –September 1992
