Application Research of Multiple Detection Technology in Equipment Fault Diagnosis

HUADIAN ELECTRIC POWER RESEARCH INSTITUTE Co., LTD. Turbine and gas turbine technology department, 310030 Hangzhou China

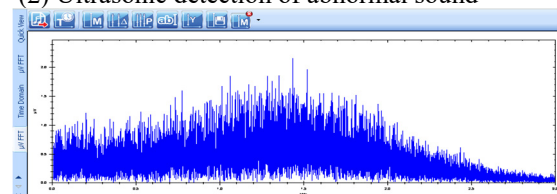
Figure 2 Ultrasonic test chart

The spectrum shows that the abnormal spectral line is mainly concentrated at the frequency of 350hz-650hz. This frequency range is typical of the wear of 6318 bearing; the fault frequency of the inner ring of the bearing and the 1x frequency sideband are obvious. Combining the data and phenomena above the inner ring of the bearing can be used to judge about wear, pit or pcc^[7-8].

1.2 Maintenance suggestions

- (1) Arrange for inspection and replacement of the drive end bearing.
- (2) Clean the bearing chamber during maintenance and replace the packing.
- (3) Adjust the clearance and tightening force of each component to meet the requirements of the maintenance regulations.

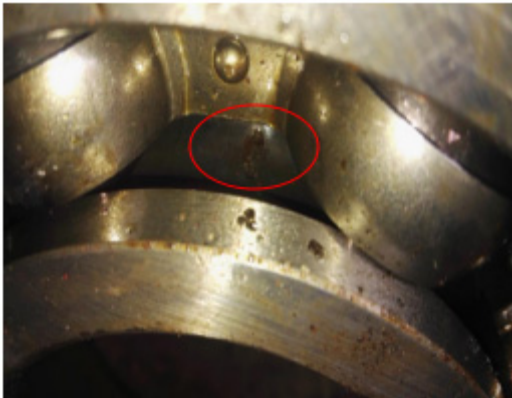
(1) Demolition inspection of the drive end bearing, the bearing inner ring raceway is spread over the pit and peeling (Fig. 3).

Figure 3: Large peeling, pits

water pump is damaged due to improper adjustment of bearing tightening force.

(2) The pump is often not adjusted in time due to water leakage enters the bearing chamber and causing deterioration of oil quality. And then lead to peeling and pits in the raceway. It is necessary to adjust the clearance and tightness between the components to the specified range according to the requirements of the maintenance regulations. And all parts should be clean.

(2) Replace the bearings and packing at both ends.

(3) Re-check the bearing tightness and adjust the gasket to pass.

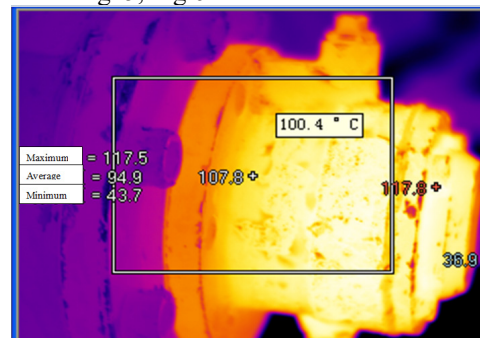
Figure 5 Oil pump infrared map

(1) It was found that the sealing temperature of the oil pump drive was as high as 110 °C during operation. After one week of operation, the temperature reached 117.5 °C, as shown in Fig. 5, Fig 6.

The oil pump vibration test data is normal. The ultrasonic test is normal. The machine seal has no sputum oil phenomenon.

(1)After the pump is replaced, the original machine seal ring spring has a compression of 7.5mm-8mm and is adjusted to 5mm. After closing the sealing force of the small machine, the sealing temperature of the machine is raised from 80 °C to 118 °C.

(2) The temperature difference about the gasket one side with another is 36 °C. Therefore it can be judged that there is a problem in the gasket installation at the oil return hole.

(1) It is necessary to stop the pump to check the gasket at the oil return hole of the machine and clear the oil return hole.

(2) AS the data is normal when detecting the vibration of the equipment. There is a certain risk in the operation of the air-side sealed oil pump during the operation. And it would not be processed temporarily. The standby group would be overhauled during the mediation.

(3) Check the sealing temperature of the sealed oil pump machine on time. The maintenance and repair suggestions are according to the temperature rise trend [9-11].

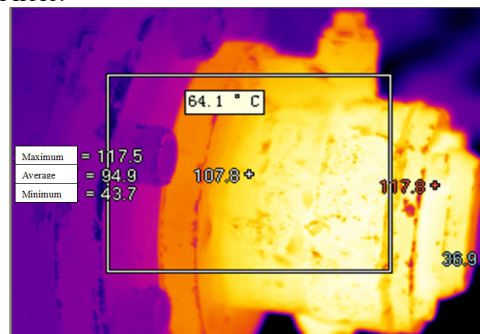
Figure 6 Temperature after the oil hole gasket 64.1 °C

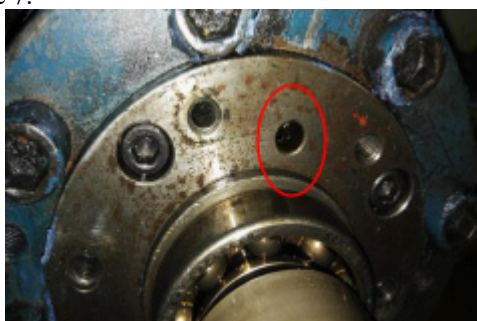
Figure 7 Machine seal return hole

(1) The gasket at the oil return hole of the machine is deflected by an angle. The installation position was incorrect and blocking the oil return hole. Replace the gasket at this point and leave the oil return hole, see Figure 7.

(3) By infrared temperature analysis the abnormal temperature of the equipment is caused by the maintenance worker's unfamiliar construction of the equipment. The work is not carefully performed. It is not properly returned to the original position, causing the clogging machine to seal back to the oil hole, requiring the machine seal temperature to rise abnormally. It is recommended that the maintenance worker to strengthen the study of the maintenance procedures.

(2) The gasket of the machine seal and the gasket at the static ring is aging and the machine seal and gasket are replaced.

(3) Recalibration the center. The circumference and the mouth deviation Should be limited within 0.05 mm.
