# Analysis on Corrosion Fracture of Guyed Rod of Cable Stayed Iron Tower in 110 kV Transmission Line

Inner Mongolia Electric Power Science & Research Institute, Hohhot, Inner Mongolia, 010020, China

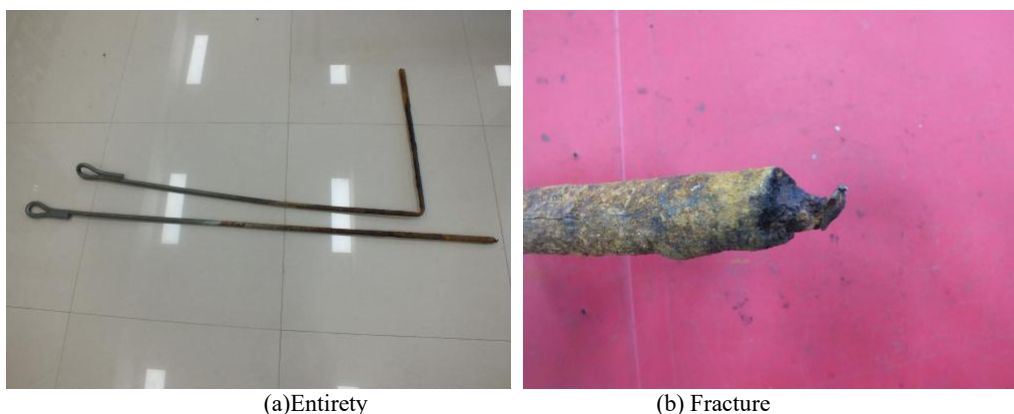
The 110kV guyed tower is located in the pastoral area without any industrial pollution. The guyed rod is made of Q235B with the diameter of 18mm and hot dip galvanizing layer is adopted as anticorrosive coating. Through excavation inspection, it is found that the underground part of guyed rod has fractured and corroded seriously, without obvious elongated deformation. Meanwhile its surface has been completely

covered with brown corrosion products, which illustrates that the zinc coating has totally depleted, as shown in figure 1. Additionally, the cross-section area of the stay guyed rod near the fracture is reduced by 70% due to soil corrosion, leading to a significant decrease in the bearing capacity. However, the above ground part of the guyed rod is almost free of corrosion, and the galvanized layer is relatively intact.

**Figure 1** The macro morphology of the corroded guyed rod.

3) The method of nesting the guyed rod into a PVC pipe could effectively isolate it from corrosive substances in air and soil, which would play a good anti-corrosion role. Moreover, epoxy resin and zinc aluminum alloy with stronger corrosion resistance could be considered as anticorrosive coating, in order to ensure the safety and stability of transmission line.

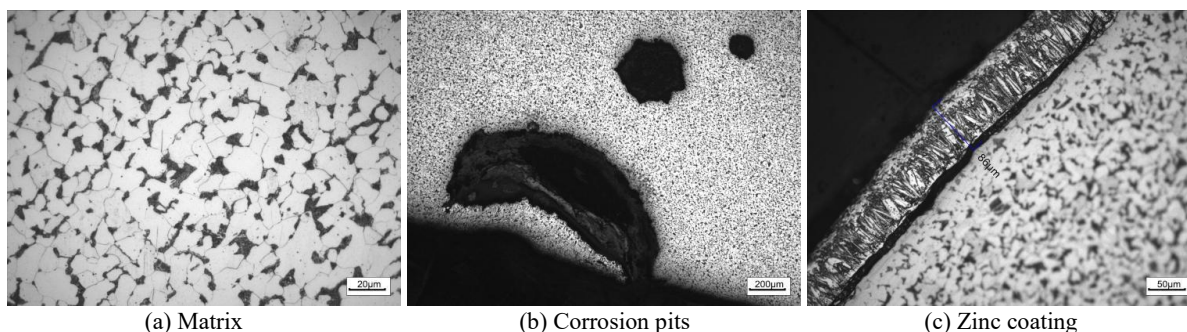
Figure 2 shows the metallographic microstructure of the corroded guyed rod. In the cross section near the fracture, the metallographic structure of the guyed rod is mainly polygonal ferrite and equiaxed pearlite, without

abnormal microstructure. Meanwhile, there are many corrosion pits in different sizes and depths on the surface of the corroded guyed rod. In addition, the thickness of zinc coating on the above ground part of the guyed rod is determined as 86μm by metallographic method.

**Figure 2.** The metallographic structure of the guyed rod.

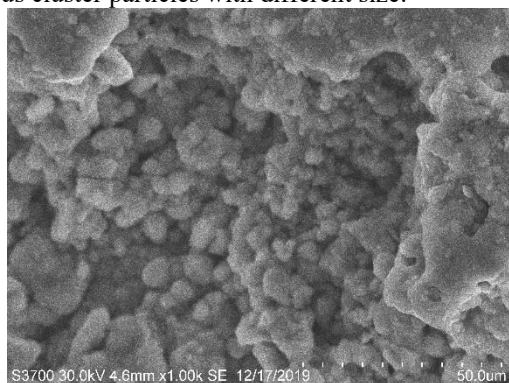
The micro morphology of the corrosion products sampled from the corroded guyed rod is investigated by means of scanning electron microscope (SEM) and the result is shown in Figure 3. It is clearly observed that the

surface of the corroded guyed rod is covered with a large number of corrosion products, which are loose and porous cluster particles with different size.

**Figure 3.** The SEM morphology of corrosion products.

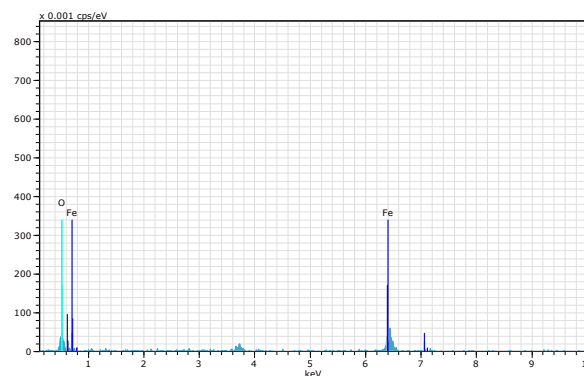
The chemical compositions of the corrosion product on the surface of the corroded guyed rod are analysed by energy spectrum analyser, and the testing result is shown in Figure 4. The result illustrates that the corrosion product mainly contains iron and oxygen without other elements, which should be iron oxide.

**Figure 4.** Energy spectrum analysis chart for corrosion product.
