# Typical failure forms and improvement measures of power grid fasteners

**Abstract.** By investigating the fastening defects of power grid components, it was concluded that unreasonable design, insufficient corrosion protection, improper assembly and insufficient fastening were the four typical forms of bolt failure. In response to the above problems, improvement measures such as design review, material sampling inspection, construction supervision, and operation and maintenance inspection were proposed.

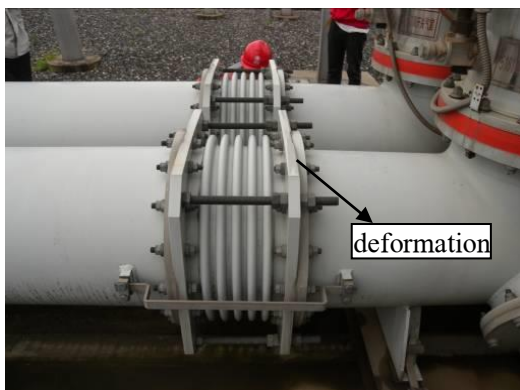
Fig. 1. Morphology of flange deformation.

The A leakage leakage defect occurred in the 126kV GIS bellows of a 110kV substation, and its model was ZF4-

110MGIS. Leakage was located at the joint between the bellows and the bus. The flange of the expansion joint of

GIS equipment had been deformed, as shown in Figure 1.

This type of bellows was an elastic element. It required a certain compensation bus bar sleeve expansion requirements during the design. The installation instructions indicated the clearance between the inner bolt (bellows side) and the flange plate to be 3-5mm, and the outer bolt (the tube side) didn't leave gaps to partially compensate for the axial expansion and contraction of the aluminum alloy cylinder. The on-site inspection of the fastening gaps between the bolts on both sides of the bellows flange plate and the flange plate found that the both-side bolts and the flange plate were locked and there was no clearance, as shown in Figure 2. By checking the installation information of the substation, the GIS equipment was installed and tested in summer. At that time, the temperature was high, and the aluminum alloy cylinder was in a thermal expansion

state. The bellows was under compression, and the maximum difference in the annual temperature of the substation was about 40°C. When the temperature was

low, the aluminum alloy cylinder shrunk and the screw directly distorted the flange plate through the outer bolts. The GIS bellows was under tensile stress. After the long-term operation, the weld between the bellows and the flange welds leaked.

1) In the design liaison meeting, the design drawings of the sealing parts and expansion parts of the main transformer and GIS and other important equipment were reviewed to avoid the problems of poor sealing and poor expansion.

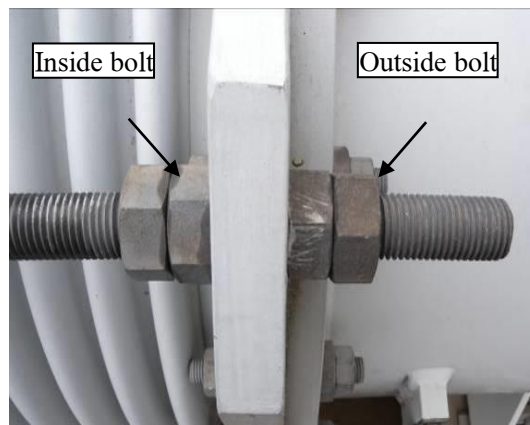
Fig. 2. Morphology of flange bolt fastening clearance.

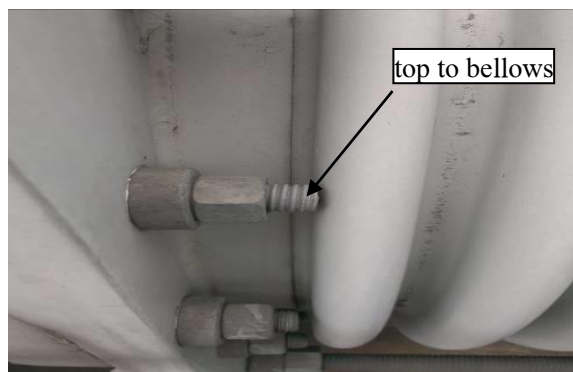
**Fig. 3.** Metallographic structure of thin walls of the flange.

In addition, there were also problems with the design of the fasteners on the inner side of the expansion joint. The screws of some fasteners were too long and had been pushed onto the body of the expansion joint, which would damage the outer surface when the expansion joint contracts, as shown in Figure 3.

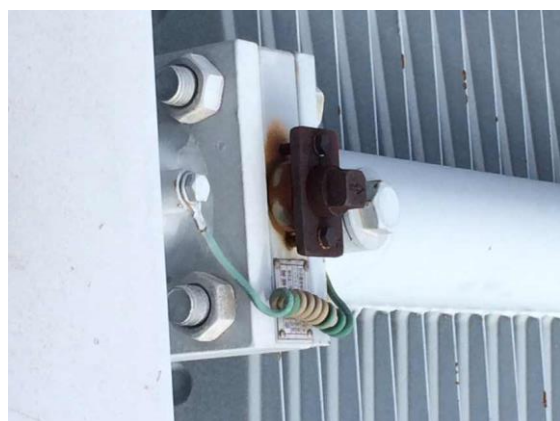
**Fig. 4.** Corrosion morphology of butterfly valve bolts.

A 220kV substation had been in operation for only 2 years. During the maintenance, it was found that the

fasteners of the main transformer butterfly valve were severely rusted, as shown in Figure 4. The bolting process used was cold galvanized, and the anti-corrosion performance was not suitable for outdoor wet environments.

2) In the material procurement stage, the quality of galvanized coatings of stainless steel bolts and the quality of stainless steel bolts should be tested to ensure their anticorrosive performance.

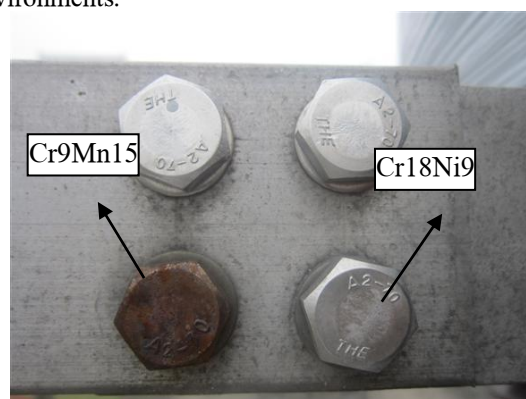
**Fig. 5.** Comparative appearance of stainless steel bolts of capacitor shunts.

In addition, the fastening bolts on the capacitor deflector of a 220 kV substation were made of stainless steel, but the corrosion of the stainless steel bolts of the same component was in sharp contrast, as shown in Figure 5. The composition was tested with a hand-held alloy analyzer, as shown in Table 1. The main component of the rusted bolt was Cr9Mn15. Ni element was not found in the composition, but the Mn content was as high as 15%. According to GB3098.6-2000 "Mechanical properties of fasteners, stainless steel bolts, screws, and studs" [3], rusted bolt was unqualified. The kind of high Mn stainless steel bolt was widely used in the power grid [4]. The unrusted stainless steel bolt was made of Cr18Ni9, which belonged to the typical austenitic stainless steel composition with excellent corrosion resistance.

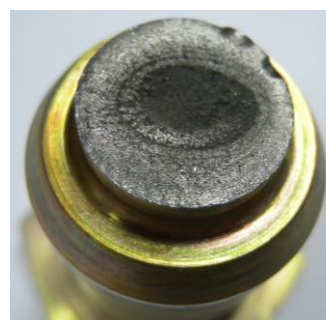
**Fig. 6.** Morphology of macro fracture of the bolt.

Fasteners could also be used as load-bearing connections in power grid switching equipment, such as closing spring energy storage connecting rod bolts. In the event of improper bolt assembly, the force was significantly different from normal conditions. A 220kV circuit breaker A-phase closing spring energy storage connecting rod bolt broke during spring energy storage, as shown in Figure 6, causing the spring and the energy storage connecting rod and bolts to punch out of the circuit breaker back cover. The circuit breaker was operated in 2009 and the bolt design material was 42CrMo steel.

3) During the construction phase, the gaskets, assembly methods, and tightening torques in the bolt assembly should be tested to ensure the installation quality. It is recommended to use a torque wrench to check the tightening force. At the same time, it is necessary to strengthen the training of field personnel for the importance of bolt installation to improve quality awareness.

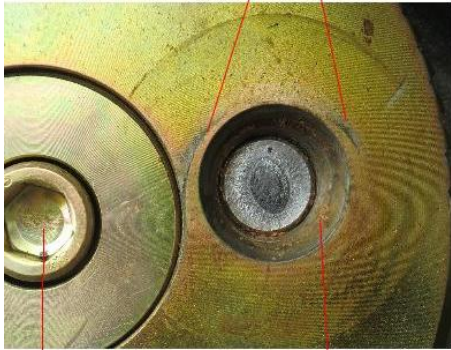
**Fig. 7.** Morphology of ratchet connected with the bolt.

Fig. 7 had shown the photos of the accidental fault bolts left in the ratchet wheel. It could be clearly seen that the thrust bearing pad had a more obvious indentation left on the surface of the ratchet wheel, which could be inferred that the connecting rod bolt was incorrectly assembled. The correct assembly was shown in Figure 8. The gasket was sleeved on the shaft sleeve. It was in free contact with the surface of the ratchet and it was impossible to leave a residual indentation. In this case, the 45°bevel of the bolt was tightly coupled to the 45°bevel of the ratchet internal thread, which could effectively cushion the impact of the bolt root during the switch operation. However, the actual assembly was shown in Figure 9. The gasket was pressed under the sleeve, so that the 45°slope of the bolt could not be coupled with the ratchet. In this way, the root of the bolt would be subjected to a large impact of additional bending moment stress when the switch was opened and closed, and eventually the root of the thread undercut would have a relatively rapid early low-cycle fatigue fracture.

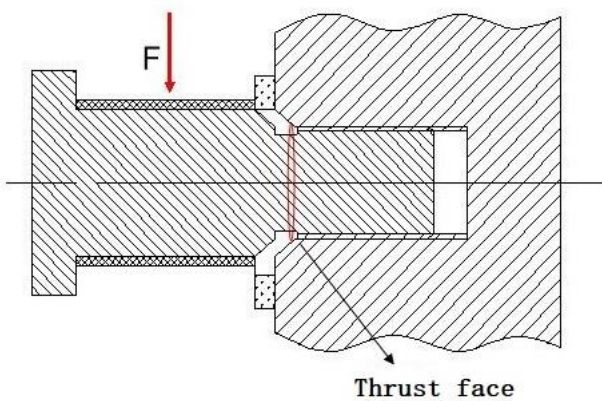
**Fig. 9.** Schematic diagram of incorrect assembly of bolts.

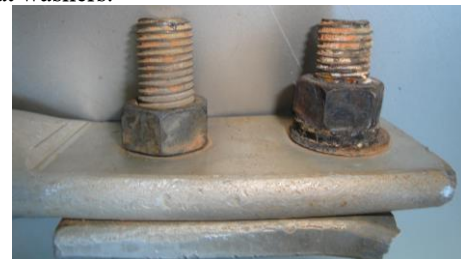
The tightness of the bolts of the grid deflection components directly affects the contact resistance of the connection parts, which results in different operating temperatures. The two sets of high-frequency protection channels of a 220kV line are abnormal. During the inspection, it was found that the drainage plate on the rear side of Phase A of Tower 107 of the line was burned out, as shown in Figure 10. The failure clamp drainage aluminum plate was connected by two bolts, and the fracture position was at the bolt connection. Obviously high temperature burns and melting deformations can be seen at the clip fracture and both bolts. In addition, the bolts and nuts was significantly rusted without spring and flat washers.

**Fig. 10.** Morphology of the failed clamp bolt.

Due to the above-mentioned quality defects in the installation process of the failed clamp, the bolt connection was loose and the local contact with the diversion caused the diversion area of the drainage plate to decrease during the operation. The temperature rose accordingly. Under the condition of a certain load, the clamp would gradually deform at high temperature until it melted. Because the melting point of aluminum is 660°C[5], which is much higher than the melting point of zinc, the corrosion-resistant galvanized layer of the connecting bolts has been melted before the aluminum plate is melted, causing serious corrosion of the bolts.

4) In the operation and maintenance phase, infrared temperature measurement should be performed on the fastening bolts of the high current part during the peak load period, and important bearing forces and seals should be monitored to avoid heating, corrosion and leakage.
