Failure analysis of isolation switch in transformer substation

Yi Xie^{1*}, Yaxia Qiao², Hao Zhang² and Hongjian Lou³

¹ State Grid Hunan Electric Power Company Limited Research Institute, Changsha, 410007, China

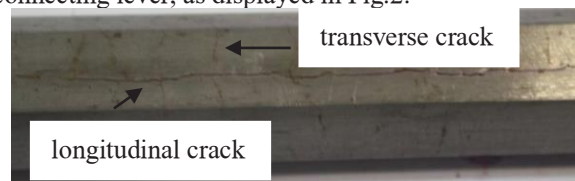
The connecting lever of isolation switch was severely cracked as shown in Fig.1. Massive cracks extend on the surface of connecting lever which was composed of 0Cr18Ni9 austenite steel with hexagonal profile. Further penetrant testing results revealed that the longitudinal crack was as long as 300mm, accounting for about 72% of the total length of the connecting lever. There are also many transverse cracks on the middle surface of the connecting lever, as displayed in Fig.2.

Fig. 1. Macroscopic feature of connecting lever.

Fig. 2. Penetrant inspection of connecting lever.

1) The main reasons for cracking of connecting lever are aging cracking and stress corrosion cracking caused by improper processing technology. It is suggested to replace hexagonal connecting lever with round steel connecting rod and strengthen the quality inspection of stainless steel parts.

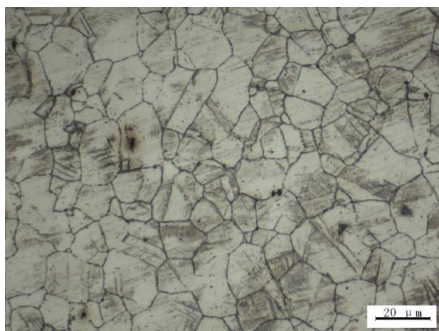
Fig. 3. The metallographic structure of connecting lever.

The microstructure of the connecting lever is combination of austenitic and carbide as shown in Fig.3, which conforms to the microstructure requirements of austenitic stainless steel. The microstructure of the

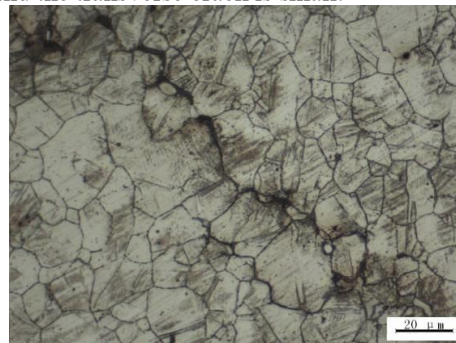
longitudinal crack is shown in figure 4. The crack extends along the grain boundary and extends inward from the surface of the sample. The longitudinal crack is large and the transverse crack is small.

Fig. 4. The longitudinal crack picture of connecting lever.

The austenitic stainless steel material is prone to aging cracking (also called delayed cracking) when the residual stress is not eliminated after processing. The processing of hexagonal connecting rod adopts the drawing technique, and the hardness exceeds the standard requirements which implying that the internal stress is large and the longitudinal crack conforms to the aging cracking characteristics.

Austenitic stainless steel is prone to stress corrosion under the condition of tensile stress corrosion. The connecting lever is in service condition of tensile stress, and contact with the external environment can provide corrosion medium. Considering that the transverse crack is densely distributed in the stress region (middle part of the connecting lever), it can be judged that the transverse crack is a stress corrosion crack. In addition, due to the low content of Cr and Ni of the connecting lever, the material composition does not meet the standard requirements of GB/1220-2007 Stainless Steel. It also has a great impact on the failure and cracking of the connecting lever.

The chemical elements, hardness, tensile strength, elongation of failed connecting lever do not meet the standard requirements which indicating the material is not qualified. The immediate cause of failure is aging crack and stress corrosion crack which is caused by improper processing.

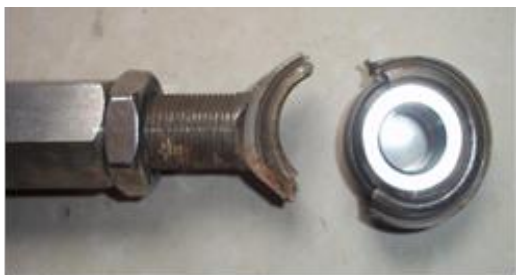
The two failed universal joint of isolation switch were shown in Fig.5 and Fig 6, respectively. There is corrosion on the surface of both samples, and the cracks are located in the directions of four o'clock and eight o'clock of the outer ring. Observed from the side of disconnected universal joint, distortion occurs from the ball head to the part above the crack, as shown in Fig.5 Further inspection revealed that the fracture exhibits no deformation.

Fig. 5. The macroscopic feature of disconnected universal joint.

2) The main reason for the damage of the universal joint is the wrong use of the material. The design material is forged 0Cr18Ni9, while the actual use material is cast ZG0Cr18Ni9 which makes the mechanical properties of the part lower than the design requirements. It is recommended to replace all the universal joints in the same batch, and to strengthen the inspection of not replacing in time.

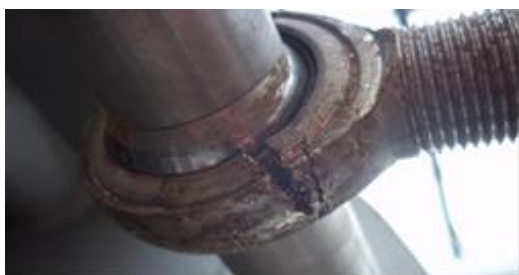
Fig. 6. The macroscopic feature of undisconnected universal joint.

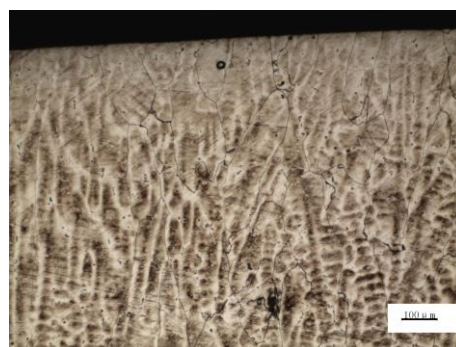
Fig.7. The metallographic structure of universal joint.

The microstructure of the sample is austenite with coarse structure, as shown in Fig.7. There is equiaxed crystal at the edge, obvious columnar crystal inside. The dendrite solidification trace could be identified, as well as immaterial twins. typical as-cast austenitic structure, as shown in Fig.8 and Fig.9.

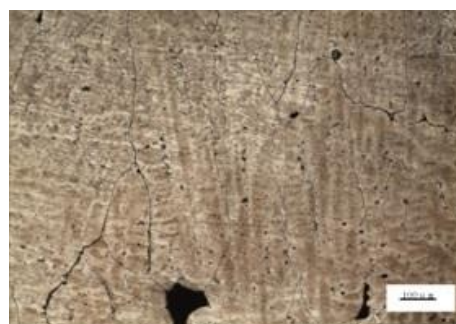
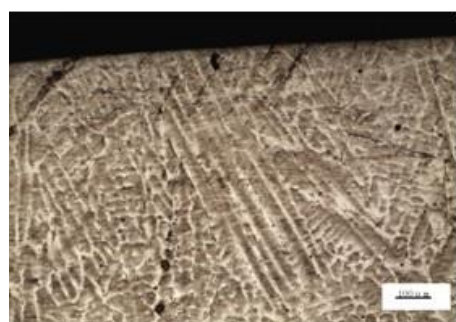
Fig.8. The picture of thick columnar crystal.

Fig.9. The picture of dendritic crystal.

According to the microstructure analysis, the actual material of universal joint is ZG0Cr18Ni9. In addition, the design requirements are forgings, the actual use is castings, the material is inconsistent with the design. The microstructure of cast steel is not uniform, there are structural defects such as element segregation, and its performance is much lower than that of machined stainless steel.

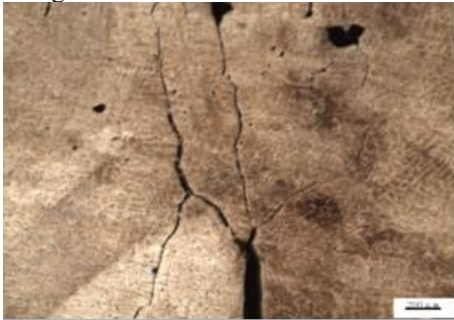
At the same time, there are multiple cracks in the microstructure. The cracks are generated from the edge and gradually grow into the tissue along the grain boundary, which is a typical intergranular crack, as shown in Fig. 10.

Fig.10. The picture of the intergranular crack in sample.
