# Assessment and retrofitting of nursing faculty building of Andalas University, Padang, Indonesia

**Abstract.** The Faculty of Nursing building is one of the administrative buildings at Andalas University. This building was designed by a planning consultant and began construction in 2013. However, during the construction period, it was found that the concrete quality was very low, that is  $f_c'=14.32$  MPa, so that the construction could not be continued because it was not in accordance with the planning quality,  $f_c' =22.39$  MPa. Therefore, it is necessary to evaluate the feasibility of the building structure before the construction is continued. In the structural analysis, the loads applied are dead loads, live loads, and earthquake loads. The analysis was carried out using the application (*software*) ETABS. Based on the analysis results, it was found that the capacity of columns and beams of the building are not strong enough to withstand the loads acting on the structure. The inter story drift also does not meet the permit limit requirements according to the New Indonesian Earthquake Code, SNI 1726:2019. Therefore, it is necessary to retrofit (strengthen) the structure o

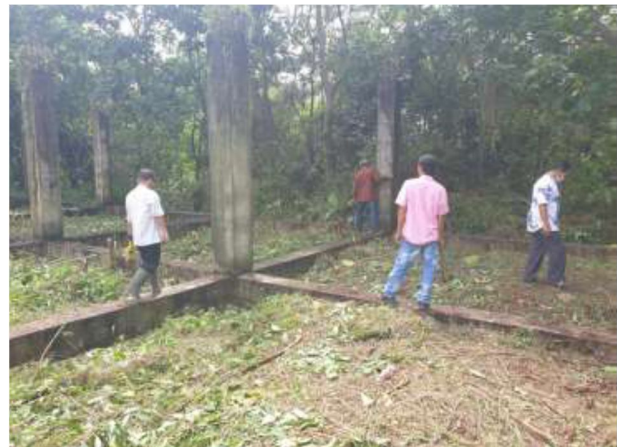
The existing structure of the Nursing Faculty Building, Andalas University consists of the foundation, slab and first floor columns, as shown in Fig. 1.

Fig. 1. Existing Building Condition

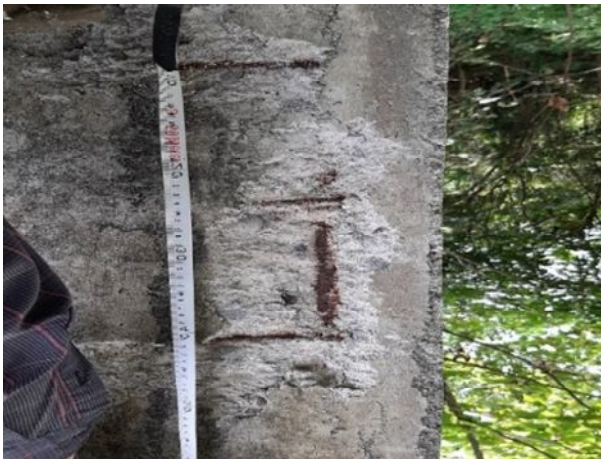
From a field survey on the existing structure, it is found that the steel reinforcement had corroded (Fig. 2) and the concrete has porous and overgrown with moss (Figs. 3 and 4). From the concrete quality test results using a hammer test, the average concrete quality is  $f_c'= 11.24$  MPa, where the quality of this concrete is not in accordance with the design concrete quality.

**Fig. 2.** Steel Reinforcement Corrosion

Retrofit of the first floor columns is carried out using the Concrete Jacketing method on all existing columns because the concrete and steel quality in the column has decreased [9,10]. The Concrete Jacketing Column Position is shown in Fig. 13.

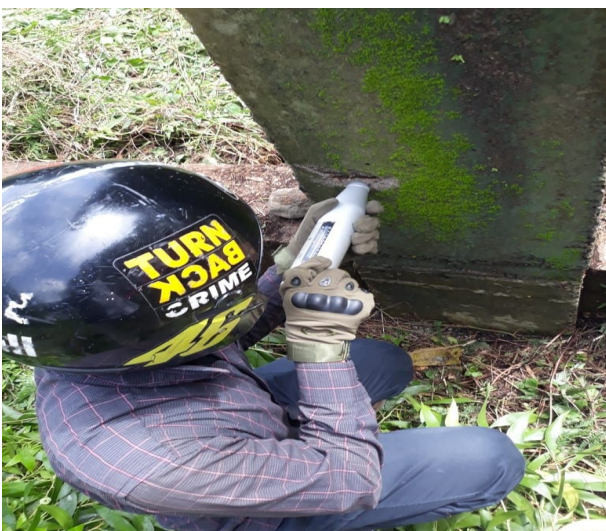
**Fig. 3.** The Concrete Surface is Overgrown with Moss

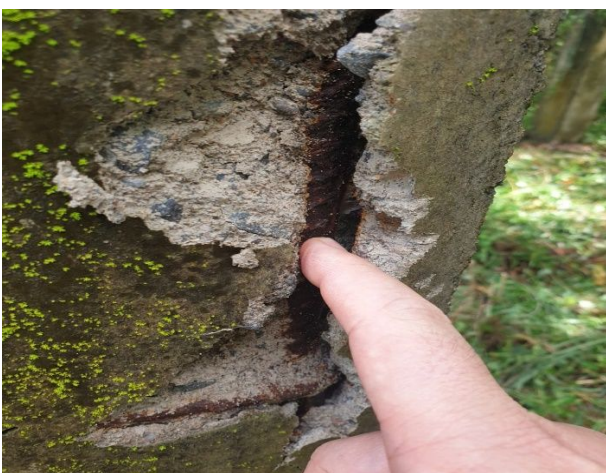
**Fig. 4.** Porous Concrete and Rusty Steel Reinforcement

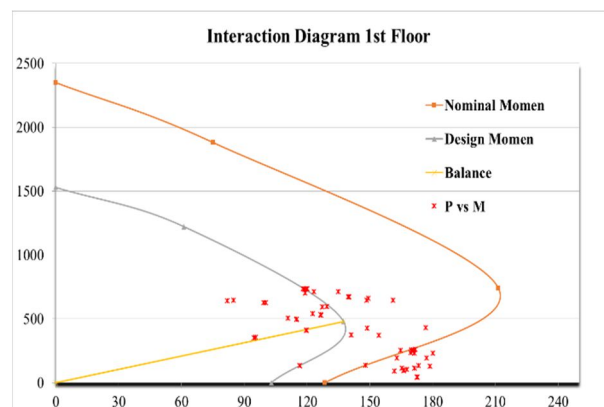
**Fig. 7.** First Floor Column P-M Interaction Diagram

As seen in Figs. 7 and 8, the first and second floor columns are not strong enough to carry the working load because some axial moment and compression forces pass through the design axial compression moment line.

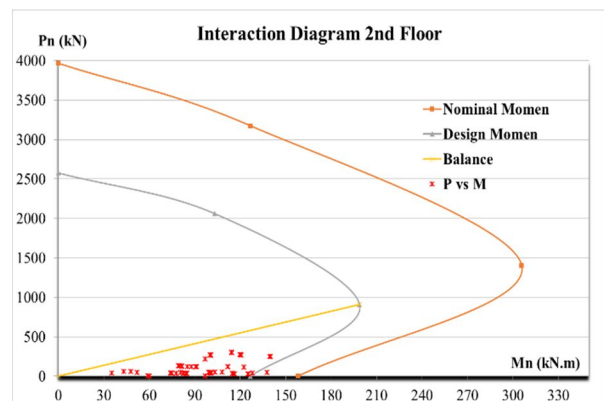
**Fig. 8.** Second Floor Column P-M Interaction Diagram

The re-design of columns was carried out on the second floor columns of the building because the capacity of the planned columns could not withstand the working loads, so the dimensions and reinforcement of the column had to be changed [4,8].

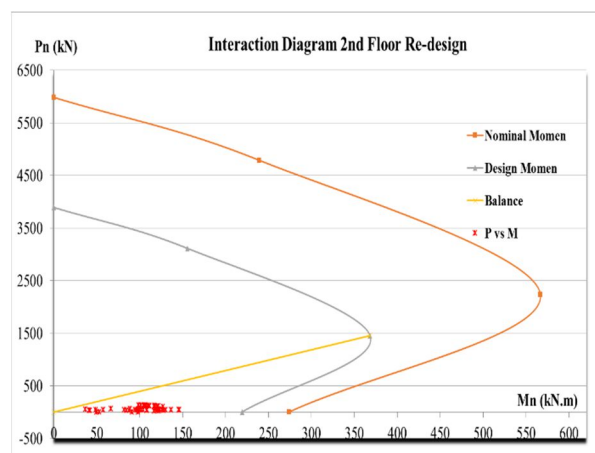
**Fig. 12.** Second Floor Column P-M Interaction Diagram Re-design

As seen in Fig. 12, all P-M values on the graph have been in the interaction diagram line indicating that all building columns are capable of carrying the working load.

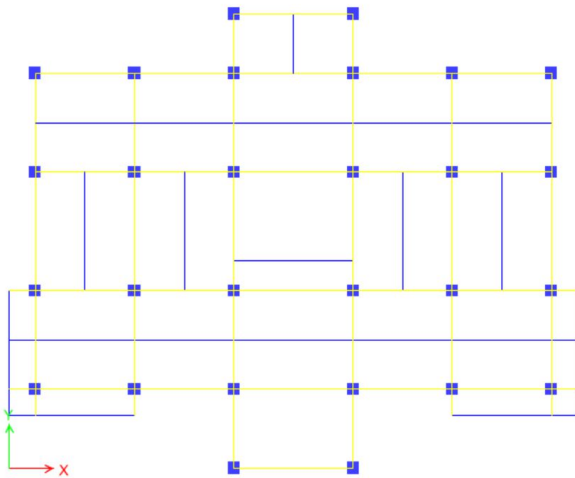
**Fig. 13.** Position of the Concrete Jacketing Column

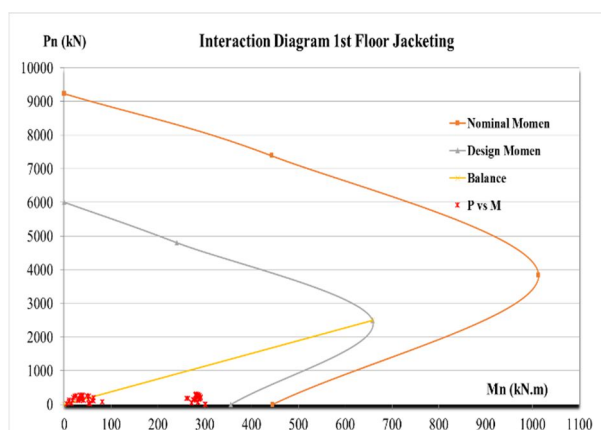
Fig. 17 shows the cross-sectional capacity of the column reinforced by the jacketing method. From the figure, it can be seen that all the P-M points on the graph have been in the interaction diagram, so that the column is able to withstand the working load.

**Fig. 17.** P-M Interaction Diagram of Jacketed Column 600x600
