Build back better and stronger the 2022 earthquake-damaged houses in Talamau–Pasaman Barat District

Seng Menghoung¹, Bambang Istijono^{2*}, Febrin Anas Ismail³, Melinda Noer², and Rahmat Fadli Zakir²

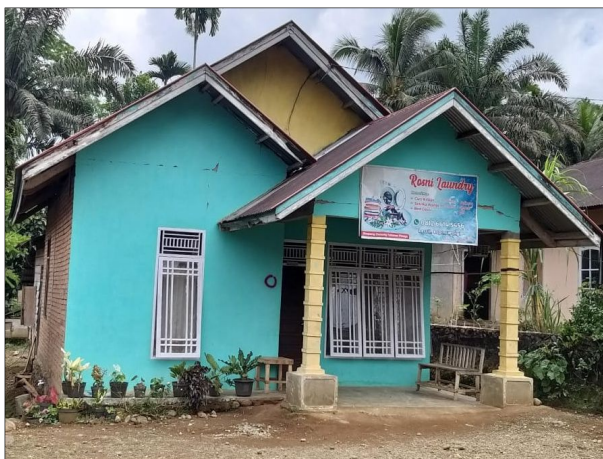
After carrying out the next vulnerability assessment activity, rebuilding a house damaged by an earthquake can be done using a combination of wire mesh and ordinary mortar. This method will provide better strength than the initial strength of the building. However, not all houses can be repaired with this method. Building houses damaged by earthquakes can be applied to houses that are lightly and moderately damaged. The first step is to select the damaged buildings. Damaged houses can be categorized into three classes: lightly damaged, moderately damaged, and heavily damaged. The selection of this house is to involve experts to predict the level of damage to the house. For houses that are categorized as lightly damaged and moderately damaged, this repair method can be applied (Figures 2 and 3). Houses that are in a badly damaged condition cannot be repaired using this method (Figure 4).

Fig. 2. Lite damaged house.

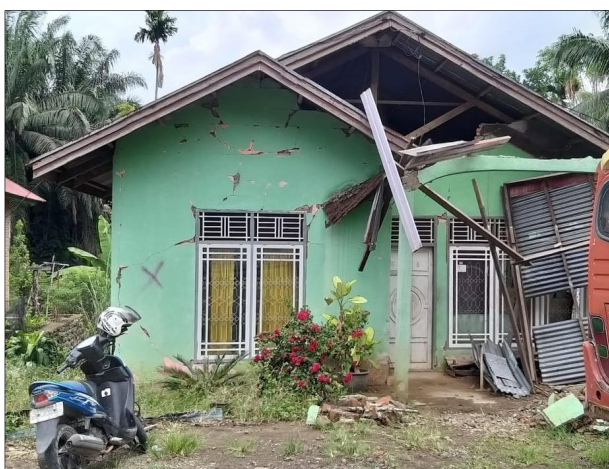
Fig. 3. Moderately damaged house.

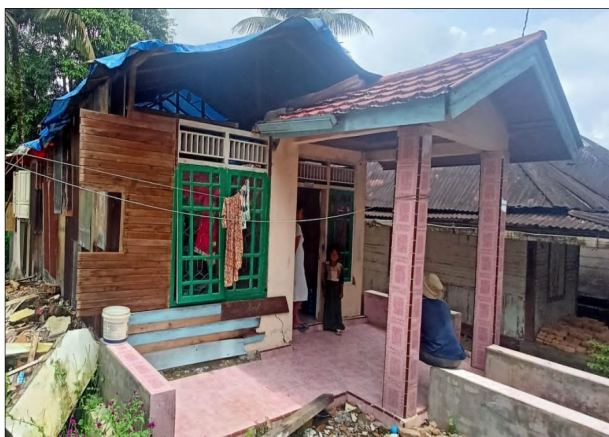
Fig. 4. Heavily damaged house.

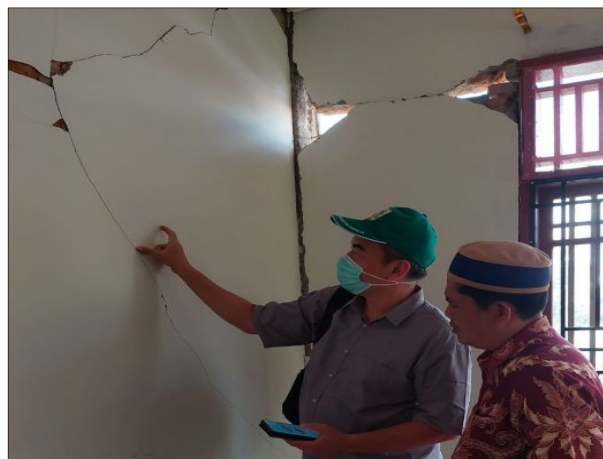
Fig. 5. Checking the damaged house.

The next step is to conduct training for local communities/builders to repair houses and assist communities affected by the earthquake by retrofitting a house that was moderately damaged and minor damaged condition by the earthquake. Training can be done by showing pictures and animations of repair work that has been done elsewhere or in the laboratory. The training is given by experts who already can explain and do homework well. Furthermore, repairs can be started directly by the employer with on-the-job training (Figure 5).

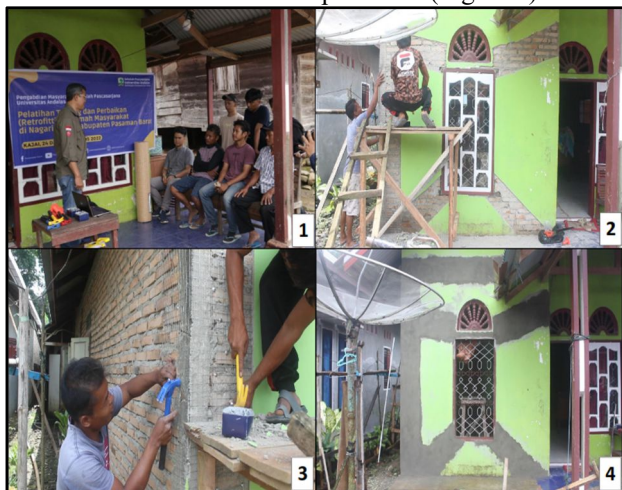
Fig. 7. Worker's training; Reciprocal stripping of stucco on cracks; The wall, the corner of the wall meeting has been peeled and ready to be installed with wire mesh; and the wall after the reciprocal wire mesh is installed and ready to be plastered.

In this activity, training on building strengthening technology through wire mesh technology was carried out for workers. Wire mesh technology or also known as ferrocement technology is a technology for strengthening the plaster layer with a wire mesh, this technology is able to strengthen the tensile stress that occurs in brick walls, so as to increase the strength of the building against earthquake shocks. This technology is suitable for use in the community because it is easy to do and inexpensive. For implementation, the team conducted a study to determine one house as a sample house (Figure 7).
