Slope Risk Management System on Toll Road: a case study Semarang-Salatiga Section

Abstract. Landslide is a geohazard event which can be caused by several factor, such as high rainfall intensity, slope geological feature and the slope geometry itself. Tropical wet climate and typical geomorphology of Indonesia derives landslide event as common disaster during the wet season. Nowadays, the paradigm in road slope management has changed to put the Slope as an Asset, like other infrastructure. In this case study, a slope risk management system was created to assist road slope managers in planning periodic monitoring and maintenance. As the building have the BIM System, the slope can also be digitalized as GeoBIM. Based on case studies, this system can be used to inventory and create an electronic database of road slope assets. Furthermore, the road slope assets are assessed and prioritized based on geological hazards and economic consequences. In the end, each slope asset will have routine maintenance schedules, costs, and a historical data of repairs and damage. Therefore, the slope asset can be handled effectively and efficiently.

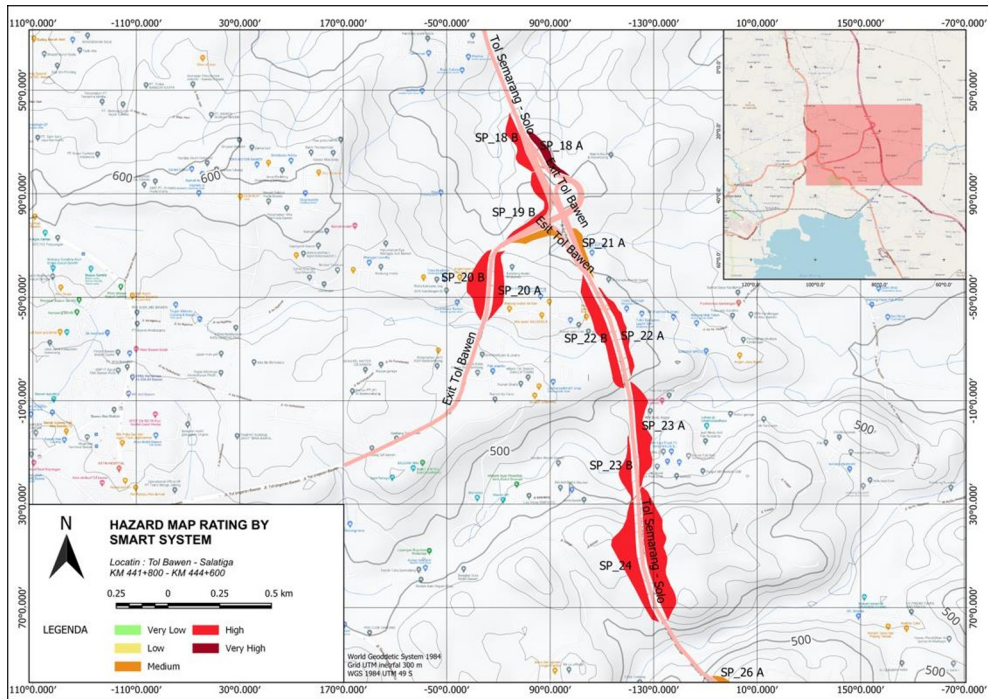
Fig. 1. Hazard map rating of the Semarang – Solo Toll Road slopes

A series of visual inspection have been conducted on 13 slopes as previously mentioned. It is found that 2 slopes are in medium risk, 10 slopes are in high risk, and 1 slope is in very high risk. The medium risk is in the embankment and medium high cut slope. Both of high and very high-risk slope is in clayshale and tuffaceous volcanic breccia area. The risk rating value and detailed slope condition are listed on **Table 6** as follow. The GIS map of slope risk rating as GeoBIM system is shown on **Fig. 1**.
