Curtain Grouting Effectivity Analysis On Foundation Rocks In Blocks 37 – 40 In The Body Of Randugunting Dam, Blora Regency, Central Java

Dian Agus Widiarso^{1*}, Tieties Firman¹, and Jenian Marin¹

¹Diponegoro University, Geological Engineering Department, Semarang 50275, Indonesia

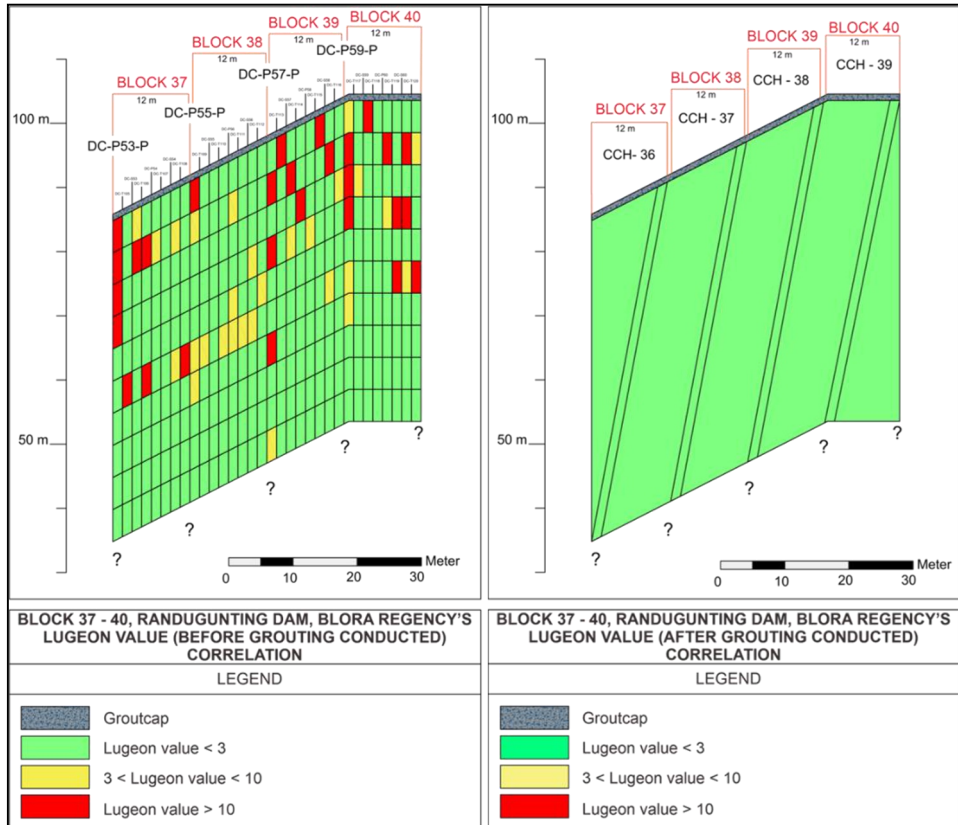
Grouting effectiveness value at Block 37 – 40 were classified as 'Good'. The average grouting effectiveness value at Block 37 – 40 was 77.58%, it also classified as 'Good'. Based on the calculation result, the curtain grouting that was conducted at Block 37 – 40 is 'effective'. The grouting effectiveness also shown by comparison between Lugeon value (Lu) correlation before and after curtain grouting was conducted. The comparison could be seen at Figure 2.

Based on Figure 2, it could be seen that the Lugeon value (Lu) correlation before curtain grouting was conducted that there are several stages color. Yellow and red color represents the area with 'Medium' and 'High' Lugeon value (Lu), and required curtain grouting treatment. Meanwhile, the Lugeon value (Lu) correlation after curtain grouting was conducted was predominantly by green color. Green color represents the area with 'Low' Lugeon value (Lu), and does not required curtain grouting. It could be seen that after curtain grouting was conducted, the area that requires grouting and has 'Medium' – 'High' Lugeon value (Lu) shows changes as it does not requires grouting anymore and has 'Low' Lugeon value (Lu). Therefore, this changes shows that the curtain grouting at Block 37 – 40 is effective.

Fig. 2. Underground condition comparison between Block 37 – 40 before and after curtain grouting was conducted
