The damage effect on the structural capacity of school building columns due to tsunami inundation in Banda Aceh city after 16 years

Bunga Raihanda^{1*} and Abdullah²

Abstract. The 2004 Indian Ocean earthquake and tsunami caused catastrophic damage to buildings and infrastructure in Banda Aceh. The impact and damage depended on several factors such as the distance of the area from the coast. It was reported that in Banda Aceh, the tsunami wave inundation reached the city center and affected over a third of the population. Due to priority reasons at the time, although the structure was submerged in tsunami inundation, numerous public facilities including school buildings still in use without any proper repair. This study aims to determine the effect of column damage due to the tsunami inundation on the strength of the building. The school building of SMPN 6 Banda Aceh is selected as the case study. Seven analysis cases were carried out to simulate the degradation of the column cross-section caused by tsunami inundation. The reduction of the column cross-section was determined from 5 to 25% with increments of 5%. The analysis results revealed that the decrease in strength has occurr

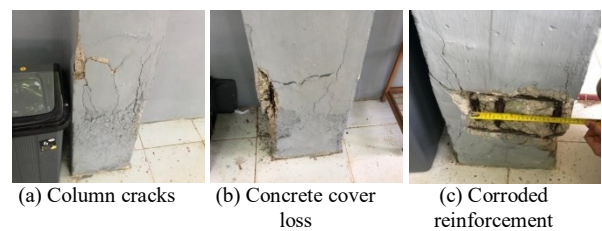
Direct observations at the SMPN 6 Banda Aceh building revealed that the concrete portion of the column which was submerged by the tsunami has cracked. Moreover, some of the concrete covers have peeled off and the exposed reinforcement was corroded. These conditions are shown in Fig. 1.

Fig 1. Column conditions

During the field survey and direct observation, it was found that most of the column on the first floor, which experienced 1.8 meter high of tsunami inundation, was degraded. Associating direct observation data and Finite Element (FE) analysis results, the columns of SMPN 6 Banda Aceh structure is classified as heavy damage.

As the structural mitigation efforts, it is recommended to evaluate the condition and the function of the school buildings, as well as other public facilities. Particularly, those submerged to the tsunami inundation and unrepaired yet, since similar damage might have occurred. The capacity of the existing structure should be enhanced by applying retrofitting methods.

One of retrofitting methods for flexural columns is by adding reinforcements. This method is effectively applied to vulnerable columns so that it can increase column capacity and reduce direct shear failure.

The other retrofitting method is column jacketing. Jacketing is a method of structural retrofitting and strengthening aims to increase or restore the structural capacity of existing structures by providing wrapping sheets of additional material around the existing member. This additional material can be of several types such as concrete, steel, FRP, and composites.

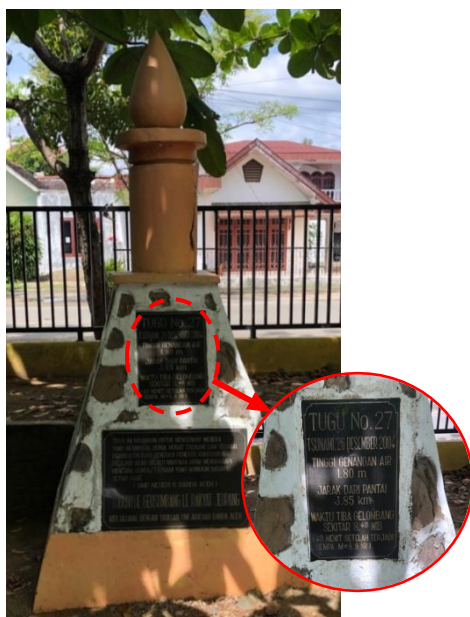
According to the research conducted by Iemura *et al* (2008) [9] in building the Tsunami Height Memorial Poles in Banda Aceh and Aceh Besar, the tsunami inundation at SMPN 6 Banda Aceh is 1.80 m high with a distance to the coast of about 3.85 Km. The tsunami memorial pole at SMPN 6 Banda Aceh is shown in Fig. 7.

Fig 7. Tsunami memorial pole in SMPN 6 Banda Aceh

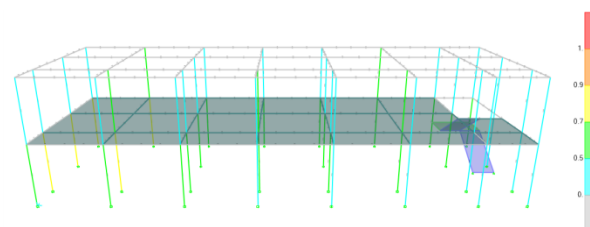
In Case 1, the analysis result shows that most of the columns are in a light blue color, indicating that the structure is safe. In Case 2, where the applied earthquake load was updated to the latest SNI, the analysis result shows more columns had turned green, indicating that the capacity of the column was decreased, in other words, the vulnerability level of the column was increased. However, the structure is still within the safe level. According to the results, it can be concluded that differences in structural capacity were observed by updating the earthquake loading standard.

Fig 9. Case 1 - Structural capacity check visualization

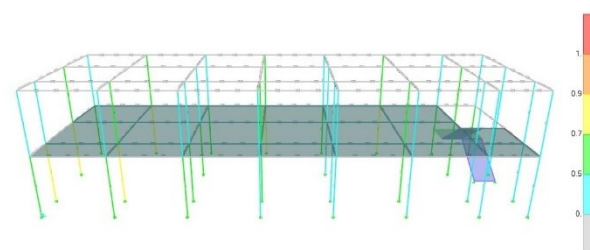
Fig 10. Case 2 - Structural capacity check visualization

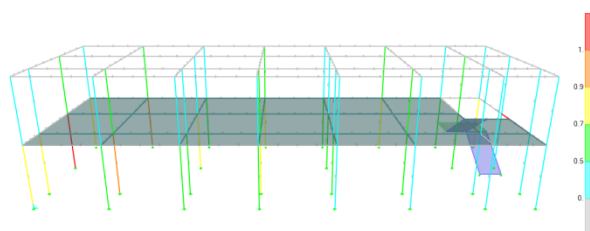
Start from Case 3, the red columns were observed. It indicates that the strength of the column was decreased and become incapable to bear the applied loads. According to the analysis results, when 10% of column cross-section has degraded, as in Case 4, it can be concluded that the risk of structural building collapse

Fig 11. Case 3 - Structural capacity check visualization

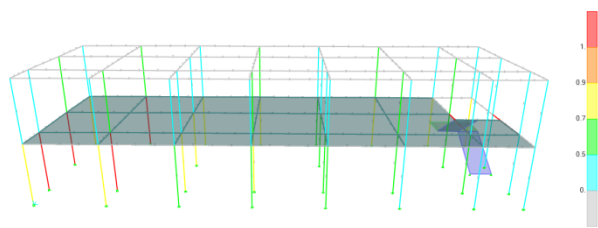
Fig 12. Case 4 - Structural capacity check visualization

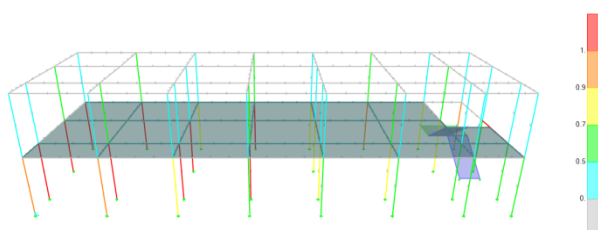
has increased. When the column cross-section has degraded for 15-25% as in Case 5-7, the structure is no longer safe and will fail because above 30% of main column of the structure is no longer able bearing the weight of the structure. Deteriorated column caused structural failure where the entire building will collapse because the column is main structural component that play important role bearing the weight of building.

Fig 13. Case 5 - Structural capacity check visualization

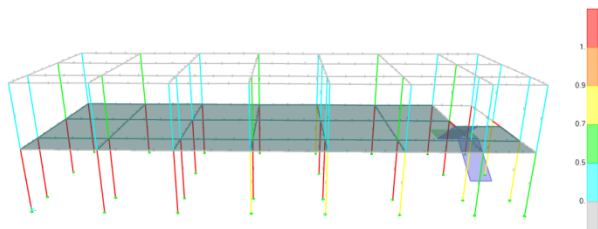
Fig 14. Case 6 - Structural capacity check visualization

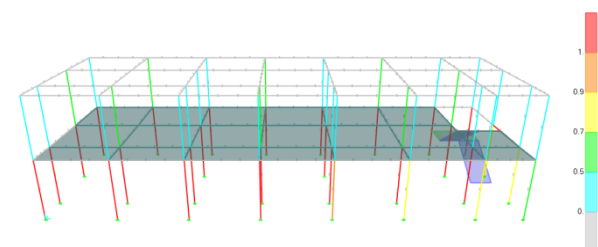
Fig 15. Case 7 - Structural capacity check visualization
