Assessment of Significant Causes to School Building Defects

M.A. Othuman Mydin¹, N.A. Agus Salim², S.W. Tan³, N.M. Tawil⁴, N. Md Ulang⁵

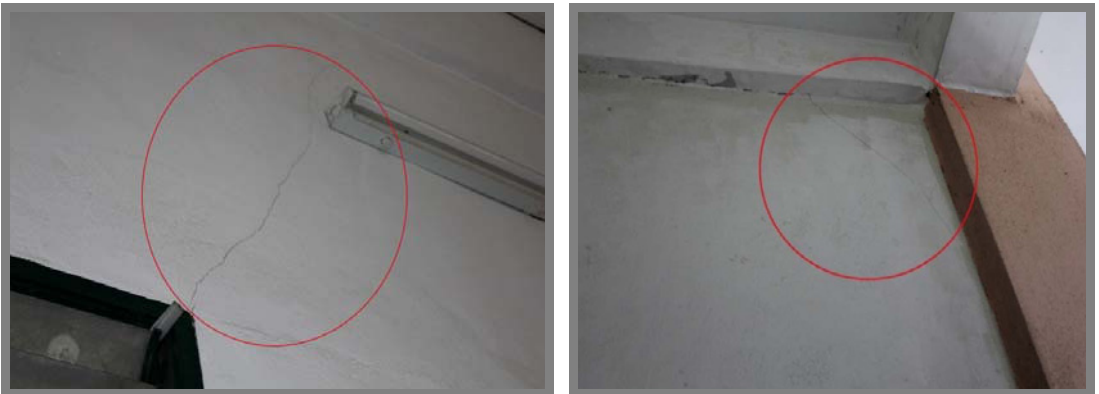
Cracks happened on the various elements in school buildings such as walls, ceilings, beams, columns and even floors (Fig. 4 and Fig. 5). There were many structural and non-structural cracks found. Structural cracks took place in walls, beams and columns. However, non-structural cracks usually happened in plaster or other finishes with cement rendering [7]. Different types of cracking such as vertical, horizontal, diagonal and hairline were found in the school buildings.

Figure 5: Diagonal crack on wall and at the corner of door

Some parts of the inspected schools showed serious cracks while some only showed minor cracks. From the inspection, cracks in wall were in various directions and varying in width from fine hair cracks to 5mm or more. The hairline cracks in plaster and other finishes affected the appearance of the structure but fortunately did not pose any safety concern [7]. There were long and continuous cracks across the walls, beams, columns, ceilings and floors. Moreover, a diagonal crack was found at the corner of door where the crack tip was very thin with increased thickness at the initial point.
