An inventory and risk-based prioritization of Steep Creek Fans in Alberta, Canada

Kris Holm^{1,a}, Matthias Jakob¹ and Elisa Scordo¹

¹BGC Engineering Inc., 500-980 Howe Street, Vancouver, British Columbia, Canada

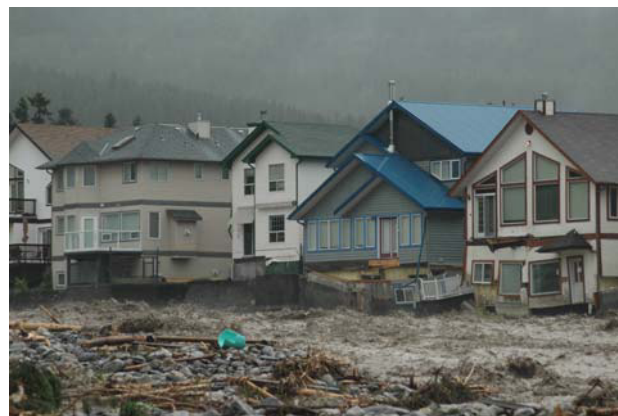
Figure 1. Cougar Creek debris flood on June 20, 2013.
Photo: Town of Canmore

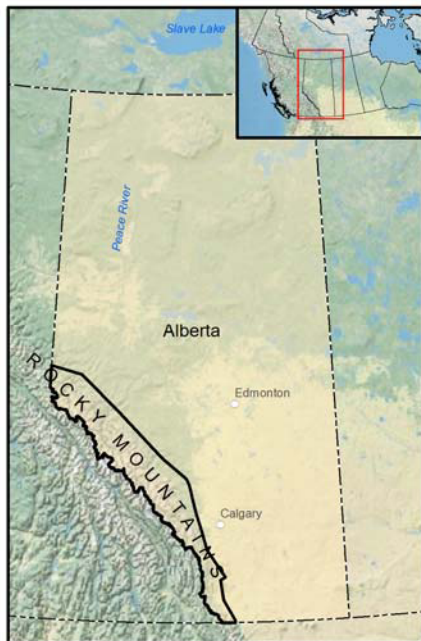
Figure 2. Study area (black outline)

The study area is underlain by faulted and folded sedimentary rocks and contains four major river basins, all glaciated at their headwaters. Furthest north, the Peace/Slave and Athabasca basins drain northeastward as part of the Mackenzie continental drainage system. In the mid and southern Rockies, the North and South Saskatchewan basins drain eastward as part of the Nelson-Churchill continental drainage system. The South Saskatchewan River Basin contains the Red Deer, Bow River and Oldman River sub-basins. These sub-basins, particularly the Bow River, contain most of the developed fans within the study area.

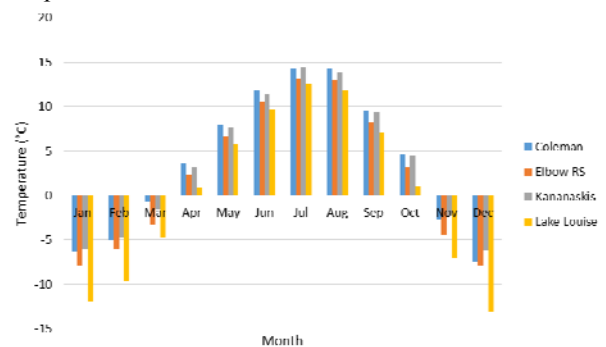
Figure 3. Temperature normals for Environment Canada’s Coleman, Elbow RS, Kananaskis, and Lake Louise climate stations for the period of 1981 to 2010 [8].

The Rocky Mountains have a continental climate with warm summers and cold winters (Figure 3). The majority of heavy storms occur in the month of June, which is also the month with the highest precipitation amount (Figure 4). Most regional floods are caused by rainfall, secondarily by snow melt, although rain-on-snow is considered a contributing factor to flooding in June 2013 [6].

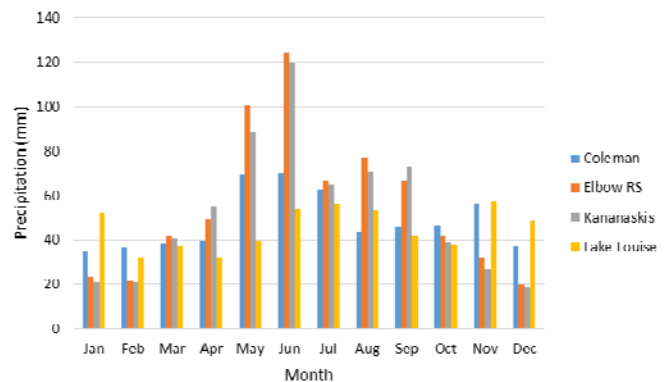
Figure 4. Precipitation normals for Environment Canada’s Coleman, Elbow RS, Kananaskis, and Lake Louise climate stations for the period of 1981 to 2010 [8].

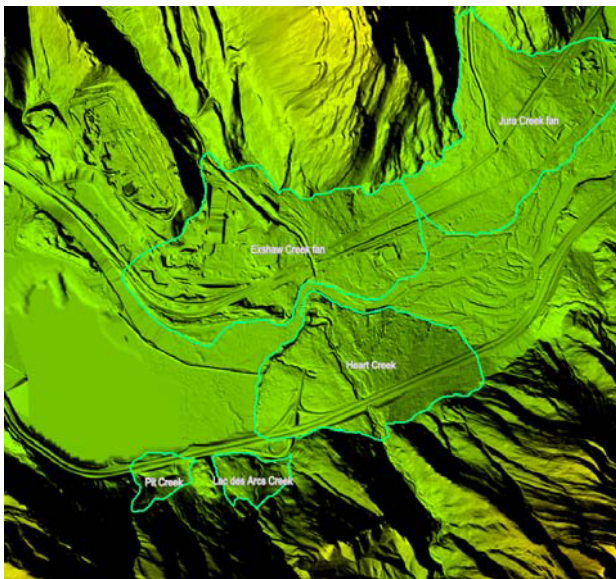
Figure 5. LiDAR hillshade showing Exshaw, Jura, Heart, Pit, and Lac des Arcs fans

Fan extents were interpreted based on 2013, 1.5 m resolution SPOT satellite imagery and hillshade images built from 2013, 1 m resolution LiDAR Digital Elevation Models (DEM) (Figure 5). LiDAR coverage is available for approximately two thirds of the study area, and hillshade images from a 25 m resolution GeoBase DEM^a are used for the remainder. Fan boundaries and hazard ratings are less certain for areas without LiDAR coverage.

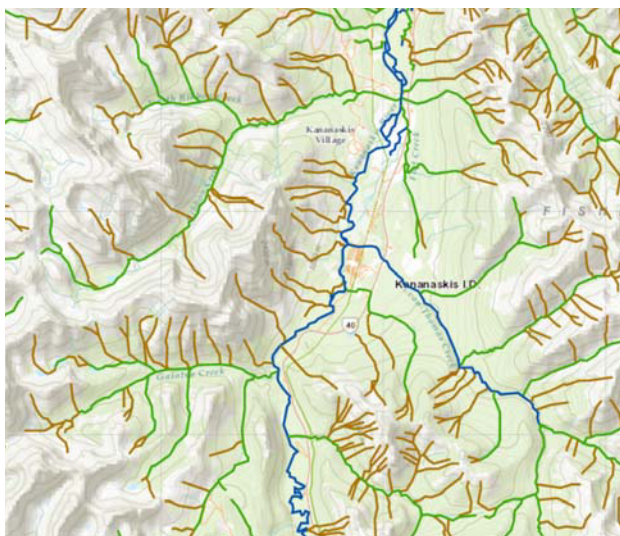
Figure 6. Statistically predicted debris flow (brown), debris flood (green) and flood (blue) stream process types near Kananaskis Village.

We used two methods to assign hydrogeomorphic processes: terrain interpretations and morphometric statistics. The statistically predicted process was applied to every stream segment in the entire study area, which totals about 77,000 km in length. These process types were considered alongside terrain interpretations to assign a dominant process type to each fan.

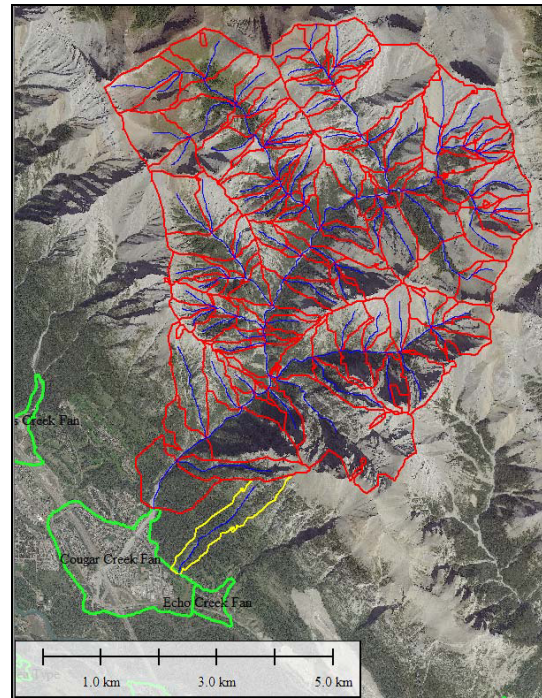
Figure 7. Cougar Creek Debris Fan (green line) and catchments (red line) for individual channel segments within the upstream watershed (blue line), and a second smaller watershed with connectivity to Cougar Creek fan (yellow line).

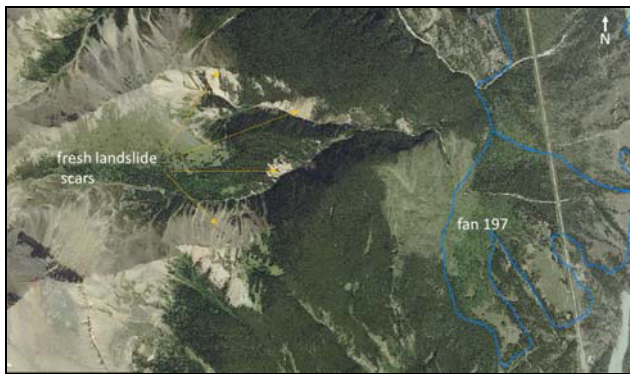
Figure 8. Example of evidence for recent landslide activity within the basin of Fan No. 197.

Hazard frequency estimates were based on surface evidence for geomorphic activity within the basin and fan, as shown by the examples in Figure 8 and Figure 9. As such, they apply to events large enough to produce visible surface evidence. Dense tree cover, for example, could obscure small events that would not be detected at the scale of study. Accordingly, the ratings are relative measures. However, hazard and risk is dominated by large events and neglecting smaller ones is thus of lesser consequence.

Geomorphic evidence for “activity” within each basin (e.g., erosion, landslides, and sediment transport) was rated as Low, Moderate, or High, based on the freshness of channel deposits and whether basin sediment supply is limited or unlimited. Supply-unlimited basins typically contain erodible deposits and/or landslides that continuously charge the channel with sediment and debris; these will trigger an event every time a hydroclimatic threshold is exceeded. Most debris-flood prone watersheds are supply-unlimited due to the abundance of often deep alluvial beds. Supply-limited basins are typically rocky or heavily vegetated, with fewer sediment and debris sources for the main channel; these require time to accumulate debris before a hydroclimatic event can lead to renewed debris flow activity.

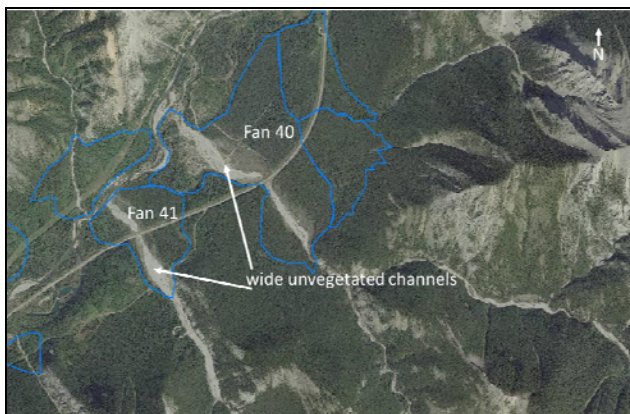
Figure 9. Example of vegetation evidence for recent debris floods on Fan Nos. 40 and 41.

Geomorphic evidence for activity on each fan (e.g., evidence for recent events) is rated as Low, Moderate or High based on freshness and visibility of recent sediment deposits and the estimated age of vegetation: pioneer (<2 year), young (<50 year), or mature (> 50 year). The rating considered evidence for geomorphic activity anywhere on the fan surface.

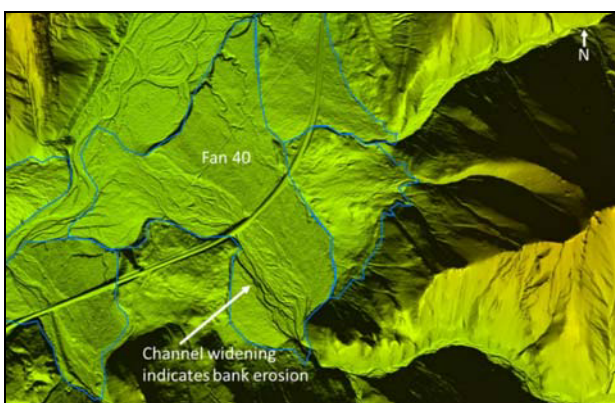
Figure 11. Example of evidence for high susceptibility to bank erosion on Fan no. 40.

Bank erosion refers to widening of the existing channel during an event. We assigned bank erosion susceptibility categories as High, Moderate, or Low, based on surface signs of previous channel widening (e.g., Figure 11). In general, the higher ratings applied to channels with moderate or lower levels of confinement. Because the remote-sensed imagery represents a snapshot in time, estimating channel widening in relation to some “equilibrium” channel width is difficult. Bank erosion susceptibility is also controlled by factors not possible to determine remotely, such as channel bank vegetation and sediment grain size distribution as well as sediment apparent cohesion. As such, this rating is subject to more uncertainty than other hazard factors.

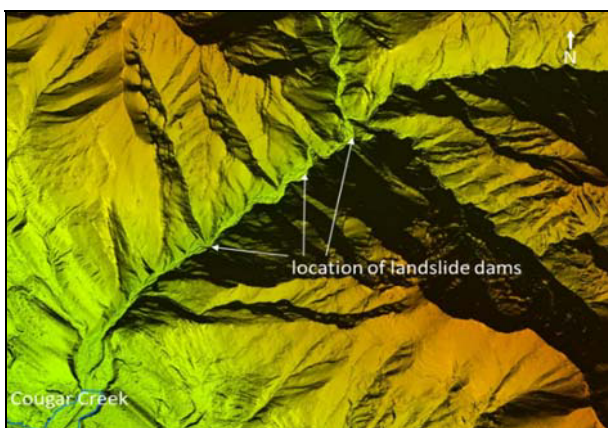
Figure 12. Example of evidence for landslide dam outbreak flood potential in Cougar Creek basin.

We assigned landslide dam outbreak flood potential ratings as High, Moderate, or Low based on evidence of past landslide dams, presence of large landslide scars with the potential to travel to the valley floor, and presence of channel sections potentially susceptible to blockage (e.g., channel constrictions). Figure 12 shows an example of landslide dam locations in Cougar Creek basin. Note that actual landslide dams are not visible at the resolution of the figure; the interpretation was based on the combination of characteristics noted above and were field checked during 2013.

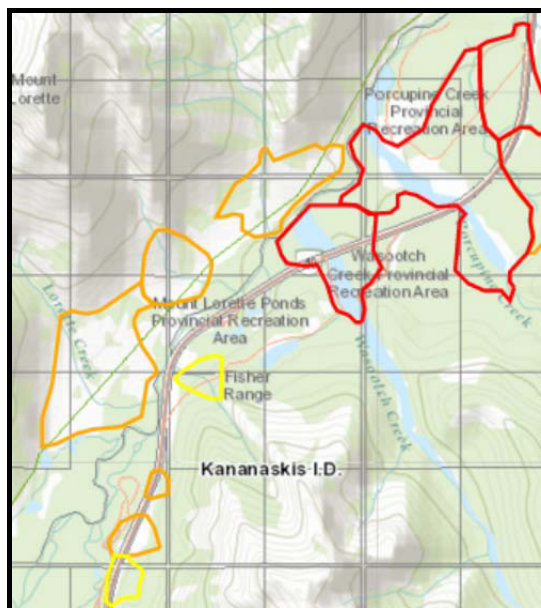
Figure 15. Boundaries of high (red), moderate (orange) and low (yellow) priority fans in Kananaskis, Alberta, as shown on the AHHit web-application.
