# Comparing overflow and wave-overtopping induced breach initiation mechanisms in an embankment breach experiment

**Abstract.** As part of the SAFElevee project Delft University of Technology collaborated with Flanders Hydraulics Research, and Infram B.V. in the preparation and execution of a full scale embankment breach experiment in November 2015. This breach experiment was performed on an 3.5m high embankment with a sand core and clay outer layer situated along the tidal river Scheldt in Belgium near Schellebelle. During the experiment a wave overtopping simulator and overflow simulator were used to initiate a breach. Both simulators were placed near the top of the waterside slope. The use of the simulators facilitated comparison between the effects of continuous overflow and the effects of intermittent wave overtopping. This paper presents the data collected during the experiment, describe the development of hypotheses on the failure processes using the latest insights, and comment on the failure initiation process of a grass covered flood embankment with a clay outer layer and a sandy core.

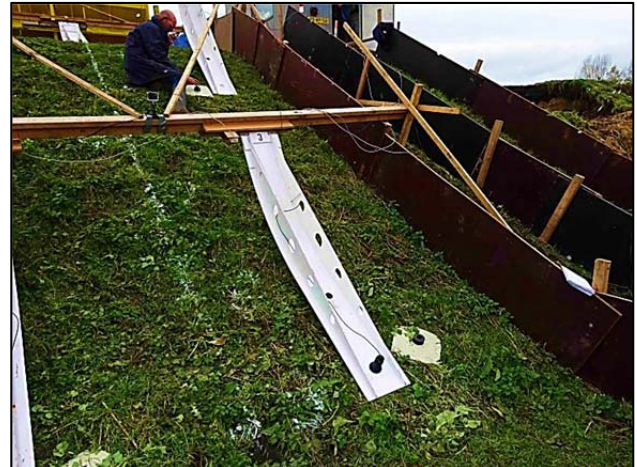
water depth was derived from measuring the change in angle of the surfboards when a wave passed under it. The paddle-wheels were placed near the downstream tip of the surfboard, both in the embankment surface and on the tip of the surfboard. This way both the flow velocity at the bed and at the surface could be measured. The front velocity of the wave was derived by measuring the time lapse in signal from the surfboards and the known distance between two surfboards.

**Figure 2.** Setup for performing hydraulic measurements during wave overtopping tests.

To assess the roughness parameters on the embankment, hydraulic measurements were performed with waves of respectively 500, 1000, 1500, 2000, 2500, 3000, and 3500 l/m. During the hydraulic measurements the flow velocities were continuously measured at the bed and surface of the waves using paddle-wheels. To measure the change in depth profile of a wave over time, a surf-board like construction was used (see Figure 2). The

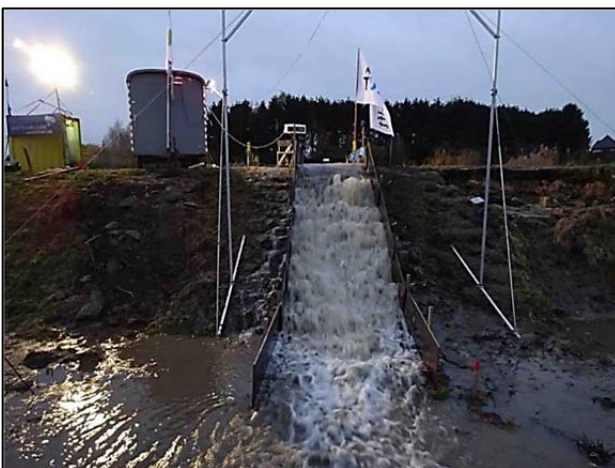
Figure 6. Observed aerated flow during the overflow experiment

Due to limitations in the minimum allowable frequency at which the pump could be operated, tests with the overflow simulator started at 10 l/m/s, followed up by 25, 50 l/m/s and 85 l/m/s. Contrary to expectations, the damage that occurred to the grass cover at overflow discharges of 50 l/m/s and 85 l/m/s was negligible. Instead of the theoretical nice smooth flow of constant density, during all overflow tests the flow became highly aerated down the landside slope (see Figure 6). This could be of influence to the spatial velocity distribution down the slope. Between changes in the discharge the flow was stopped during which became apparent that contrary to the behaviour of grass during wave overtopping the grass cover remained in a flattened position and did not bounce back upwards. Another noticeable, and potentially important observable difference with the wave overtopping tests, was that during overflow the reattachment point of the flow was closer to the crest than during wave overtopping. The normal impact at the reattachment point is therefore also expected to be smaller during overflow than during wave overtopping. These differences with wave overtopping could potentially help in better explaining the difference in timing in failure initiation of the grass cover.
