# The consequences of the inappropriate use of ventilation systems operating in indoor swimming pool conditions - analysis

**Abstract.** Increasingly more leisure facilities, such as water parks or indoor swimming pools are being built in Poland nowadays. In order to ensure the air quality required by standards for such leisure facilities it is necessary to fit them with effectively functioning ventilation. For the removal of excess humidity, as well as chlorine ions occurring as a result of the disinfection of water as well as the carbon dioxide emitted by people using the facility, the ventilation system needs to be appropriately designed and efficient. For this reason, studies into the air quality in such facilities were undertaken. The paper presents the causes and consequences of the inappropriate operation and maintenance of ventilation systems in swimming pools. The study found that the causes of deterioration in the technical condition of the system which was operated in an environment with chlorine ions were: an inappropriate manufacture of its components and the wrong choice of construction materials for the given environment of operation. Furthermore, failure to follow

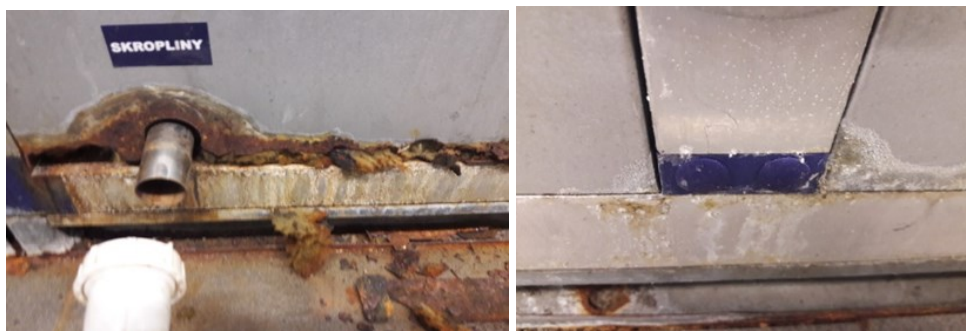
The studies assessed the state of the air handling units. A visual inspection of available internal and external structural elements of both ventilation units showed significant corrosion damage, which negatively affects both the quality of air entering the pool hall and the life cycle of the installation itself [7]. Heavy surface damage and material losses were observed at the bottom of the cover panels made of aluzinc-coated metal sheet. White (corrosion of zinc) and red corrosion products were present on the surface of the cover panels-degradation of the coating (Fig. 1-2).

**Fig. 1.** View of the external cover panels of the air handling unit (air handling unit 1).

Appropriate anti-corrosion protection of the parts of swimming pool installations operating in conditions of high humidity and an aggressive medium is a key factor allowing an increase in their life cycle and failure-free operation. The increased corrosion resistance of parts can be achieved by: painting with wet epoxy paints or powder surface protection with chemicals-cataphoresis process, the application of polymer coatings in the form of polyester, polyamide or epoxy resins (electrostatic or fluidizing).

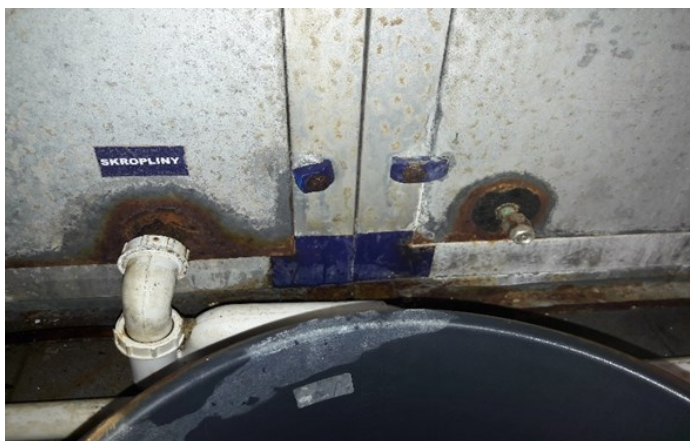
**Fig. 2.** View of the external cover panels of the air handling unit (air handling unit 2).

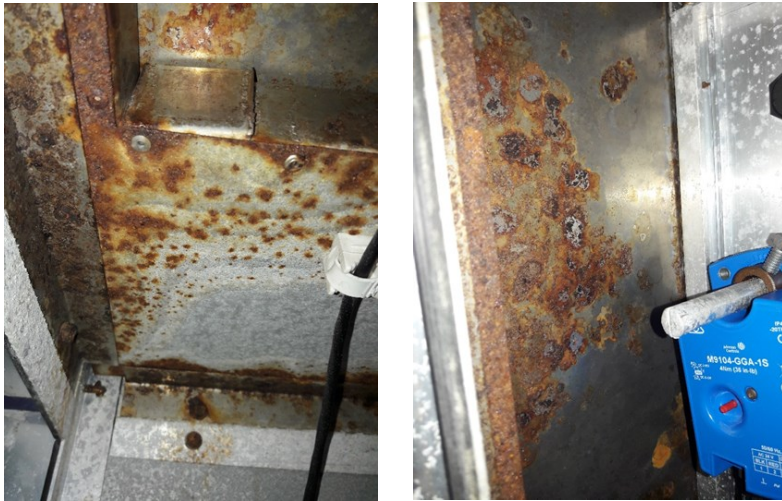
Corrosive damage and products of the corrosive process taking place were also observed on the side panels of the unit (Fig. 3) and floor panels made of X5CrNi18-10 sheets (corrosion pits) in various sections of the units (Fig. 4). Damper blades (Fig. 5), droplet separator (Fig. 6) and aluminum guides (Fig. 7) were also subject to corrosion.

**Fig. 3.** View of the inner surface of the unit's side panels.

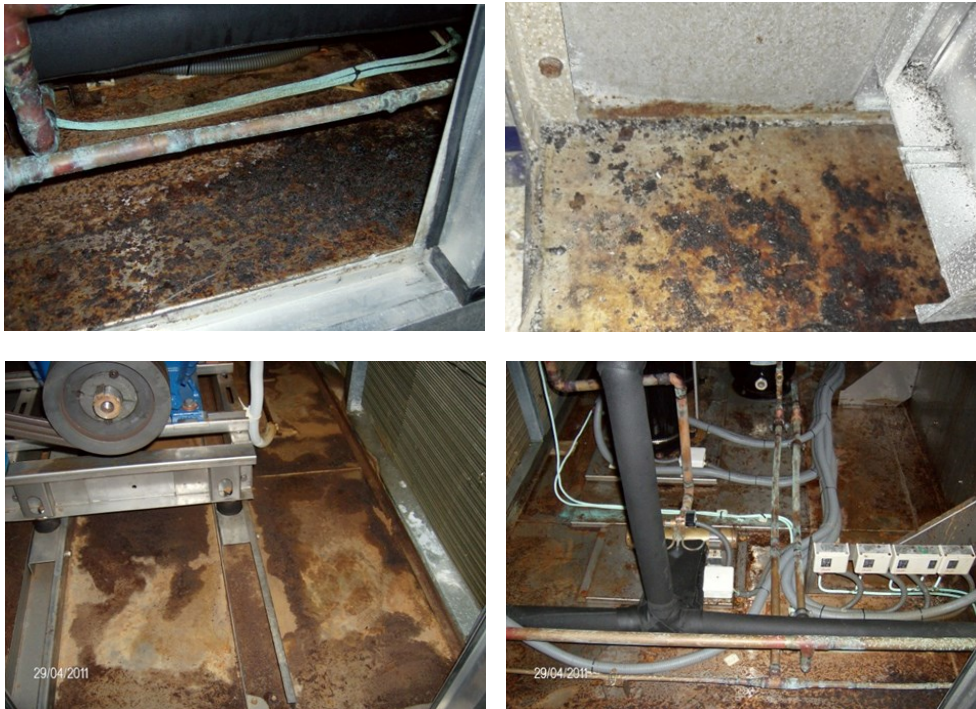
**Fig. 4.** View of the inner surface of the unit's floor panels.

The analysis of the available documentation showed that in the initial stage of operation of the ventilation unit, the construction of the wall air intake did not ensure adequate protection of the unit against the influence of weather conditions. The lack of a protective roof has caused an additional amount of water coming from atmospheric precipitation (rain, snow) to enter the intake duct. The water excess (rainfall and moisture from the air removed from the pool hall) was not sufficiently discharged from the condensate tray of the ventilation unit, which resulted in overflow outside the tray. The lack of the possibility to drain the excess water contributed to premature damage to the floor panel surface.

A necessary condition for a rational choice of material meeting the requirements set at the design stage is a careful analysis of steel grades, taking technical and economic optimization criteria into account. Virtually none of the available steel is completely resistant to corrosion in the microclimate of swimming pools. In environments containing water vapor, the use stainless steels of an austenitic structure is recommended. In swimming pool buildings, for parts that are not both structural elements and are not subjected to continuous washing by the basin water steel 316 (316Ti, 316L, 316LM) or higher corrosion resistance steel (when there is a risk of SCC corrosion cracking) are used. More corrosion-resistant types of steel than those commonly used in swimming pools are, for example, 904L (austenitic), ferritic-austenitic steel also called duplex steel (1.4462) or super duplex (1.4507) [9]. Duplex steel, compared to that commonly used, is characterized by high strength properties, good ductility and much higher corrosion resistance, especially in environments containing chlorine ions.

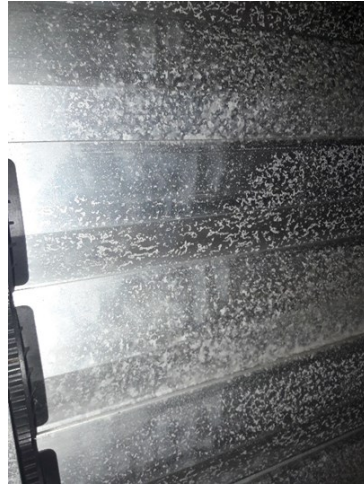
**Fig. 5.** View of the damper blades' surfaces made of aluminum in unit 1.

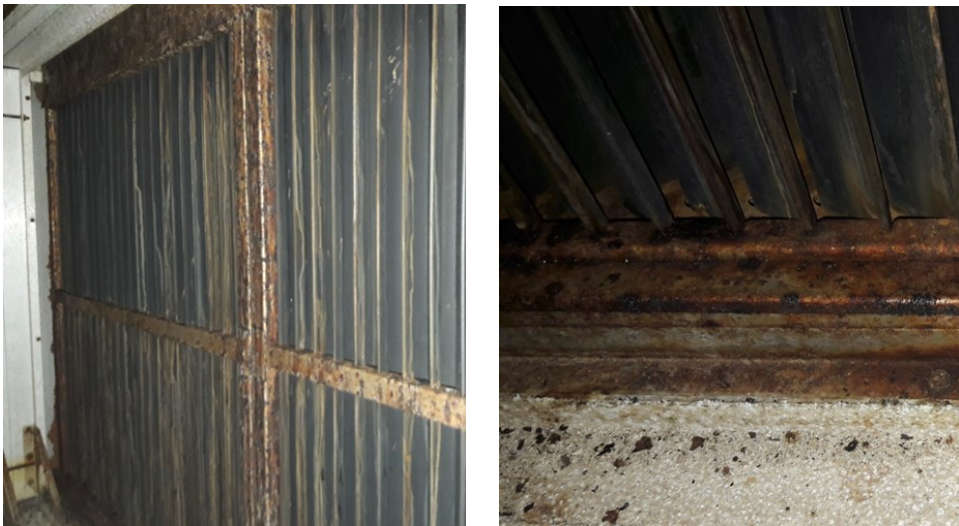
**Fig. 6.** View of the evaporator area in unit 1.

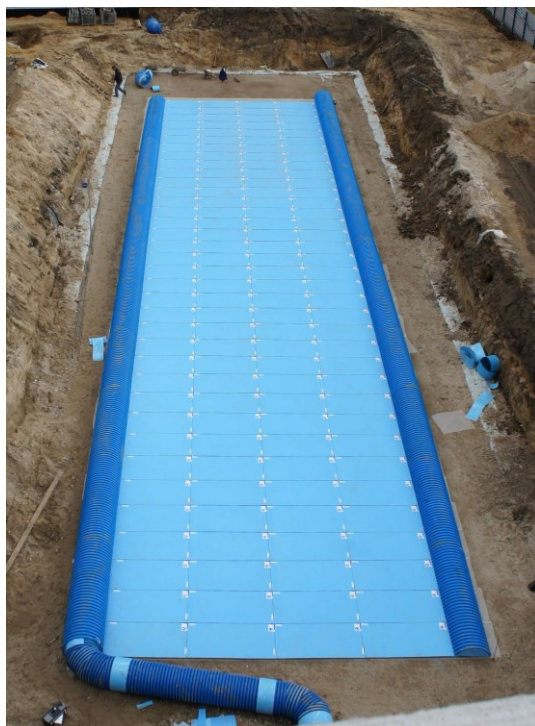
At the same time, installing a ground-coupled heat exchanger outside of the building was suggested, through which fresh air drawn in by the field intake from the building's surroundings would be introduced into the ventilation system. An example of a ground-coupled heat exchanger is shown in Fig. 7.

**Fig. 7.** Suggested solution of a ground-coupled heat exchanger [10].

Use of a ground-coupled heat exchanger of 120 m<sup>2</sup> will allow reducing the energy needed to heat the air entering the pool hall by 11% on average over the year (from 2% during summer to 23% in the coldest winter months).
