Analysis of indoor air quality in a naturally ventilated church

Abstract. The quality of air in sacral buildings is an important factor that affects users. Church buildings are characterized by a specific microclimate, because they accommodate many people in short periods of time, which results in rapid changes in air quality. Sacral buildings usually only have natural ventilation through doors, return air inlets and window leaks, which can cause uneven distribution of fresh air. The aim of this article is to analyze the results of research on the basic parameters of air quality: carbon dioxide, relative humidity and air temperature in the church. The analysis carried out on research results allowed to state that the measured parameters of air quality – the concentration of carbon dioxide and the level of relative humidity significantly exceeded the standards recommendations. High level of air humidity was recorded at 75%. In the analyzed sacral building there is the need to improve air quality in terms of carbon dioxide and relative humidity. Ways of improving air quality, such as installation of mechanical ventilation, will help prevent damage to structures and equipment, and im

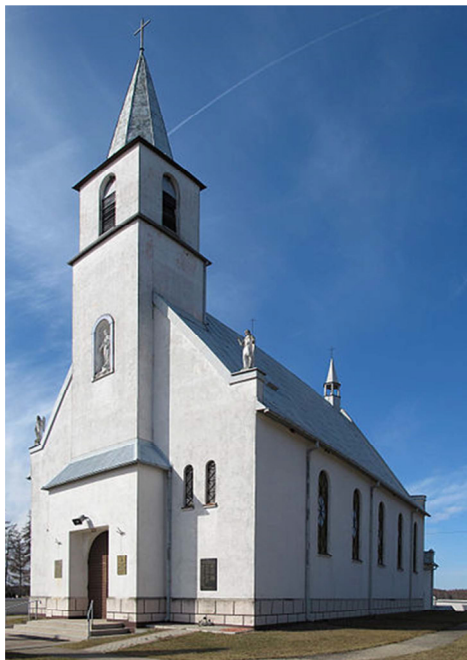
Fig. 1. View of the church (own collection).

The church building has stained single glass windows, with poor insulating properties. Ventilation in the facility takes place naturally, through five ceiling openings, main doors, side doors and leaks. The building is equipped with an air heating, which is carried out using a Benson oil furnace. The interior of the temple, where measurements of basic air quality parameters were made, has the following dimensions: length - 24 m, width - 12 m, height - 12 m. The cubature of the building is approximately 3400 m³.

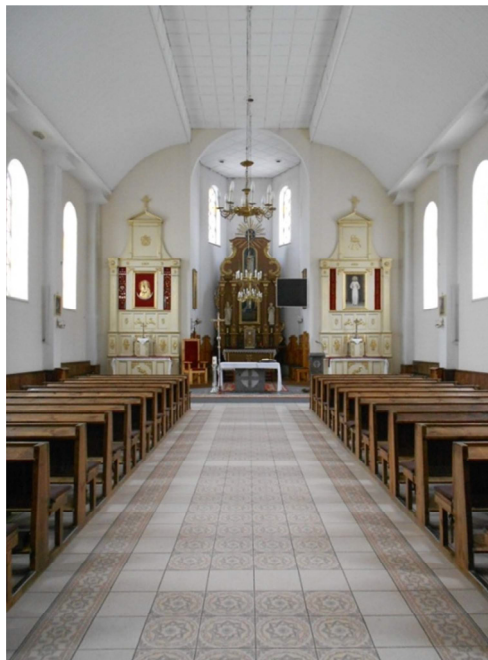
Fig. 2. Interior of the Church of the Immaculate Conception of the Blessed Virgin Mary in Tryczówka (own collection).

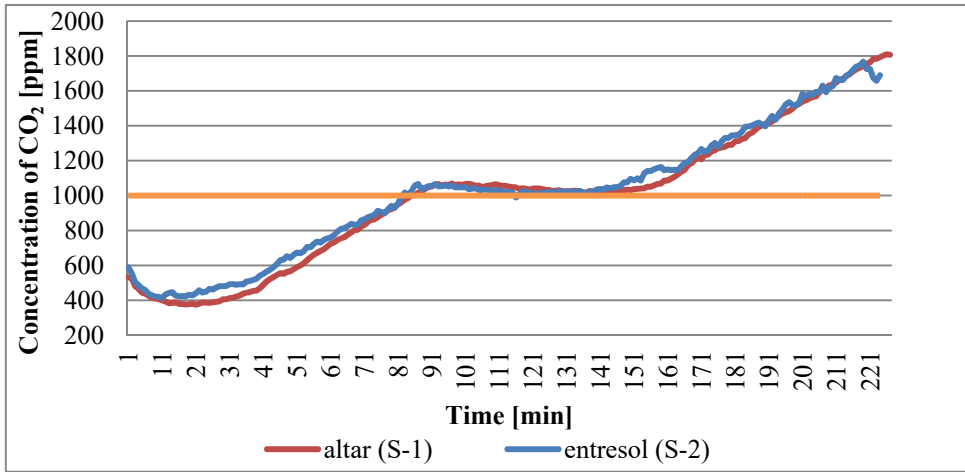
The graph (Fig. 4) shows the results of measurements of carbon dioxide concentration. During the first 10 minutes of the study, the device recorded stabilized minimum measurements: 374 ppm (S-1) and 413 ppm (S-2). At that time there were four people in the temple. At the beginning of the first service at 9.00 (after 35 minutes of research) there were 128 people in the church. The level of CO₂ began to increase significantly, at the end of the service, it exceeded the minimum hygiene threshold of 1,000 ppm [12]. During an hour's

Fig. 4. Concentration of carbon dioxide in a church (date: 11.02.2018, 8.25 a.m.–12.10 p.m.) (own study).

break between meetings, the level of carbon dioxide still fluctuated around 1,000 ppm. Conclusion about low efficiency of the gravity ventilation system and ventilation through the entrance door can be made, because the CO₂ concentration remained at the same high level. At the start of the second Sunday service there were 155 people in the church, the CO₂ level began to increase again, up to 1,810 ppm (S-1) and 1,768 ppm (S-2). In the temple you could feel the stuffiness, breathlessness and stale air.

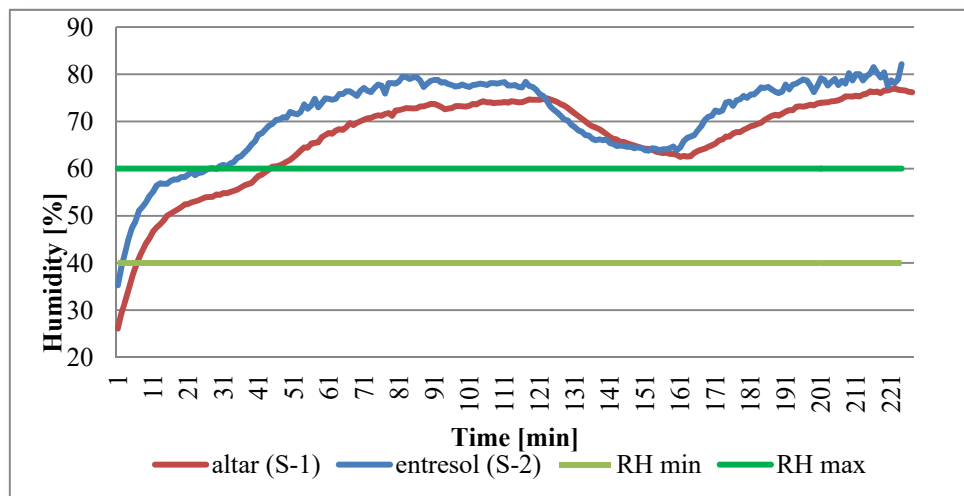
Fig. 6. Relative humidity in a church (date: 11.02.2018, 8.25 a.m.–12.10 p.m.) (own study).

Last parameter tested was relative humidity of the air (Fig. 6.). Higher relative humidity was recorded on the S-2 measuring point, located at a height of about 6 m, where the maximum result is 82%. During the time people stayed in the church, as well as during the break, the relative humidity level remained at 60–80%, which, with the recorded temperature of 2.4–6.6°C, enhanced the feeling of coolness and humidity in the air. Such a high level of relative humidity, combined with low temperature, does not have a positive effect on thermal comfort of building users, and additionally has a destructive effect on the construction and equipment of the building [14, 24].

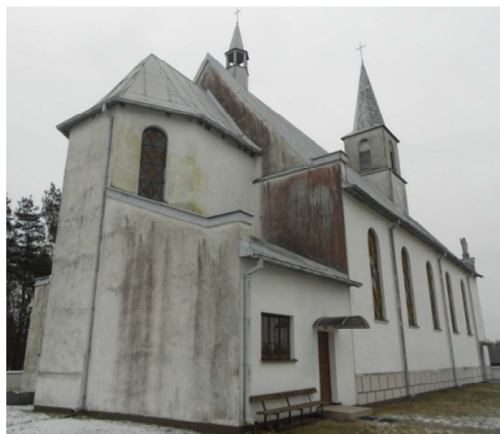
Fig. 7. Fungus on the outside wall.
Source: own collection.

The analysis carried out on the basis of the research results allowed to state that the measured parameters of air quality – the concentration of carbon dioxide and the level of relative humidity significantly exceeded the recommendations contained in the standards. High concentrations of carbon dioxide, reaching the level of 1,800 ppm, thus significantly exceeding the minimum of hygiene, may cause discomfort to people in the church building. Relative humidity reached a maximum of 82%. Such a high moisture content in the air negatively affects the thermal comfort of users, and additionally has a destructive effect on the structure of the building and its equipment, because it promotes the growth of mold and fungi (Fig. 7, Fig. 8).

In the analyzed facility, there is a need to improve the air quality in terms of carbon dioxide and relative humidity. Ways of improving air quality, such as the installation of mechanical fans, will remove excess moisture and prevent damage to the structure and equipment and improve the comfort of the faithful staying in the church. In addition, there is a need for a thorough analysis of the origin of excess moisture in the air. It is possible that the high relative humidity is caused by moisture coming from the ground, which is why

we should pay attention to the waterproofing of the building. In addition, the roof of the church must be renovated to stop water infiltration from the upper part of the building. A valid solution is also the use of air dryers that would help remove excess moisture from the air.
