Groundwater Flooding due to Tropical Cyclone Cempaka in Ngreneng Karst Window, Gunungsewu Karst Area, Indonesia

Abstract. Tropical Cyclone Cempaka occurred on November 27, 2017 in the Indian Ocean, just south of Central Java. This incident induced high rainfall leading to flash floods in the southern part of Central Java, including Gunungsewu Karst Area. The highest rainfall recorded on November 28, 2017, in this area was 239 mm/day (Automatic Rainfall Recorder/ARR Station in Pindul Cave) and 341 mm/day (ARR Station in Tepus). The extreme rainfall also caused groundwater flood in Ngreneng Karst Window. This study aimed to analyze the mechanism of this flood. The results of the analysis showed that it was caused by water filling up the conduit passage in the entire Bribin-Baron underground river system. The flow of the conduit pushed the diffuse flow into the surface fast, and the water that came out of Ngreneng Karst Window was thereby clear. The inundation lasted for ten days and submerged up to 26.4 ha of the study area.

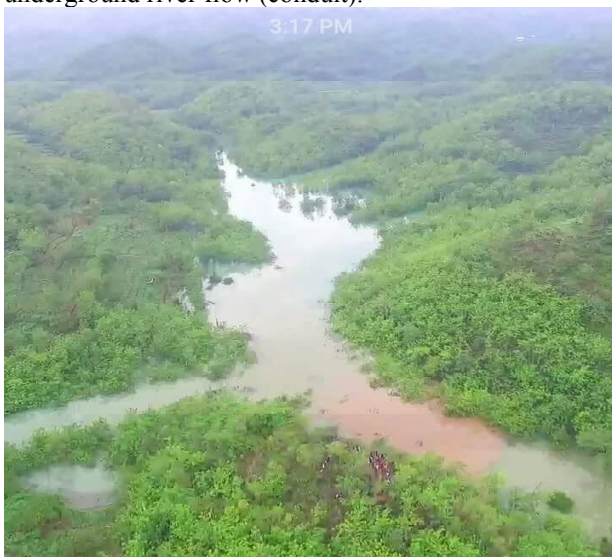
Fig. 2. The Oblique Aerial Photograph in the Study Area (Photo by HENDY FATCHUROHMAN)

Analyzing the aerial photograph taken with an unmanned aerial vehicle (UAV) (Figure 2) and the results of the field survey (Figure 3), the research found that the maximum inundation area due to groundwater flooding at Ngreneng Karst Window was 26.4 ha (Figure 2). The inundation followed the topography of the closed basin or doline. The most extensive flooding occurred on November 29, 2017, which receded ten days later on December 7, 2017.

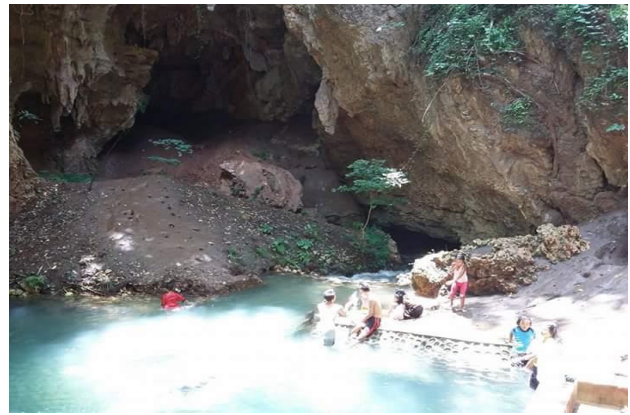
Fig. 6. The Small Drainage Tunnel of Ngreneng Cave (Photo was taken in the dry season of 2011, by Ahmad Cahyadi)

The main cause of overflow in Ngrengeng Cave was the large volume of water transported by the underground river. The flow exceeded the small drainage capacity of the underground river in Ngrengeng Karst Window (Fig. 6). A large amount of Cempaka-induced rainfall significantly increased the volume of water that had to be transported or drained by Bribin Underground River. The manager of Bribin Dam affirmed this condition. Normally, the water level at the dam was 36 m, but on November 28, 2017, it rose to 64 m. Therefore, the water pump machine at Bribin Underground River II or Sindon had to be turned off. The water input was greater than the distribution capacity of the underground river passage, causing water to rise through the karst window and then recede after a certain period. A simple scheme of this mechanism is presented in Fig. 7.

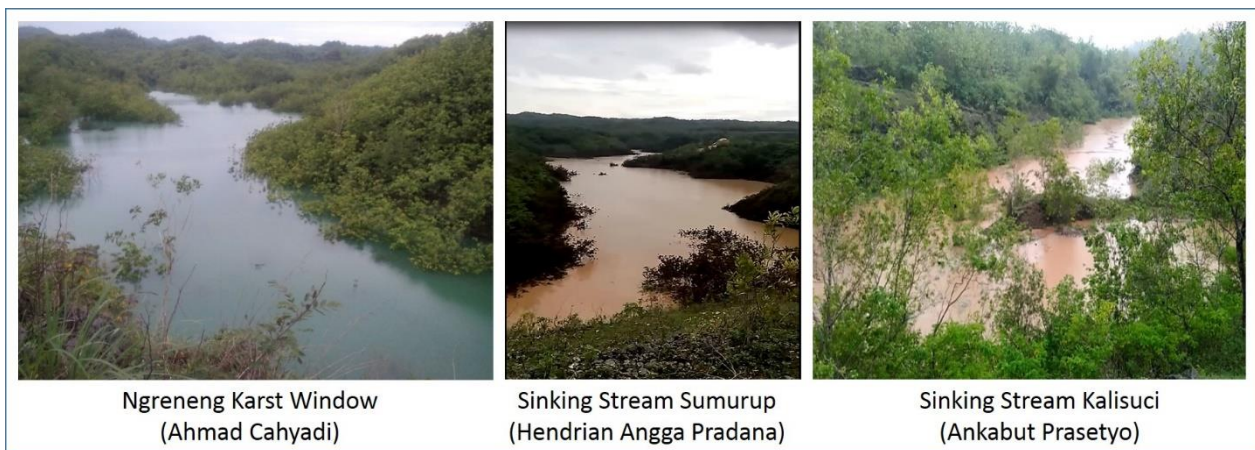
Fig. 8. The Differences between the Indundations around Ngreneng Cave, Sumurup Cave, and Kalisuci Cave

The groundwater flooding in Ngrengeng Karst Window was unique because the overflow was clear or not murky. This condition is different from the flooding in Kalisuci Cave and Sumurup Cave (Figure 8). There are at least two reasons that can explain this uniqueness. First, it is attributable to the main recharge that flows

into Ngreneng Cave and, second, the diffuse flow dominates the drainage mechanism.

In karst hydrology, the recharge of groundwater or underground river is broadly divided into two, namely allogenic and autogenic. Allogenic recharge originates from non-karst regions and enters through surface rivers that flow into underground rivers as sinking streams [12], such as Kalisuci Sinking Stream and Sumurup Cave. Kalisuci Sinking Stream, for example, is an outlet of Jirak River that flows from Ponjong District and some regions in Semanu District [12-14]. Water that flows on the surface is murky because it mixes with eroded soils [15]. Different conditions occur if the water recharge is autogenic, i.e., rainwater seeping through cracks in karst areas and gravitationally descending into an underground river [16-18]. The filtering process by the soil, cracks, and rock cavities purifies the water that enters the underground river [7]. Although Ngreneng Karst Window has both autogenic and allogenic systems [12], the discharge capacity of its diffuse flow is considerably large [10]. Consequently, clear diffuse discharge is dominant, which was the same case as the large autogenic recharge at November 30, 2017. The allogenic flow pushed the diffuse flow that had already filled the underground river passage during the flood. In other words, the water rising to the surface and inundating the base of karst basin was diffuse flow. It was also evidenced by the color change that began to occur after four days. The allogenic flow entered later and made the water inundating Ngreneng Karst Window murky.
