Dismantling of hipped roof and restoration of cribbed structure of monastic buildings, churches and temples

Abstract. The paper is devoted to the problem of adaptation and restoration of monastic structures, churches and temples without complete dismantling of the elements of the main load-bearing structures, using technologies and methods of work that allow delicately and effectively restoring the most important elements of buildings. The progress of work on the restoration of the hipped roof, using the lifting method - lifting the load-bearing part of the cribbed roof structure, is accurately and consistently described in the paper, as well as flexibility and efficiency in choosing a new solution for lifting, taking into account the features of the object identified during the work. The work on raising the roof was carried out during the course of adapting the building to modern use, based on the needs of the Kirillo-Belozersky museum-reserve.

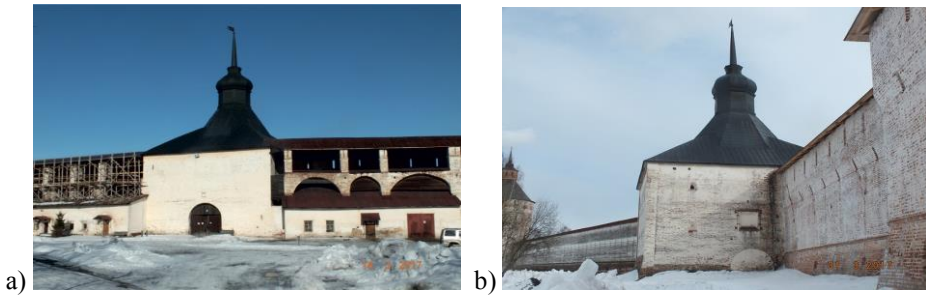
Fig. 2. Kosaya tower. The author of the photos is Galaktionova O. S.: a) - west facade; b) - south facade.

The tower is an almost regular square of walls in plan, cut by two large openings: in the center of the southern wall and in the southern part of the western wall (at the time of restoration, it was closed). A squat monolithic four-sided volume is covered by a hipped roof of complex shape: an octagonal hipped roof is embedded in the lower four-sided cap, completed with a faceted drum, a figured head and a slender spire with a slotted ensign [10].

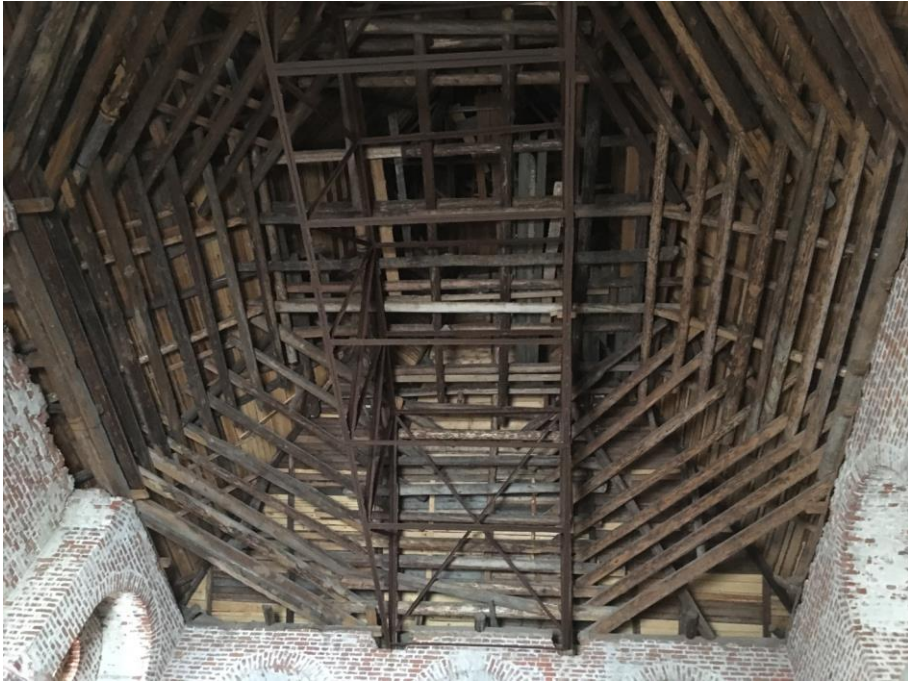
Repair, restoration and engineering works were carried out for the monument in the 1970s [2]. The most difficult works were carried out to strengthen the structure of the hipped roof. On the first floor, after removing the upper parts of the masonry of the walls, the trusses which supported structure of the hipped roof were installed (project of engineer I. S. Makolov). On the second floor with the help of trusses, by jacking, it was managed to replace the rotten crowns of the log cabin of the hipped roof (project of engineer G. N.

Fig. 4. A cribbed structure of hipped roof and a supporting metal truss installed in the 1970s. The author of the photos Galaktionova O. S.

At the moment of the beginning of work in the building there was a transformer substation, intended for removal. There are also longitudinal shrunken cracks of wood, local areas of prosthetics of elements of the truss structure. There is no antiseptic protection of the wooden truss system. Surface corrosion damage of metal structures of the truss is expressed. Drainage from the roof is not organized, which leads to active soaking of the walls, especially in places where fence made of long poles is adjacent. The above-mentioned problems became one of the reasons for the work.

The metal roof covering was replaced with copper in 2000.

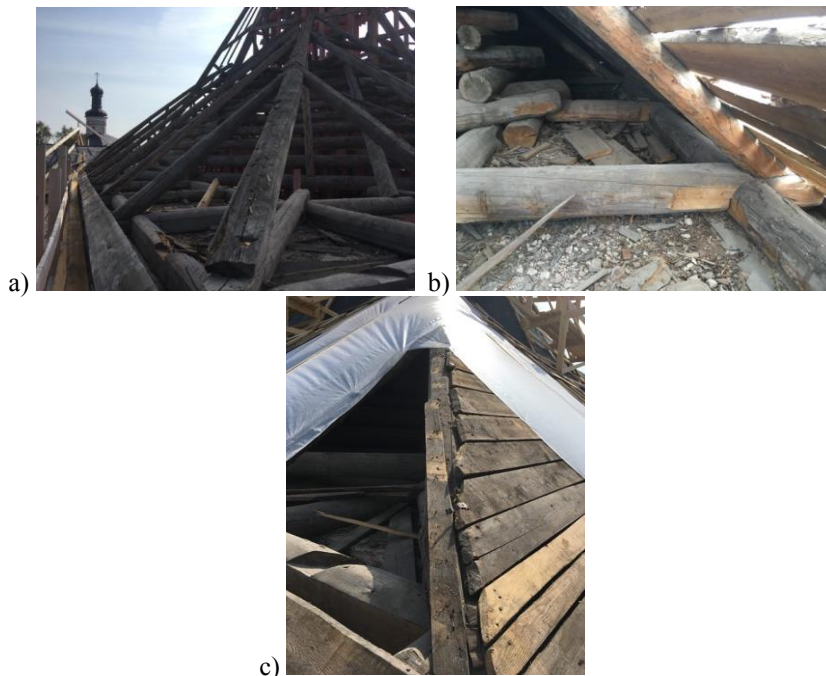
Fig. 7. Condition of the roof. The author of the photographs is Zhivotov D. A.: a) - the place where the cribbed structure is leaning on the walls; b) - existing and identified double wall plate; c) - condition of the crate.

- the presence of a double wall plate, which is the main reason for the inability to climb according to the developed design scheme;
- cribbed structure and wall plate made with cuts;
- cribbed structure lies through the supports on the metal truss;
- the individual elements of the crib have been strengthened by duplication with the fixing through the bracket and wire;
- weakened brick walls of the object in the upper part, destroyed parts of the former arches (Fig. 6).

Thus, the principle of lifting the roof by the method of “lifting” becomes the following:

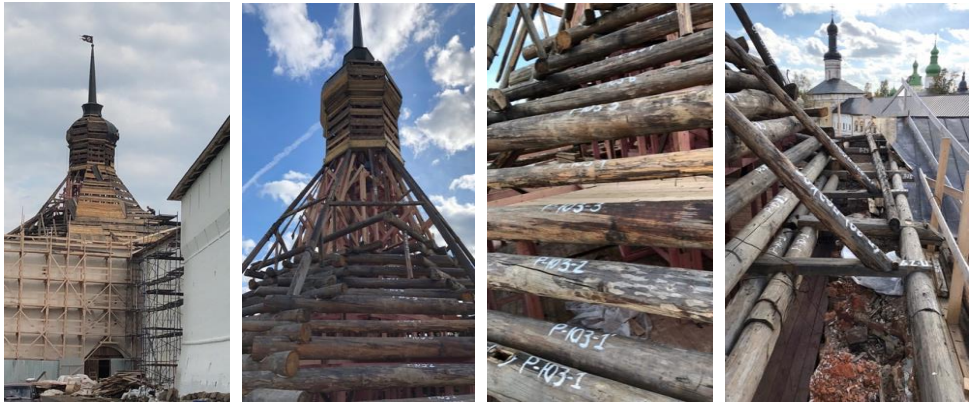
Fig. 8. Marking of wooden elements of the roof. The author of the photographs Galaktionova O. S.

1. Completely removed copper coating.
2. The crate of the four-sided and octagonal hipped roof is dismantled, the crate on the faceted drum and the shaped head with the spire remains.
3. All elements of the truss structure are marked: truss boards, crib, supports (Fig. 8).

4. The marked elements are removed near the object to prepared platforms, where the logs are further examined, cleared, places for prosthetics are identified or the need for complete replacement of the element is determined.

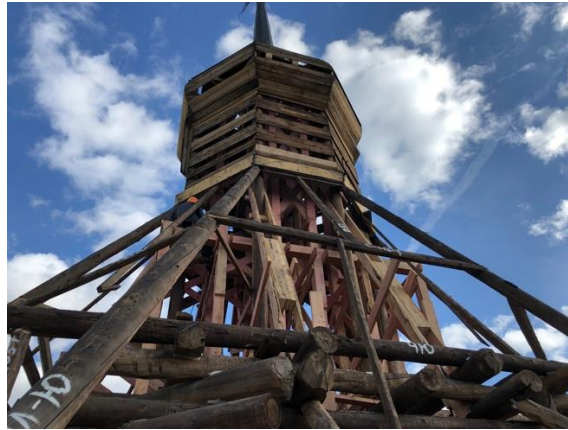
Fig. 10. The structure of the drum, bulb and spire. The author of the photographs is Zhivotov D. A.

The entire structure of the scaffolding is a pyramid with the tip pointing upwards. From under the drum on each of the four sides radiate two inclined reinforced racks. Each such rack crimps a log. These four logs laid cross - on-cross are the support for the drum racks and are transitional elements in the crib. The entire lifting will be carried out from this place. Only the structure of the drum, bulb and spire will be raised, so the crate on them was not previously disassembled (Fig. 10).

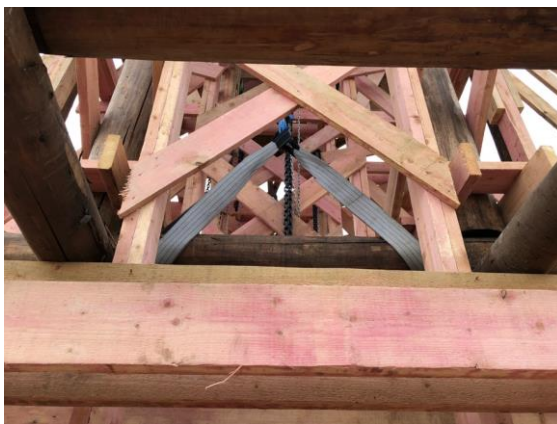
Fig. 11. Arrangement of 8 hoists for lifting the roof of the tower. The author of the photographs is Zhivotov D. A.

Winches are mounted on each side - inside the “glass”, additionally, two more winches are installed on the southern and northern sides. In places where four logs rest on the crib, jacks are installed on prepared bases-racks (Fig. 11). As they lifting, the jacks will also rise and provide an additional stabilizing effect.

After carrying out all the preparatory work, they begin to lift. Eight people start winches and jacks (Fig.11). Light grating, tension of the hoists. Torn off!

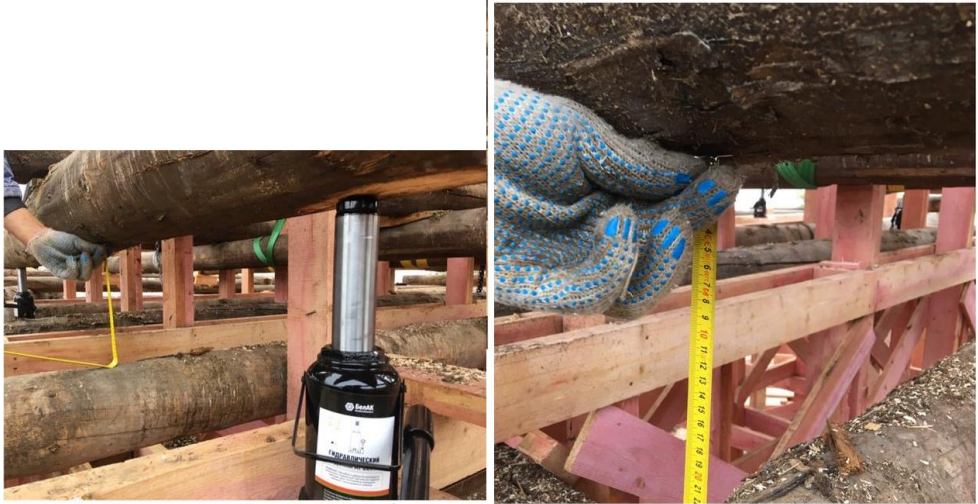
Fig. 12. Arrangement of jack for lifting the roof of the tower. The author of the photographs is Zhivotov D. A.

Now the structure is fully stabilized, completely based on the installed scaffolding and is not connected to the rest of the cribbed structure. The crib begins to be disassembled. All logs are marked and carefully lowered to the ground near the object. As well as truss boards, logs are inspected, cleared, and restored.

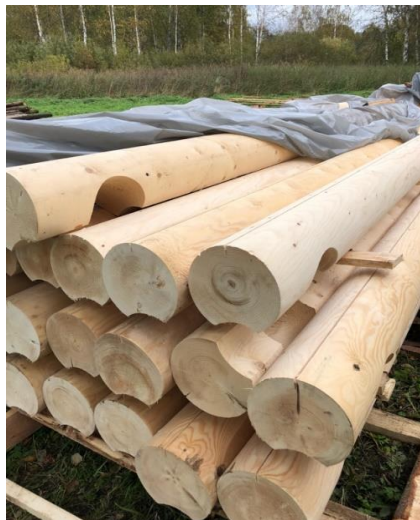
Fig. 13. Calibrated log for a new log house. The author of the photographs is Zhivotov D. A.

Further lifting was performed with alternating laying of 2 crowns, lifting the jacks to the height of the next 2 crowns, and so up to a height of 2 meters = 7 crowns. A calibrated hewn log measuring 300-350 mm was used (Fig. 13).

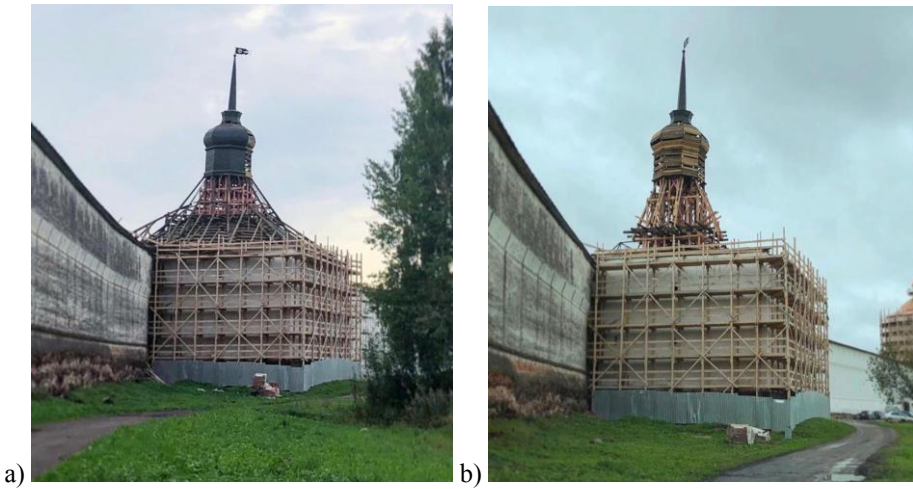
Fig. 14. a) - dismantling of the crate, b) - disassembly of the crib. The author of the photographs Galaktionova O. S.

After gaining the necessary design height, the overlying part of the roof was delicately lowered onto the newly created wall, fixed by means of a connection arrangement “in a bowl”.

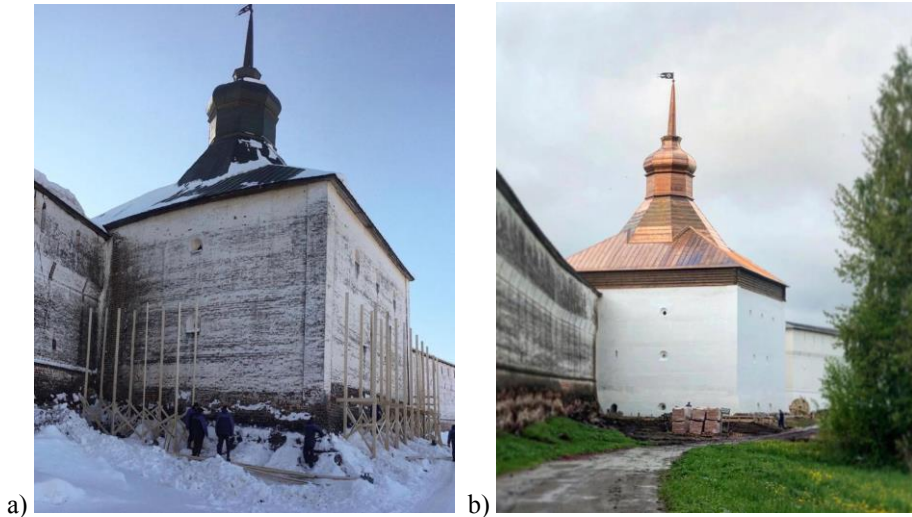
Fig. 18. a) – Kosaya tower BEFORE the execution of the works, b) – Kosaya tower AFTER the execution of the works. The author of the photographs Galaktionova O. S.
