Fracture analysis and countermeasures of the grid switch castings

Abstract. Based on the detection technology of direct reading spectrum, metallographic microscope and X-ray, the defects of the grid switch castings were analyzed. The four main forms of casting fracture were summarized as poor physical and chemical properties, material misuse, casting defects and designing defects. In order to strengthen the quality control of the source of the product, it was proposed to carry out targeted network inspection in the two stages of material arrival and infrastructure acceptance.

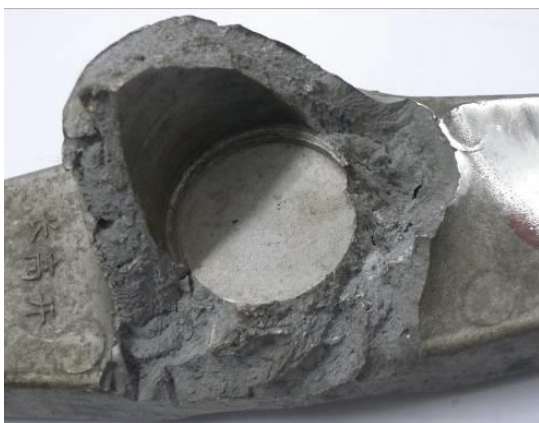
Fig. 1. Fracture morphology of the flange.

The GW16 switch vertical connecting rod flange broken during maintenance of a 220kV substation. The design material of this flange was die-cast aluminum alloy YL112. The flange broke in the middle. The fracture was flush and did not have any plastic deformation, which was a typical brittle fracture feature, as shown in Figure 1.

Samples were taken at the middle and end of the flange for tensile tests, and their tensile strengths were 184 MPa and 337 MPa, respectively. By consulting relevant research data, the design strength of YL112 at room temperature should be 330MPa. According to the technical requirements of GB / T9438-2013 aluminum alloy castings, the sample tensile strength of the I and II

castings with important bearing capacity should not be less than 75% of the design strength value[4]. Using the above standard calculation, the strength of the middle wall thickness of the hoop was about 55% of the design strength, which was unacceptable. It was confirmed that the performance of the wall-thickness part having the needle-like Si-Al eutectic structure was degraded.

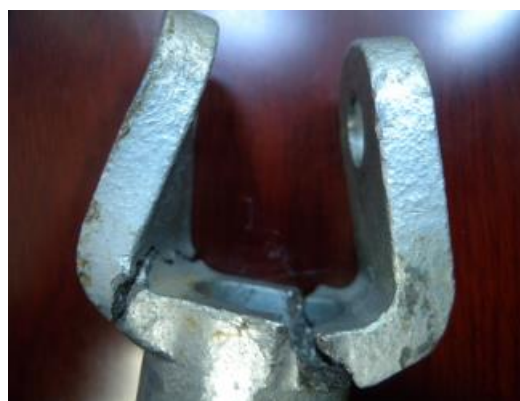
Fig. 4. Fracture morphology of the universal joint fork.

In an 110kV substation, a universal joint fork of the 5X14 switch broke during replacement and debugging, as shown in Figure 4. The joint fork design material was ZG270-500. For comparative analysis, a qualified universal joint fork of the same material and model was also provided.

By direct reading spectrum analysis, the C content of the fractured universal joint fork was 0.17wt.%. According to GB / T11352-2009 Standard for Casting Carbon Steel Parts for General Engineering [4], the C content of ZG270-500 material was 0.32-0.39%. The C content of the fracture universal joint fork was in the range of the

standard low-strength grade ZG200-400, which did not meet the ZG270-500 material requirements. Since C was the most important strengthening element of cast carbon steel parts, a decrease in the C content would lead to a reduction in the proportion of pearlite structure in carbon steel parts and a decrease in the strength of the material.

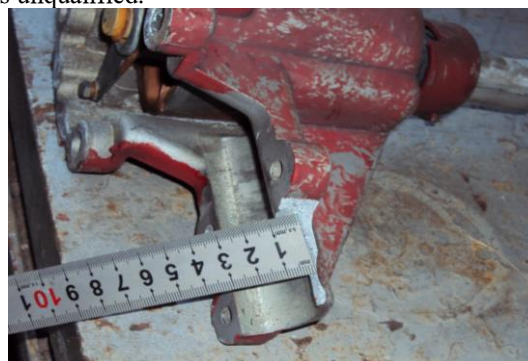
Fig. 7. Fracture morphology of the terminal block.

The GW4 switch terminal block in a 110kV substation was broken. The design material of this terminal block was die-cast aluminum alloy ZL102. The fracture position was at the clamping position of the terminal block bolt, and the fracture was a brittle fracture without plastic deformation, as shown in Figure 7.

Further measurement of the wall thickness at the break of the terminal block found that the thinnest part was less than 3mm. It was more important that this part bears the moment of the bolt and the conductive rod, which was an important part of the component. Compared with other manufacturers' products of the same type, the minimum wall thickness of this part was required to reach 6mm. The literature had reported that the cast aluminum parts fractured due to the thickness of the stress point at 5mm [6]. It showed that the insufficient design thickness of the terminal block bolt clamping was another major cause of fracture.

network access detection of the metal parts and move forward to the technical supervision point. On the one hand, casting manufacturers should improve technology, strengthen quality management, and prevent unqualified products from leaving the factory. On the other hand, power grid construction and operation and maintenance units have strengthened the equipment's network detection and acceptance work to avoid the maximum commissioning of defective equipment.
