Internal wall insulation with a new aerogel panel: SLENTITE® for energetic retrofit in historic buildings

Abstract. We present two recent test case application examples of a new high-performance insulation panel with product name SLENTITE® used as core element of a rendered internal wall insulation system. The first case study refers to the 18th-century building Alte Schäfllerei now the Fraunhofer Centre for Conservation and Energy Performance of Historic Buildings, at the monastery Benediktbeuern, southern Germany, where SLENTITE® was applied in 11/2017. The second test case was installed in 04/2019 in a heritage building situated in the historic center of Luxembourg. In Benediktbeuern, a single layer of insulation material was chosen, in Luxembourg we applied two layers of insulation. In both cases, detail work around the windows was a main task and we gained experience on product processing under real conditions. In terms of indoor room usage, the object in Benediktbeuern is used as exhibition hall with rare traffic and well controlled climate, whereas the object in Luxembourg is used as meeting room without climate control. Measured data of 20 months from the object in Benedik

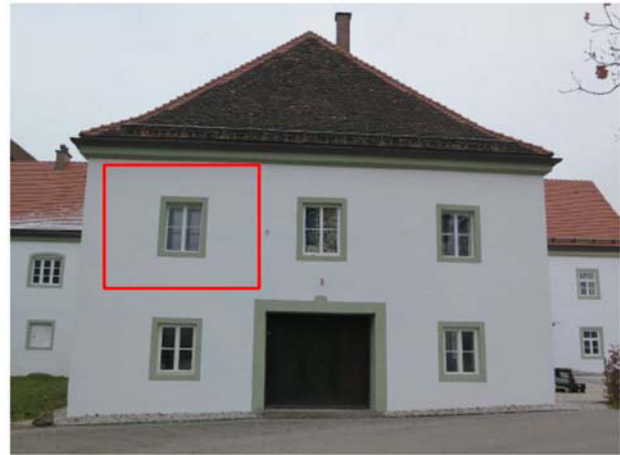
Fig. 1. Indication of the test area on the west façade / Benediktbeuern.

building is used as exhibition area and meeting room. In the first floor of the building, on the north-west corner, an area of about 12 m² on the west facing wall was insulated with SLENTITE. The area includes a box type window. The building was object to repeated changes in the past and consists mainly of mixed brickwork.

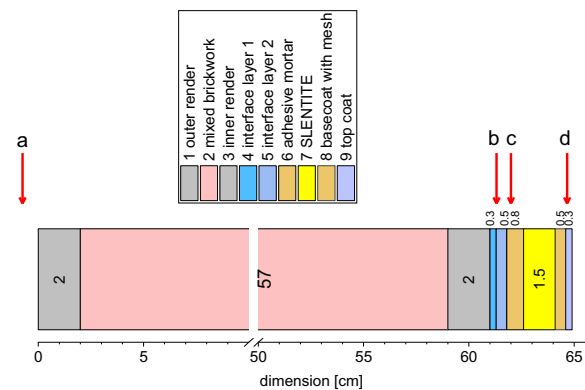
The insulation system was applied in November 2018 over an interface layer designed to allow reversibility [7]. SLENTITE was applied in one layer of 15 mm in a classical rendered system as sketched in Fig. 3.

Fig. 3. Cross section of refurbished wall with indication of sensor positions / Benediktbeuern.

The indoor temperature is conditioned to a target value of 20 °C and relative humidity to 50% rh, with recording and control in the center of the room (*e* in Fig. 3.). In the second winter of the test period, there were some irregularities due to equipment malfunction of the humidifier. Outdoor data showed a few very cold days in early 2018 with extremes reaching -16.9 °C, and a less strong second winter with a minimum of -12.4 °C.

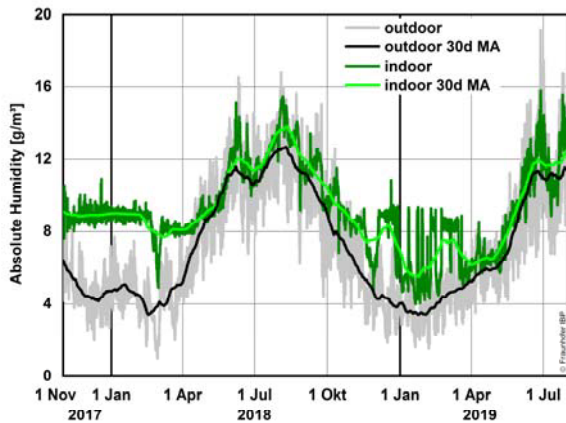
Fig. 4. Absolute humidity indoors (green) and outdoors (black) as hourly measured values and monthly moving averaged values (30d MA) / Benediktbeuern.

The absolute humidity indoors and outdoors is shown in Fig. 4. In the first winter period, the absolute humidity level lies about 9 g/m³ and the outdoor level about 4 to 5 g/m³. The absolute humidity varied in the second winter period from 2 to 5 g/m³ with the irregular conditioning.

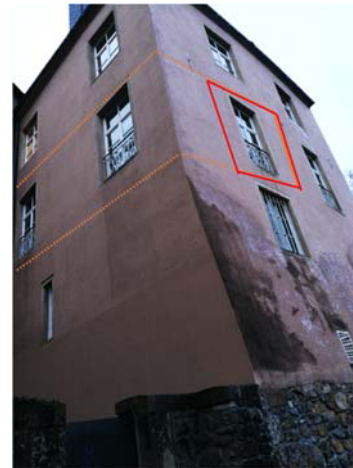
Fig. 5. Indication of the room and test area as seen from south-east / Luxembourg

The test room is located in a historic building in the city center of Luxembourg [8] which is used as a highly frequented meeting room. The wall area equipped with SLENTITE comprises a tall window, faces East and measures about 8 m². The existing wall is about 90 cm thick and made of broken sandstone. This side of the building is strongly exposed to weather.

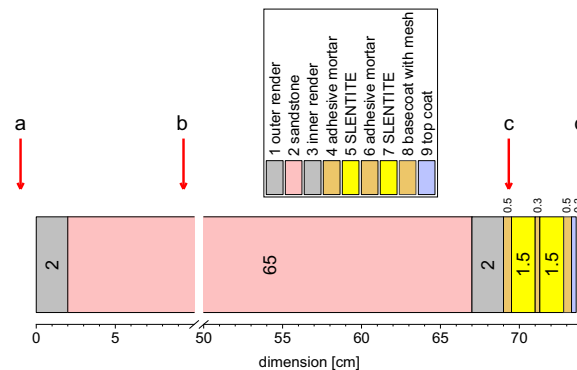
The area in Luxembourg was insulated in April 2019 with a two-layered system as sketched in Fig. 7. The insulation panels were installed passing twice over the full area including the large window jambs, working the second pass over the joints of the first pass. The whole room was equipped with a uniform topcoat and finish by a local project team in May 2019, about three weeks after the insulation layers.

Fig. 7. Cross section of the refurbished wall with indication of sensor positions / Luxembourg.

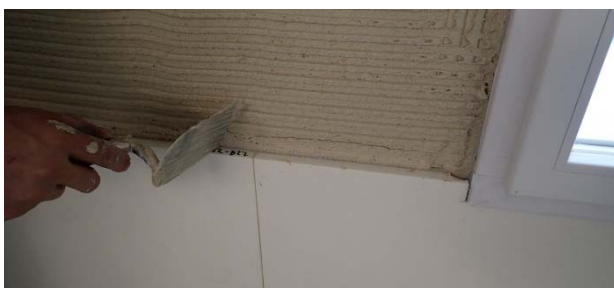
Fig. 8. Avoiding adhesive from entering in joints between insulation panels.

At both sites, SLENTITE® panels of original product size 55 cm × 36 cm were used for the main flat areas. The existing substrates (special reversible layer in Benediktbeuern, Trasskalk in Luxembourg) were plane, smooth and easy to work over, i. e. well prepared in the research setup of the sites. The adhesive mortar was applied with a notched trowel to the substrate and the pristine panels pressed in place. Special care was taken to avoid thermal bridges at joining panels. The two-layered variant was done similarly, with a second adhesive layer applied on the first insulation layer.

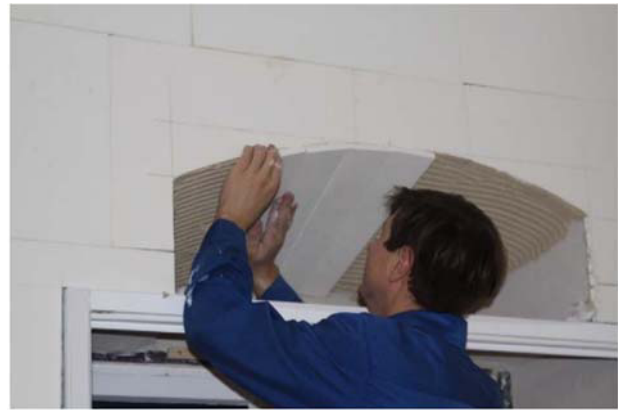
At both sites, some details required special attention. In Benediktbeuern, a rounded detail at the window head was equipped with small trapezoid stripes that were cut by jigsaw on site, as shown in Fig. 9.

Fig. 9. Applying insulation on a rounded area at the window head reveal / Benediktbeuern.

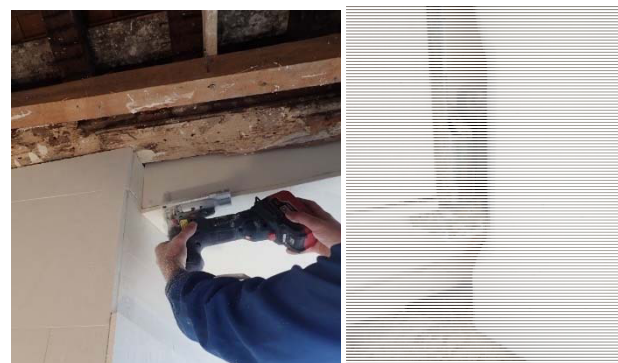
In Luxembourg, curvatures in the area of the wooden beam ceiling were aligned by the insulation using a jigsaw and smoothing planer. As only one room was insulated from the inside, the ceiling connections had to be meticulous and airtight. In the area of the window hinges, small details were modelled with sandpaper as shown in Fig. 10.

Fig. 10. Modelling the insulation panel around details such as connection to historic wood beam ceiling, window hinge / Luxembourg.

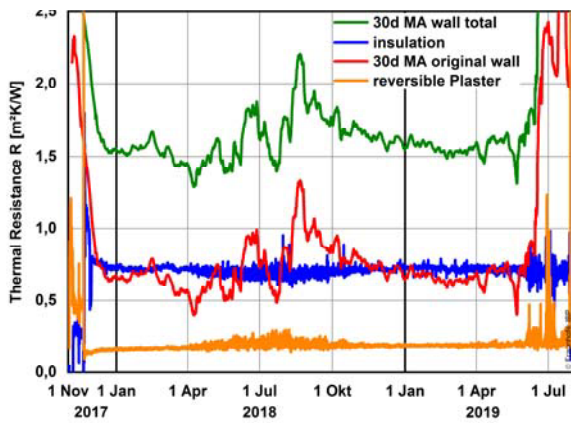
The performance of the insulation system was evaluated with respect to thermal resistance according to equation (1). Transient results are shown in Fig. 11.

Fig. 11. Calculated thermal resistance of wall cross section as a whole (green, top curve) and individual layers (insulation: blue, at approx. $R=0.75$) with hourly averaged data and 30 day moving average (30d MA).

The average effective thermal conductivity of SLENTITE® as by equation (3) for the first and second winter is $0.021 \text{ W/m}\cdot\text{K}$ and thus slightly above the declared lambda value of $0.018 \text{ W/m}\cdot\text{K}$ (measured as usual at $10 \text{ }^\circ\text{C}$ in dry material).

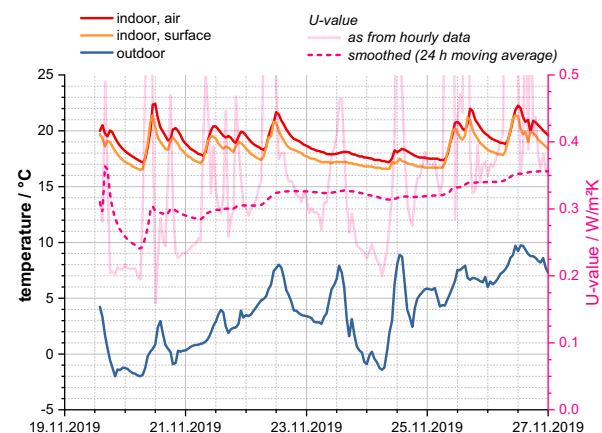
Heat flux \dot{q} and temperature T data from sensors on the inner and outer surfaces (index i, o) was evaluated to determine the effective U-value as in equation (2). The direct and smoothed result is represented in Fig. 14. The evaluation of an 8-day period in November results in a U-value of the insulated wall of about $0.35 \text{ W/m}^2\cdot\text{K}$. Considering the U-value before the insulation of approx. $0.97 \text{ W/m}^2\cdot\text{K}$, this corresponds to an improvement of 63 %.

Fig. 14. Sensor recordings and U-value evaluation / Luxembourg.

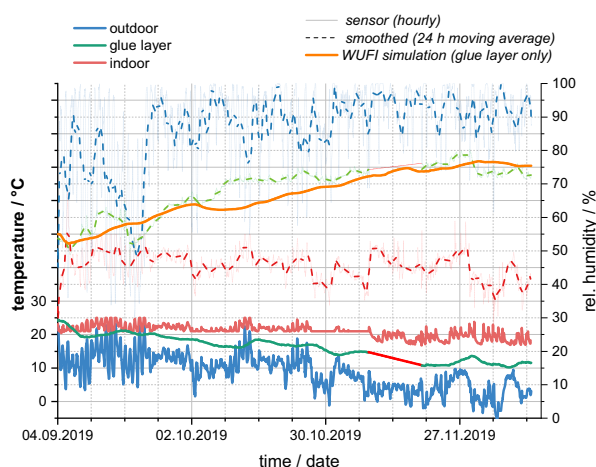
Fig. 15. Simulation compared to measurement / Luxembourg.

Fig. 15 shows the measured temperature and humidity values beneath the interior insulation and the course of the values simulated with WUFI. A good agreement is to be recognized. Conversely, it can be assumed that at least within the experimentally assessed humidity range of 60 - 85%, simulations with WUFI for the SLENTITE® product lead to reliable results for other indoor and outdoor climates if the edge parameters are selected correctly.
