# Moisture safety in CLT construction without weather protection – Case studies, literature review and interviews

**Abstract.** This project aims to expand understanding of how cross-laminated timber (CLT) constructions, including joints, connections and attachment points, are impacted by precipitation during construction. The project's case studies have been based on measurements of moisture contents and material sampling as well as microbiological analysis during the construction stage of the structure. The study does not include control of remediation. A literature review and interviews with seven individuals also were conducted. The results are based on two case studies with a total of four buildings. The field measurements show microbiological growth in all buildings and essentially on all investigated floor structures. Of a total of 200 analysed measuring points, half had some growth and about a third had moderate or extensive growth. Based on the outcome, it seems difficult or impossible to avoid the appearance of microbial growth during construction with CLT without weather protection. The literature review shows that microbiological analysis of CLT is extremely rare in bo

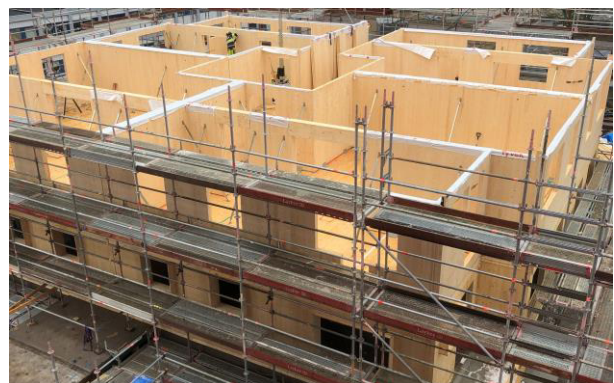
**Fig. 1.** Ongoing assembly of CLT frame without weather protection in central Sweden.

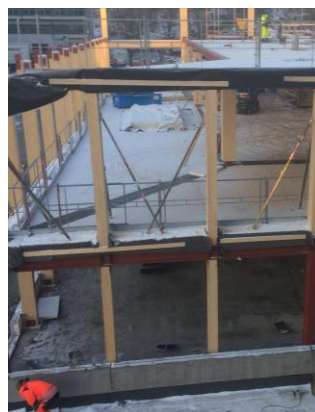
**Fig. 2.** Frame construction at the case study in west Sweden and snow on the floor structures. Assembly of CLT frame without weather protection.

The construction of the structure for a seven-floor office building in western Sweden, Figure 2, was monitored using measurements. The building frame consists of seven floors of laminated columns and CLT floor structures. The floor structures consist of seven layers with planed timber with a total CLT thickness of 230 mm and the upper layer with a thickness of 40 mm. The frame has also been braced with steel columns and steel floor beams. The CLT moisture content at delivery was 12%. The frame began to be built in January 2018 and was divided into three stages where half of the building's frame, stage A, was built to floor structure five. Then the second half of the building was built, stage B, to the fifth floor. Each floor required approximately up to three weeks for assembly. Stage C began from the fifth floor and the roof was made watertight at the end of July 2018.

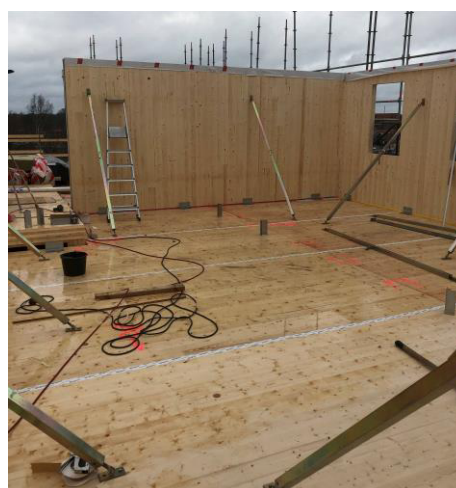
**Fig. 3.** Ongoing assembly with water standing on the floor structure after precipitation in central Sweden.

Three seven-floor buildings in central Sweden were studied as their frames were built, see Figure 1 and 3. The building frames consist of CLT walls and CLT floor structures. The floor structures consist of 5 layers with planed timber with a total CLT thickness of 200 mm and the upper layer with a thickness of 40 mm. The exterior walls had a thickness of 200 mm and the interior walls were between 140 and 200 mm thick CLT. The CLT moisture content at delivery was also 12%. The wood frame of the first building was assembled in December 2018 and the roof was watertight in the beginning of March 2019. The second building began to be assembled in January 2019 and the roof was watertight in mid-March 2019. The third building began to be assembled in March 2019 and the roof was watertight in mid-May 2019.

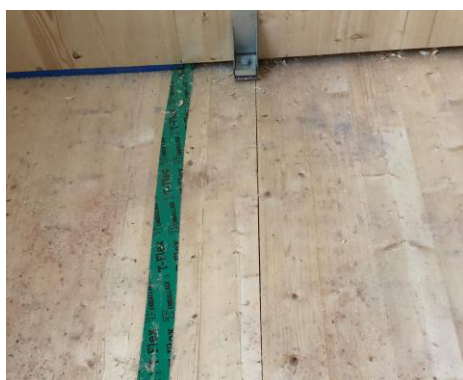
**Fig. 4.** Taped floor structure joints.

The CLT provider had no problem meeting the specified 12% moisture content at delivery of these projects. Moisture measurements were conducted about every other or every third week and were documented by the contractor's moisture safety manager and/or the developer's moisture expert. It proved difficult to keep the tape attached during precipitation while assembly took place and sometimes the tape fell off. It was also difficult to seal uneven surfaces and connected openings in the floor structure. The conclusion was that it was not possible to completely seal using tape. It was also difficult to ensure that the seals created with boards and plywood remained sealed. Since the leaky parts of the floor structure were located in about the same spots vertically, water was able to continue to several lower floor structures since these were also leaky at the same points, see Figures 5 and 6.

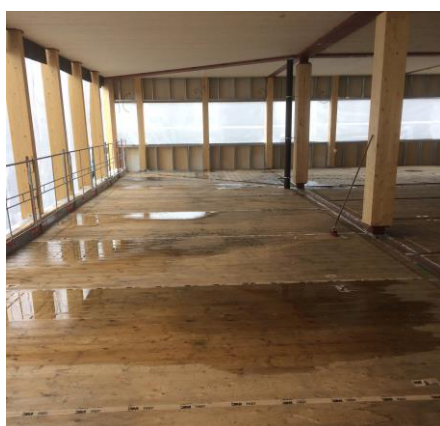
**Fig. 5.** On several occasions, water pooled on the floor structure. Precipitation ran down primarily from the above floor structures.

It proved difficult to remove water quickly and with larger leaks it was difficult to vacuum away all of the water in a timely fashion. Since most of the floor structures were exposed to water, they had a high moisture content on these surfaces until they were dried. Remediation of surfaces consisted of sanding, sawing with a circular saw in openings, and other measures, and there was more remediation work than planned. This information was provided by the moisture safety manager or the developer's moisture expert.

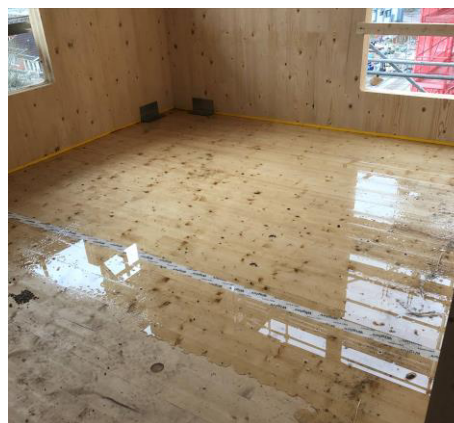
**Fig. 6.** Pooled water on floor structure in central Sweden. Precipitation ran down from the above floor structures.

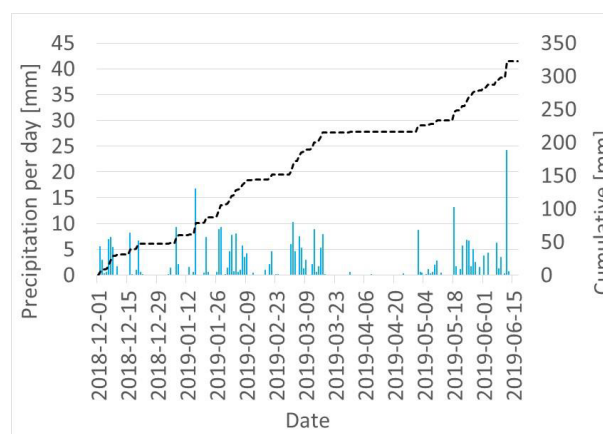
**Fig. 7.** Precipitation in mm rain per day and cumulative in mm rain during construction stage in central Sweden.

The analyses showed no risk of mould growth at all related to either the outdoor air or indoor air. On the other hand, precipitation data [48] has been analysed, see for example Figure 7, and compared with the assembly periods, see for example Table 1, and this has shown that most floor structures were exposed to precipitation during construction before floor structure above or protective roofing was installed.

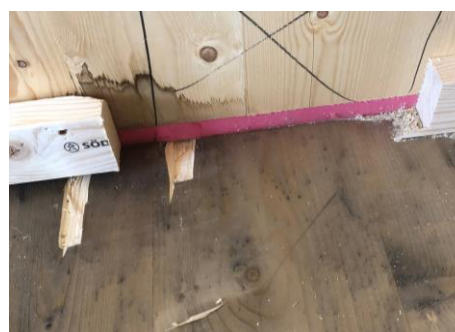
**Fig. 8.** Sample taken from the top side of the floor structure (CLT) under the sound and vibration pads and inner walls (CLT). The surfaces have been stained primarily by discoloured water.

Material was sampled using either hammer and chisel, see Figure 8, or a core drill to reach deeper into connection gaps, see Figure 9, or panel joints. Measurements of the top sides of floor structures under the sound and vibration pads were done diagonally downward with long insulated steel pins. Since the outer-most layer of the walls had a thickness of 20 mm, both layers were often measured. The samples were taken in the field and were examined in the laboratory under stereo-microscope at 10 to 40 times magnification. To quantify growth, a preparation from the material surface is made, which is studied at magnification of up to 400 times. The preparation is made by scraping part of the surface with a sharp preparation nail or by taking a tape impression of the surface. These are then placed in a drop of lactic acid with cotton blue or alternatively a drop of potassium hydroxide solution on a microscope slide and then covered with a cover glass. The microbiological analyses are based on a defined method [51] and the analysis results are provided in a four-point scale: no growth, limited growth, moderate growth or extensive growth.

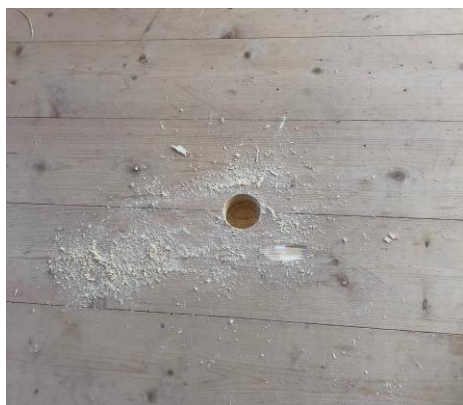
**Fig. 9.** Sample taken with a core drill in the connection gap between two timbers from the top of the floor structure (CLT).
