The Research of real-time identification system of types of lightning failures of UHV transmission lines based on UV detection technique

Abstract. Engineering running experience shows that with the increase of the operating voltage of the transmission line, the lightning trip rate is increasing. According to theoretical calculation, UHV transmission lines should be provided with full lightning protection characteristics; however, running experience shows that the lightning withstand level of UHV transmission lines is high, not completely lightning protection; it puts forward higher requirements for lightning protection design of UHV transmission line in China. UHV transmission line is mainly against direct lightning stroke characteristics, one is caused by lightning counterattack trip, the other is the shielding failure of lightning around the line to strike the wound caused by the wire. The lightning fault type identification is based on the micro topography of UHV transmission tower, accumulation of historical data, the development of a more targeted and high voltage transmission line lightning protection scheme is of great significance. In this paper, a real-time identification

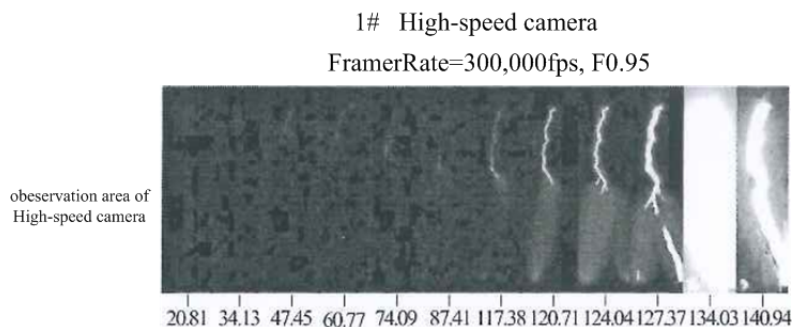
Figure.2 The process of shielding failure and couter attack of the UHV transmission lines

delays between the corona bursts and the changes in the initial positions are dependent upon these two opposite functions of strengthening and weakening of the electric field; the spatial charge flow generated by the corona weakens the electric field, while the shockwave head that is applied in the high-voltage electrode strengthens the electric field. When the total electric field strength near the high-voltage electrode is smaller than 2600kV/m, the collision free coefficient is smaller than the de-free coefficient, the electron avalanche begins to stop development. The lighting phenomenon of this zone appears and enters the dark discharge phase. The initial corona discharge process of the lightning shockwaves is shown in Fig. 2.
