# Study on the Leakage Damage Mechanism and Repair Technology of Shangmaji Weir

**Abstract:** As a type of dam with a long history and a wide range in the construction of water conservancy projects in my country, weir dams have the functions of flood control, irrigation and diversion. Due to the limitation of construction conditions and environment at that time, the treatment of weir and dam is not standardized enough, which leads to different degrees of problems in weir dam. Based on the example of Shangmaji weir, the article focuses on the analysis of the leakage damage mechanism of the weir, and proposes to choose the corresponding technology to repair it from two angles of the water-facing slope.

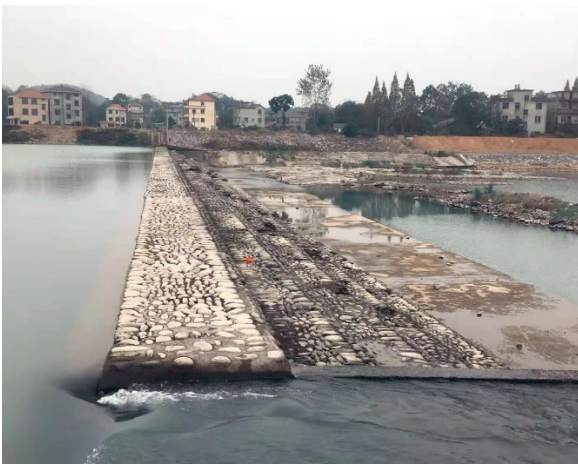
Fig 2. Cross-sectional view

Shangmaji Weir is located in Wanyao Irrigation District. The irrigation area is located in valley basins and hilly areas on both sides of the middle and lower reaches of Jiangshan Port. It has a low geographical latitude and belongs to a subtropical monsoon climate zone. The main climate characteristics are warm and humid, four distinct seasons, and abundant rainfall. The main disasters are low temperature, cold current, rainy season and typhoon<sup>[6]</sup>. Therefore, the water flow of the weir is the largest in April to June, and the cross-section of the entire weir is only 9.4m. The designed seepage diameter is too short to meet the requirements of the seepage diameter length in the high water period, which results in the weir a certain degree of leakage occurs. (Figure 2)

(1) For the treatment of cracks on the waterfront surface, on the one hand, surface covering materials can be applied. This method is the simplest and easy to operate method in adding an impermeable layer on the waterfront surface, which can greatly shorten the construction period and is economical commonly used surface covering materials include asphalt mortar, rubber sheet and acrylic emulsion mortar<sup>[9]</sup>. In the construction, firstly, the original dam surface must be humped, washed, etc; and the polymer mortar application process must be carefully mastered to achieve a good leakage treatment effect; on the other hand, you can choose to use sprayed concrete panels. This method does not need to erect a template, the construction is relatively simple, and the construction period is short.

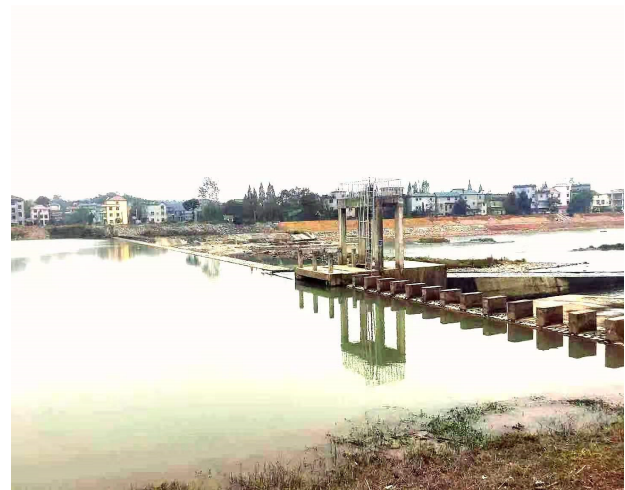
There is a water intake on the left side of the weir. The

survey data shows that the water intake is 1.8m wide and 1.4m deep. It is only lined with concrete and has no anti-seepage measures (Figure 1). Therefore, when the water flows through the water intake, it is easy to seep to both sides. Under the long-term water infiltration, the weir will also leak and damage.

Fig 1. Leakage at the intake

(2) For the anti-seepage treatment of the water intake, because it is necessary to ensure the amount of water diversion, it is not suitable for large-scale thickening repair, so a relatively simple anti-seepage plan can be adopted, that is, laying geomembrane. Geomembrane is a coiled material, which is convenient for transportation, convenient for construction, and short construction period. At the same time, the cost of using in an anti-seepage system is 30% or more lower than that of a traditional reinforced concrete anti-seepage structure. And the geomembrane has strong acid and alkali resistance, anti-aging, anti-ultraviolet abilities, and can be used quickly in various complex environments and is durable. Geomembrane can be used together with non-woven fabrics. Non-woven fabrics have a rough surface and can generate greater friction with the contact surface to ensure that the geomembrane and the protective layer are in a good and stable state.
