Research on Failure mechanism and Reinforcement Technology of Shangmaji Weir

Abstract. After the reinforcement and repair of the Shangmaji weir in Wanyao Irrigation District of Jiangshan City in 2014, the results of the repair did not improve much. The surface layer of the weir fell off, these not only affected the drainage function of the weir, but also the appearance was different from what is now advocated "Green ecology" is incompatible. This paper analyzes the causes of damage to this problem, and obtains two solutions: drilling, grouting, vertical paving, and to extend the width of receiving water step. After adopting the research programme, the degree of shedding of pebbles is greatly reduced, and the strength of the weir is significantly increased.

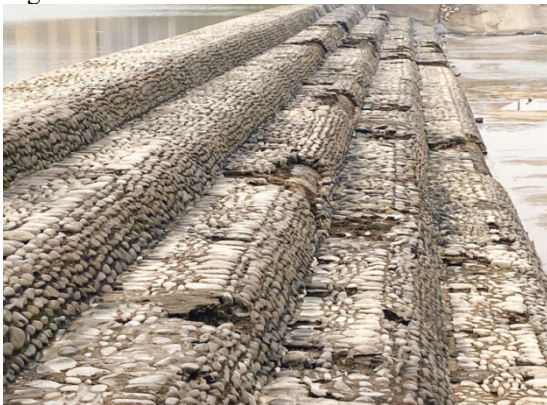
Fig1. Barrage damage map

It can be seen that the Shangmaji weir encounters a large water flow during the flood season every year. After many years of such erosion, the pebbles on the surface of the weir are easily damaged. As shown in Figure 1, although measures are taken every year to repair, they can only maintain for a short time. Around the year, the surface damage is more serious.

Construction tools include hand air drill, mixer, grout pump, grout pipe^[9]. Before construction, clarify the spacing of the holes, the number of holes and the position of each hole. The width of receiving water step is 1.6m and the length of the weir is 180m. Therefore, two rows of vertical holes are used. The outer row is 0.45m from the outer edge, and the inner row is The distance between the holes is 0.45m from the inner edge, the distance between the two holes is 0.61m, the number of holes in each row is 90, the spacing is 2m, and there are 180 holes in total^[10]. The borehole diameter is 45mm and the depth is 1.1m. Before construction, the pebble concrete within the radius of 0.2m with the center of the hole as the center is knocked out. When grouting, the concrete is poured in this area together, and then the pebble is erected to Make the pebble concrete and the lower layer become a whole, strengthen the bonding force between the pebble concrete and the concrete layer, and strengthen the stability of the weir.

The drilling and grouting vertical paving pebble reinforcement method uses a 40mm PVC pipe inserted into the grouting hole, and the penetration depth is not less than 30cm^[11]. When grouting, seal the contact point between the PVC pipe and the borehole, and keep the grouting pressure between 0.2 and 0.5Mpa. When grouting, the principle of first outside and then inside is used^[12]. Now the outermost hole is grouted, and then the inner hole is filled. After the grouting overflows, pour a circular area with a surface diameter of 0.4m to a thickness of 6cm, and then pave the pebbles tightly into the concrete so that the upper surface of the pebbles exposes the concrete, and the exposed height shall not exceed 1cm.

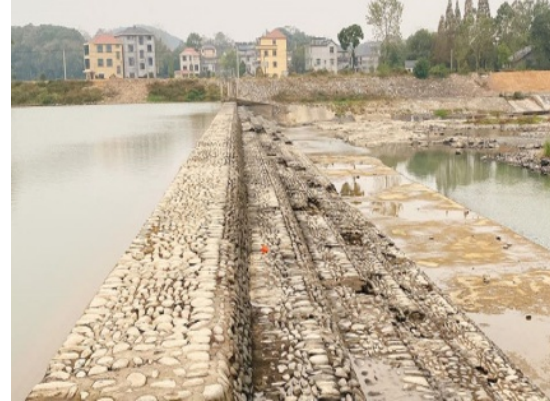
Fig2. Shedding of outermost pebble

The overflow platform of the Shangmaji Barrage adopts the laying method of "leveling one layer, standing three layers, and leveling one layer"^[7], so that the laying method will make the pebble on the outermost edge easily washed away by the large flow, and the inner side Laying

pebbles is relatively safe. When a large flow of river water passes through the top platform of the embankment, the arc will fall on the middle or the outermost side of the lower platform, so the laying method of the inner pebbles is not restricted. As shown in Figure 2, the pebbles of the barrage basically fall off the outermost part first, causing the damage gap to become larger and larger, extending to the inside of the platform, exposing the concrete cushion.

Understand the structure of the dam before construction, and redesign the receiving water step of the dam. Since the pebble concrete and the concrete layer are not well bonded, the width of receiving water step needs to be lengthened to alleviate the shear damage caused by the impact of the water flow on the pebble layer. The width of the designed receiving water step is 2.2m, and the length of each receiving water step must be widened.

The method of increasing the width of the receiving water step is to knock off the pebbles on the top surface of each layer on the weir. Construction according to the height of receiving water step is 0.6m and the width of receiving water step is 2.2m, a total of five layers of platforms are used to Pouring concrete. After the maintenance is completed. Apply 6cm thick concrete on the surface, re-use the knocked-out pebbles and lay them on the concrete layer, so that the concrete fully wraps the pebbles, and the exposed pebbles at the top do not exceed 1cm. The side pebbles are laid with the same process, and concrete is used between each layer of pebbles. Pack tightly so that it fully envelops the pebbles.
