The role of the irrigation network in the efficient use of water

With this in mind, the research was carried out considering the problems observed in the study of the canal "Khumbuz" at the level of service, i.e., safety criteria to reduce the breakdown and damage to hydraulic structures in the canal.

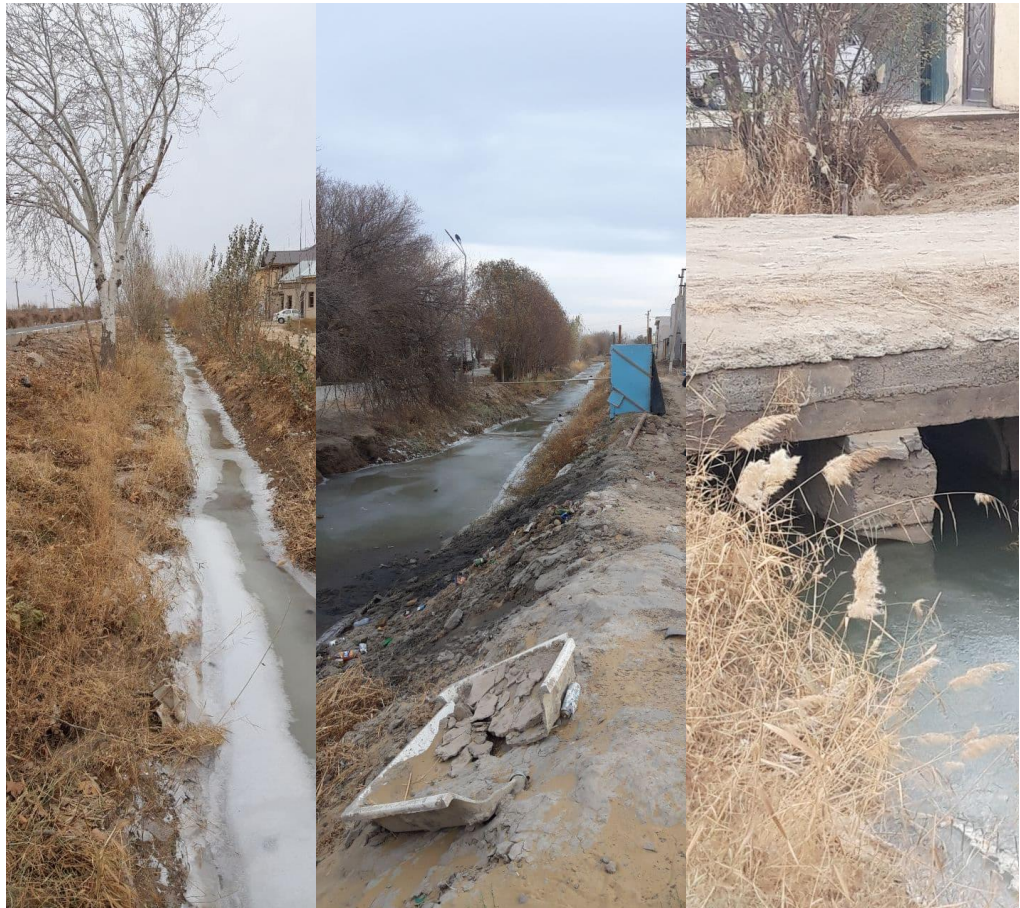
In addition to the above, the technical failure of the Khumbuz canal is mainly due to the failure of the canal users to maintain the water in a timely manner (see Figure 2).

Fig. 2. Technical condition of Khumbuz canal
