Natural resource management in the engineering protection of puppet theater structures from external impacts

The object of visual and instrumental examination is the load-bearing structures of the building of the Voronezh State Puppet Theater named after V.A. Volkhovsky, located at the address: Voronezh, Prospekt Revolyutsii, 50 (Fig. 1).

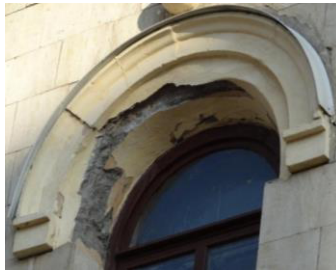
As example of defects is shown in Fig. 2 (Technical report on the results of engineering and geological surveys. Object: "Voronezh State Puppet Theatre named after V.A. Volkhovsky". Voronezh region, Voronezh, Prospekt Revolyutsii, 50 Arch. No. 24-10-2019):

- falling away of the plaster layer and decorative elements fragments;
- cracking of cornices, falling off of cornices modillions, as a result of design flaws in their fastening.

Fig. 2. View of defrosting and falling of decorative elements of window frames and masonry.

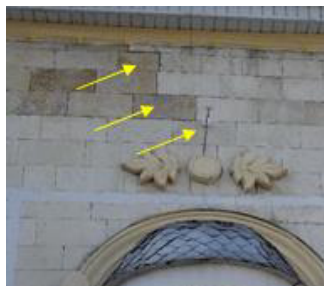
Another example of defects is inclined cracks in the outer and inner walls, caused by uneven settlement of foundations, with an opening width of up to 6.0 mm (Fig. 3).

Fig. 3. View of inclined cracks in the facade wall.

Ensure the normative technical condition of water-bearing communications to prevent soaking of the subsiding soil of the foundations.

Perform a set of works to protect the basement of foundations, composed of subsidence soils, from moisture;

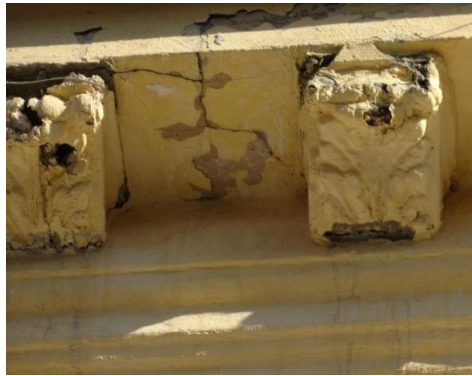
Cracking of cornices, danger from falling fragments of the plaster layer and the construction of cornices (Fig. 4).

Fig. 4. Example of cornice cracking.

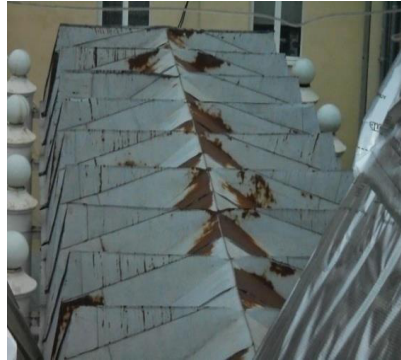
- through corrosion damage to steel sheets of the roof of the open gallery (Fig. 5).

Fig. 5. View of through corrosion damage of steel roofing sheets.

Perform corrosion protection of steel structures in accordance with the requirements of SP 28.13330.2012 "Protection of building structures against corrosion";

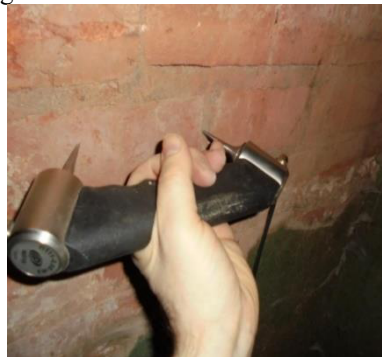
The work on strength measurements by the ultrasonic pulse method was carried out using the Pulsar-1.2 ultrasonic device (Fig. 6), included in the State Register of Measuring Instruments at No. 24690-06.

The device used has oscilloscope modes for viewing and analyzing ultrasonic testing. When determining the speed of passage of an ultrasonic pulse, in concrete and in masonry mortar, visual control of the shape of the pulses of the first entry was performed to exclude the influence of reflected signals and macro cracks.

Fig. 6. Determination of brickwork strength by ultrasonic pulse method.

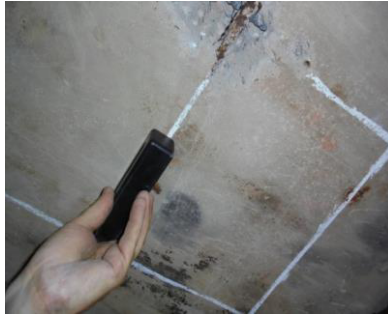
The control of the reinforcing scheme and the determination of the diameter of the reinforcement were carried out by the magnetometric method using the Poisk 2.5 device (Fig.

7). The device is included in the State Register of Measuring Instruments at No. 26398-09. The principle of its operation is based on registering the change in the electromagnetic field of the sensor during its interaction with the armature. Determination of the thickness of the protective layer and the unknown diameter of the reinforcement is carried out using a standard plexiglass spacer.

Fig. 7. View of the control of the reinforcing scheme of reinforced concrete elements by the magnetometric method.

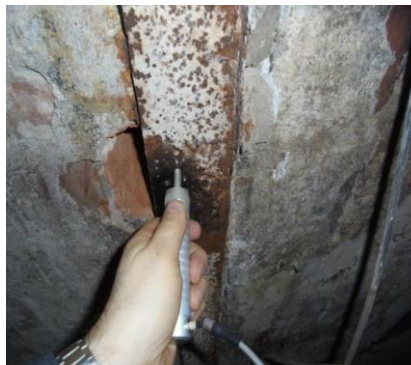
In the process of the instrumental part of the survey, the hardness of the structural steel of the elements of the lantern trusses was tested, followed by the transition to the scale of the temporary strength of steel. Steel hardness was measured using a TKM 459C ultrasonic hardness tester (Fig. 8). The TKM 459C device is included in the State Register of Measuring Instruments at No. 45302. The principle of operation of the hardness tester is based on the method of measuring the ultrasonic contact impedance of a diamond tip embedded in a metal surface. The surface of the structures at the control points was pre-treated to a maximum roughness of not more than $R_z=80$. To increase reliability, the value of a single measurement in a series is obtained by automatically performing 11-12 measurements. Each series of measurements is subjected to mathematical processing with the determination of the average value, standard deviation with automatic rejection of incorrect results. Processing of the results is performed automatically according to statistical algorithms, software-built into the device used. The results of hardness determination can be obtained on the HB, HRC, HV or MPa scales (corresponds to the tensile strength of steel).

Fig. 8. Hardness testing of steel structural elements by ultrasonic contact impedance using the TKM459S device.

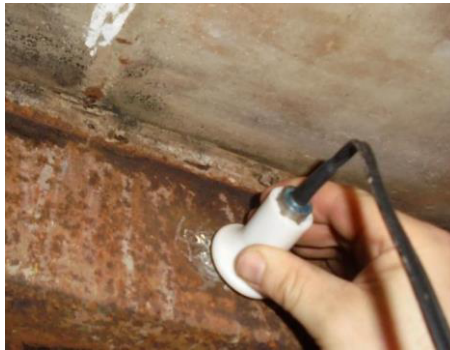
The control of the residual dimensions of the walls of the elements with one-sided access was performed using an ultrasonic thickness gauge TT100 (Fig. 9). The TT100 device is included in the State Register of Measuring Instruments at No. 19411-00. The principle of its operation is based on the ultrasonic contact echo-pulse method of non-destructive testing using longitudinal volumetric ultrasonic waves. The surface of the structures at the points of thickness control was pre-treated to a maximum roughness of not more than $R_z=80$. To create a reliable acoustic contact with the emitter, silicone gel "Contact" was applied to the surface of the construction material.

Fig. 9. Determination of the actual wall thickness of sections of steel structural elements by the contact echo pulse method using the TT-100 device.
