# Performances of Erosion Control Blanket Made From Palm Fiber On Reducing Erosion In The Slopes Of Lake Limboto Basin

**Abstract.** Lake Limboto is one of the key lakes with severe siltation, caused by sediment delivered by river currents. This study aims to reduce the impact of sedimentation by controlling erosion with a palm fiber net with mesh dimensions of 5 cm x 5 cm and a thickness of 5 mm. The Palm fibre installation is installed on slopes with erosion potential; each location has a different slope: location 1 has a slope of 40°, location 2 has a slope of 45°, and location 3 has a slope of 50°. With the findings obtained, palm fiber nets erosion control was shown to be effective in repelling erosion. The first site has an 8:3 ratio, the second location has a 5:2 ratio, and the third place has a 1:0.5 ratio, net performance at each location of 42% location 1, 39% location 2, 41% location 3 and 0% at location 4. Differences in soil structure and slope of the slope generate variations in the data acquired from each location.

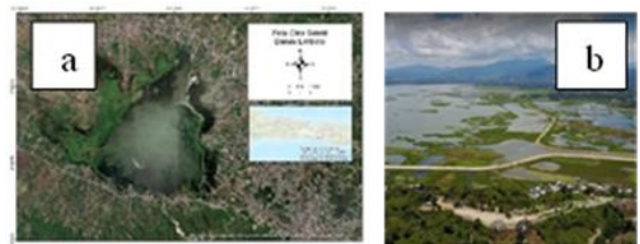
**Fig. 1.** Limboto lake map showing the location is mainly in Telaga, Batudaa and Kota barat district (a). The photograph of Limboto lake from hills in Dembe village of Kota barat district of Gorontalo city showing the rapid siltation takes place.

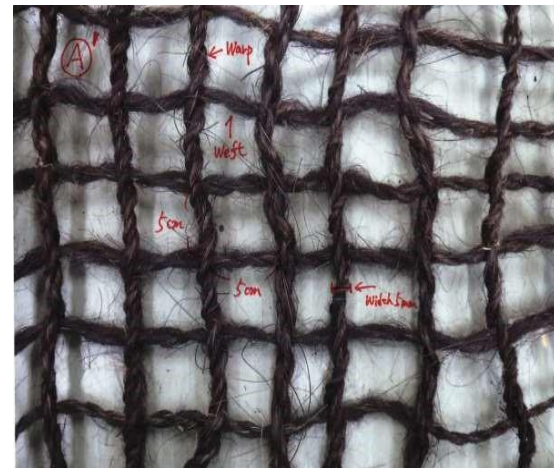
**Fig. 2.** Examples of dunula nets (fiber) with mesh dimensions of 5cm x 5cm, and 5mm thick.

The main material that will be used is the palm fibre net, with a mesh size of 5 cm x 5 cm, and a thickness of 5 mm (shown in Fig. 3). The fiber net was produced in Tulabolo village of Bonebolango reGENCY Gorontalo with mesh design provided.

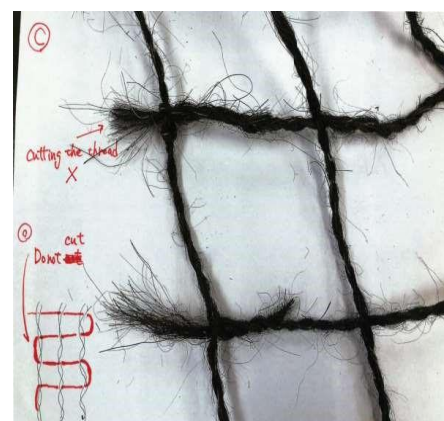
**Fig. 4.** In this dunula net, the rope on the side of the net will not be cut.

There are many ways that can be used in making a net, in this dunula net we use type C (Fig. ure 3, and 4). This method is considered very effective in the defense of the net when applied to the oblique plane, because the fiber rope is woven and bind to each other so that the net will not easily shrink.

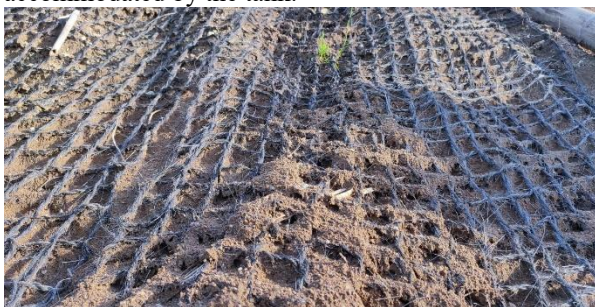
**Fig. 6 .** Sediment stuck in nets.

Pressure from rainwater causes the release of soil particles then soil starches that are detached from the structure will be transported by the water. This process will be minimized because of the presence of nets as a retainer but there are still soil particles that escape and accommodate in the container box. While in other parts that do not have a net, soil particles transported by water will derail without retaining so that sedimentation in the part without nets will be more accommodated by the tank.

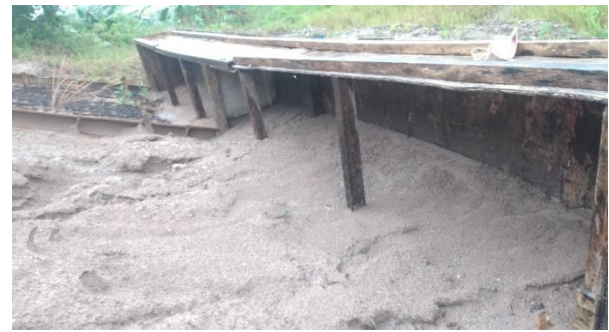
**Fig.7.** Sediment on the tank.

When retrieving data, the sediment is collected and measured using a bucket with a volume of 3,700 cm<sup>2</sup> (Fig. 7). The data retrieval process is carried out at a time starting from August 22, the sediment reservoir is emptied, and the next sediment collection and measurement is carried out on September 6, 2021.
