Vertical Displacement of the Surface Area over the Leakage to the Transverse salt Mine in 1992–2012

Tomasz Lipecki^{1,*}

¹ AGH University Science and Technology, Faculty of Mining Surveying and Environmental Engineering, A. Mickiewicza Av. 30, 30-059 Krakow, Poland

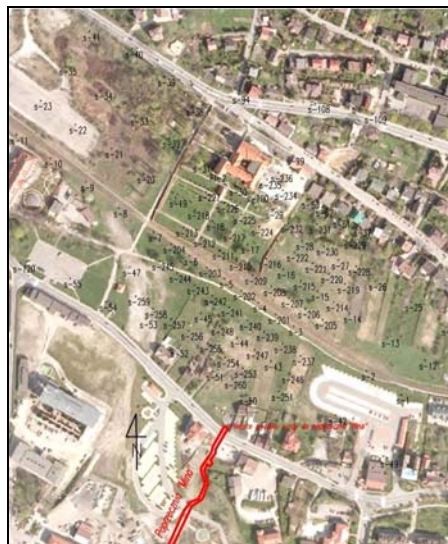
During the catastrophic effects of leakage, a number of studies based on geophysical measurements, such as gravimetric and electrofusion, were conducted. However the most frequently performed tests were surface deformation measurements in the form of precision leveling on an established control network [6] covering the extent of the fallen depression from September 1992. For the control of successive states also used InSAR [7] and laser scanning [8]. Initially, the network consisted of 55 ground points distributed regularly every 50 m and two wall-mounted repairs on the walls of the monastery. After further flows of water, the net was enlarged in the north and east direction and was thickened to a mesh of 25 m as well as a number of wall markers were stabilized in the surrounding buildings (Fig. 4).

Fig. 4. Location of observation points of fallen trench along the course of transverse
