Application Research of Multiple Detection Technology in Equipment Fault Diagnosis

HUADIAN ELECTRIC POWER RESEARCH INSTITUTE Co., LTD. Turbine and gas turbine technology department, 310030 Hangzhou China

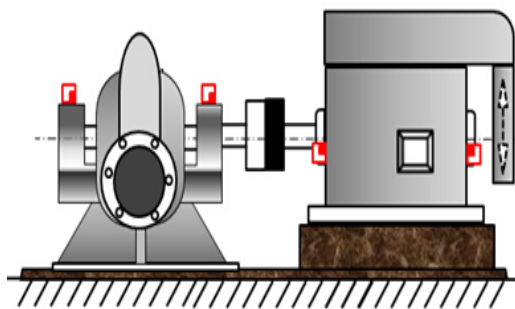
Figure 1 Equipment structure

The cooling water pump usually used as an important equipment in the factory to provide cooling water for steam turbine systems, lubricating oil systems, generators, vacuum pump coolers, etc., to keep the temperature of each system controllable and normal^[5-6]. The pump information is shown in Table 1.

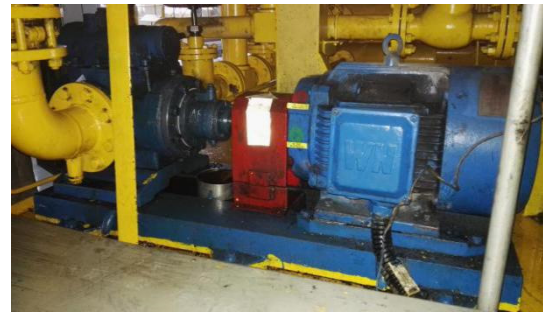
Figure 4 Appearance of the device

The heat generated during engine operation is cooled by hydrogen. The oil pressure generated by the sealed oil pump isolates the hydrogen from the outside world. It enables the generator to be fully and reliably cooled. The hydrogen can be charged safely and fully. The appearance and parameters of the oil pump are shown in Figure 4 and Table 4.

(1) It was found that the sealing temperature of the oil pump drive was as high as 110 °C during operation. After one week of operation, the temperature reached 117.5 °C, as shown in Fig. 5, Fig 6.

(3) Check the sealing temperature of the sealed oil pump machine on time. The maintenance and repair suggestions are according to the temperature rise trend [9-11].
