# Typical failure forms and improvement measures of power grid fasteners

**Abstract.** By investigating the fastening defects of power grid components, it was concluded that unreasonable design, insufficient corrosion protection, improper assembly and insufficient fastening were the four typical forms of bolt failure. In response to the above problems, improvement measures such as design review, material sampling inspection, construction supervision, and operation and maintenance inspection were proposed.

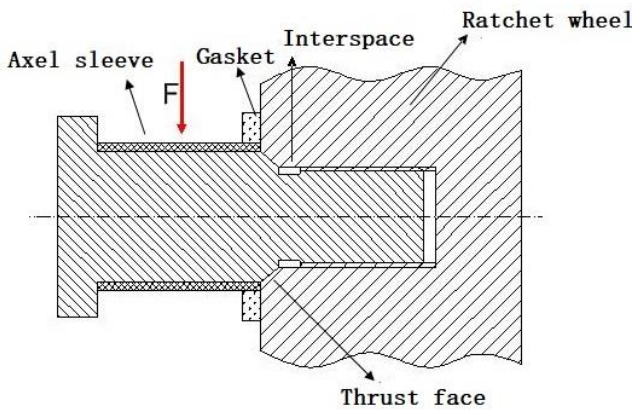
**Fig. 8.** Schematic diagram of correct assembly of bolts.

Fig. 7 had shown the photos of the accidental fault bolts left in the ratchet wheel. It could be clearly seen that the thrust bearing pad had a more obvious indentation left on the surface of the ratchet wheel, which could be inferred that the connecting rod bolt was incorrectly assembled. The correct assembly was shown in Figure 8. The gasket was sleeved on the shaft sleeve. It was in free contact with the surface of the ratchet and it was impossible to leave a residual indentation. In this case, the 45°bevel of the bolt was tightly coupled to the 45°bevel of the ratchet internal thread, which could effectively cushion the impact of the bolt root during the switch operation. However, the actual assembly was shown in Figure 9. The gasket was pressed under the sleeve, so that the 45°slope of the bolt could not be coupled with the ratchet. In this way, the root of the bolt would be subjected to a large impact of additional bending moment stress when the switch was opened and closed, and eventually the root of the thread undercut would have a relatively rapid early low-cycle fatigue fracture.
