# Assessment and retrofitting of nursing faculty building of Andalas University, Padang, Indonesia

**Abstract.** The Faculty of Nursing building is one of the administrative buildings at Andalas University. This building was designed by a planning consultant and began construction in 2013. However, during the construction period, it was found that the concrete quality was very low, that is  $f_c'=14.32$  MPa, so that the construction could not be continued because it was not in accordance with the planning quality,  $f_c' =22.39$  MPa. Therefore, it is necessary to evaluate the feasibility of the building structure before the construction is continued. In the structural analysis, the loads applied are dead loads, live loads, and earthquake loads. The analysis was carried out using the application (*software*) ETABS. Based on the analysis results, it was found that the capacity of columns and beams of the building are not strong enough to withstand the loads acting on the structure. The inter story drift also does not meet the permit limit requirements according to the New Indonesian Earthquake Code, SNI 1726:2019. Therefore, it is necessary to retrofit (strengthen) the structure o

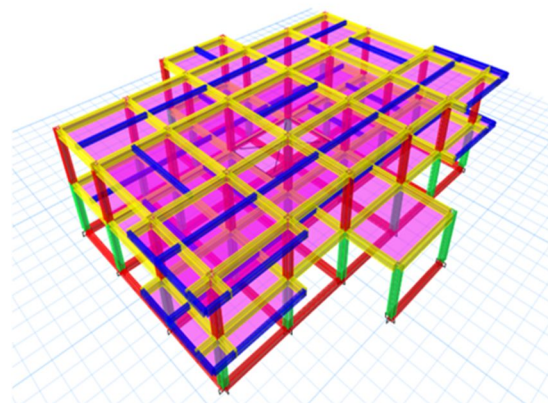
**Fig. 5.** Modeling of Structure

The results of the modeling of the building structure can be seen in Fig. 5.

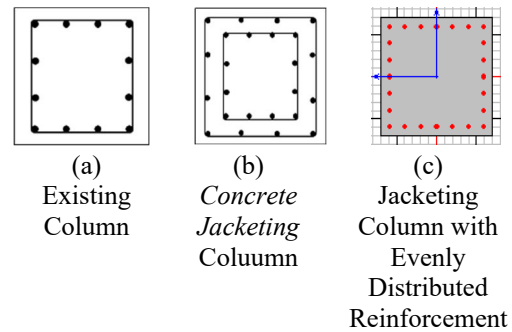
**Fig. 14.** Concrete Jacketing Column Reinforcement Modeling

From Figs. 14 and 15, it can be seen the assumption of the definition of the jacketing column in the ETABS software. Fig. 16 shows the comparison of the column cross-section between the existing column and the jacketing column.

- The quality and amount of added steel reinforcement are the same as the existing one, that is  $f_y = 350$  MPa with 12 D16.
