The damage effect on the structural capacity of school building columns due to tsunami inundation in Banda Aceh city after 16 years

Bunga Raihanda^{1*} and Abdullah²

Abstract. The 2004 Indian Ocean earthquake and tsunami caused catastrophic damage to buildings and infrastructure in Banda Aceh. The impact and damage depended on several factors such as the distance of the area from the coast. It was reported that in Banda Aceh, the tsunami wave inundation reached the city center and affected over a third of the population. Due to priority reasons at the time, although the structure was submerged in tsunami inundation, numerous public facilities including school buildings still in use without any proper repair. This study aims to determine the effect of column damage due to the tsunami inundation on the strength of the building. The school building of SMPN 6 Banda Aceh is selected as the case study. Seven analysis cases were carried out to simulate the degradation of the column cross-section caused by tsunami inundation. The reduction of the column cross-section was determined from 5 to 25% with increments of 5%. The analysis results revealed that the decrease in strength has occurr

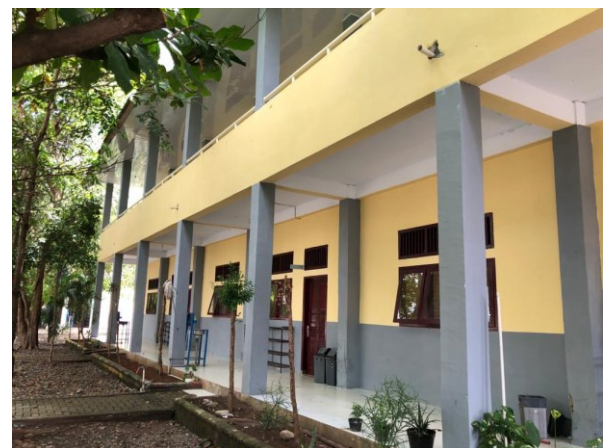
Fig 1. Column conditions

Direct observations at the SMPN 6 Banda Aceh building revealed that the concrete portion of the column which was submerged by the tsunami has cracked. Moreover, some of the concrete covers have peeled off and the exposed reinforcement was corroded. These conditions are shown in Fig. 1.

In actual condition, the column was built following the cross-section of the design size. Then, since the column was submerged by tsunami inundation and was not repaired, the degradation of column section, cracking, and cover loss is unavoidable. The column cross-section sizes gradually decreased and lead the reinforcement to corrode.

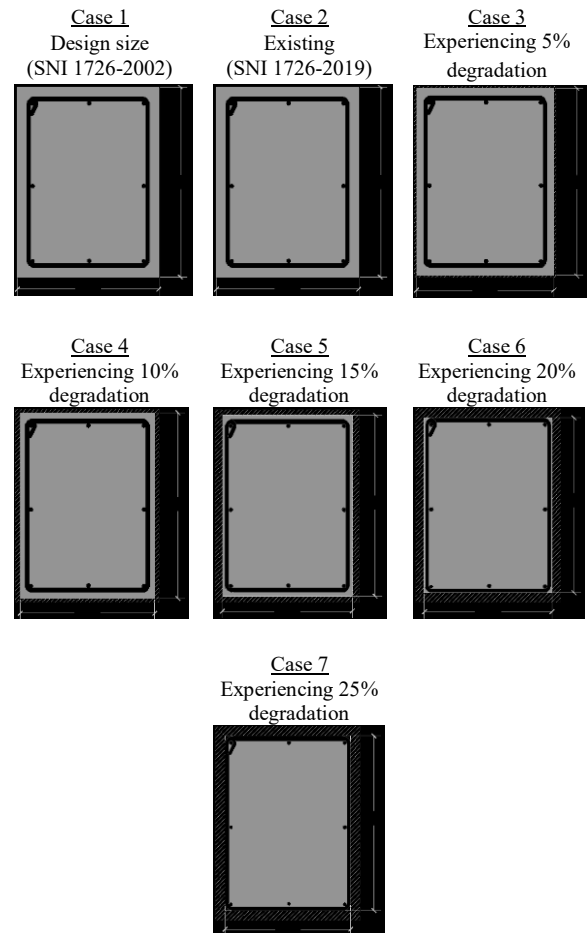
Fig 8. Column degradation included in the analysis

To simulate the effect of degradation of the column cross-section caused by tsunami inundation, seven scenario of analysis cases were carried out as illustrated in Fig. 8. The degradation of the column size was carried out sequentially to evaluate the capacity of the building structure. The reduction of the column cross-section was determined from 5 to 25% with increments of 5%. The degradation percentage of column cross-section were applied on each side of the width and depth.

Case 1 was the condition of the column cross-section following the design size and the applied earthquake loading from SNI 1726-2002 was used. Case 2 was the condition of the column cross-section following the

design size but the special earthquake loading from SNI 1726-2019 was used. Case 3 to 6 was analyzed by reducing the cross-sectional size of the column due to concrete cover deterioration caused by tsunami inundation. In case 7 the analysis was carried out with

complete loss of the concrete cover, and the degradation of the size of the reinforcement due to corrosion.
