Build back better and stronger the 2022 earthquake-damaged houses in Talamau–Pasaman Barat District

Seng Menghoung¹, Bambang Istijono^{2*}, Febrin Anas Ismail³, Melinda Noer², and Rahmat Fadli Zakir²

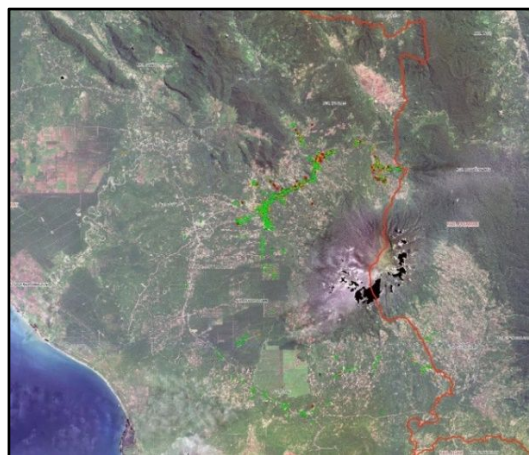
Fig. 6. The distribution of the locations of heavily damaged, moderately, and minor damaged houses in Pasaman Barat District.

Inventory of damaged houses that was recorded by the Government of Pasaman Barat District and the National Disaster Management Agency, houses with severe damage condition of 544 units, moderate damage 895 units, and minor damaged condition of 1,973 units, as shown in Table 1 and the location of the distribution as shown in figure 6.
