# Study on wind turbine blade defect detection system based on imaging array

**Abstract.** Currently in the process of wind farm inspection, wind turbine blade appearance inspection mainly adopts the telescope or high-definition cameras, low detection efficiency, labor intensity and the precision is limited, in order to solve this problem, a kind of wind turbine blades defect recognition system based on image array is proposed. Through the joint of array camera and image processing server, the functions of the image acquisition, processing, and defect recognition and detection results output are implemented. The software of artificial intelligence deep learning based on neural network algorithm is used to identify the defects of blade image, and output quality analysis report, to realize automatic detection of wind turbine blade surface defect. The field measurement results show that the system greatly improves the efficiency and accuracy of wind turbine blade defect detection.

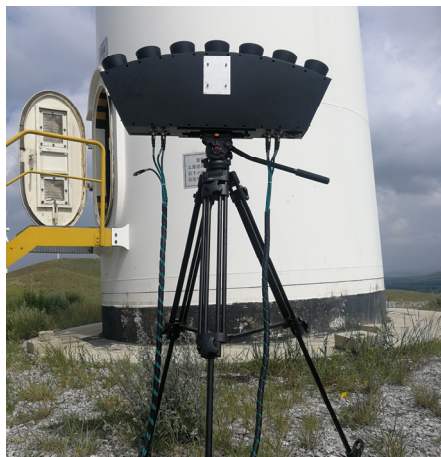
According to the field conditions of the wind farm, the camera array system for wind turbine blade image acquisition built in this paper is shown in Figure 1. The schematic diagram of the connection between camera array and image processing server is shown in Figure 2.

Fig. 1. Camera array system.

- The camera array is mounted on the cradle head to adjust the shooting angle.
- The camera array is connected to the computer by a network cable, with a length of up to 100m, which facilitates field wiring.

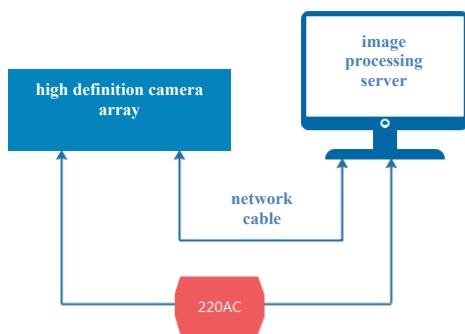
Fig. 2. Schematic diagram the connection between camera array and image processing server.

The connection relationship among camera array, wind turbine and image processing server is as follows:

- The whole set of equipment is physically divided into two parts: camera array and image processing server, which are connected by a communication cable for on-site assembly and disassembly.
- There are two sets of cameras in the camera array, one is a high-definition array, which is used to identify defects; The other is a positioning camera, which is used to determine whether the positioning blade fills the entire

field of view and assist in adjusting the shooting angle of the camera array.

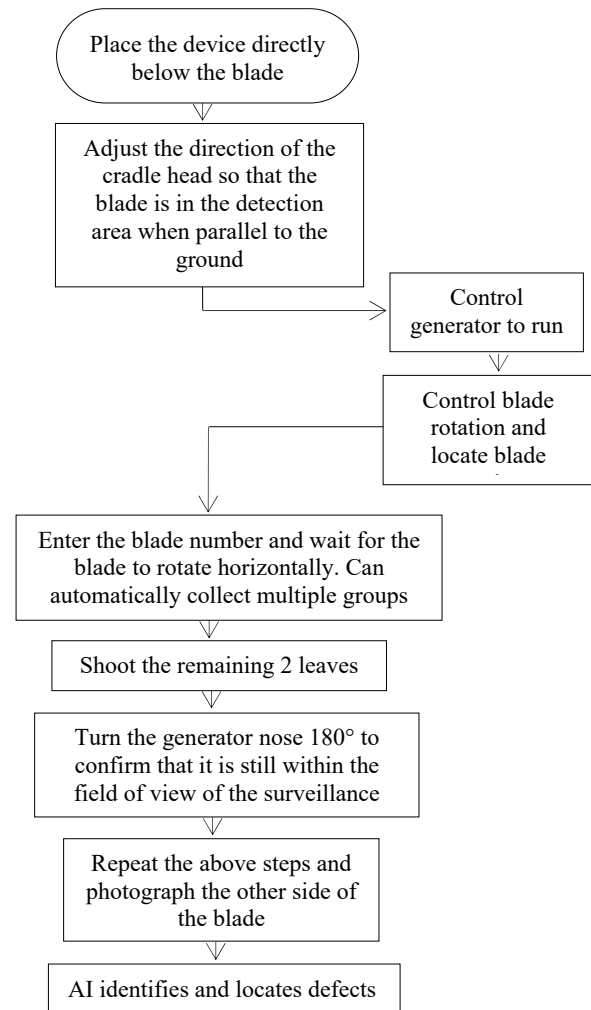
The working process of this system is shown in Figure 3:

Fig. 3. Working process of the system.

The system takes multi-angle photos of the stationary wind turbine blades by using a high-definition camera array mounted on the cradle head, and stores them in a computer. For one thing, the stored images are detected by the wind turbine blade defect detection system; for another thing, they are stored in the defect database and compared with the defect information from the system, so as to prepare for the accurate detection of blade defects and the output of blade quality analysis report.

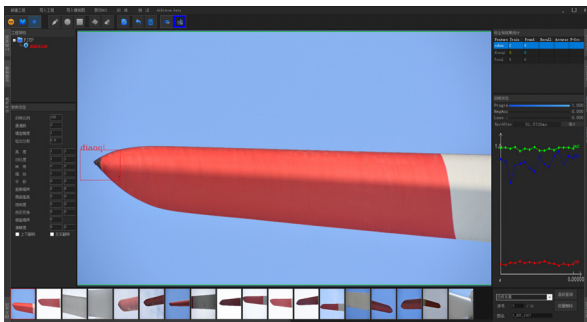
After the sample is imported, GT frame is labeled on the target that needs to be positioned and recognized, as shown in Figure 4.

Fig. 4. Labeling of samples.

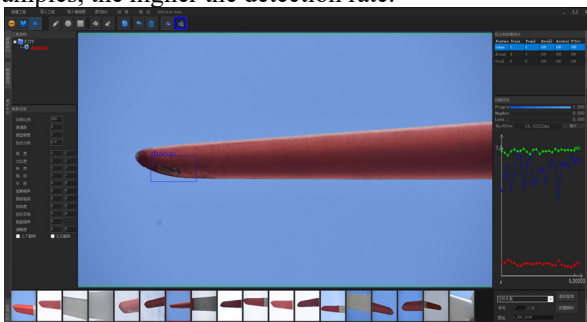
After all the samples are labeled, the samples can be "trained", as shown in Figure 5. After the training, the recognition effect of all samples will be automatically tested. The detection rate of defects depends on the number of training samples, and the larger the number of samples, the higher the detection rate.

Fig. 5. Training of samples.
